**MARINE INVESTIGATION REPORT
M13L0185**

LOSS OF TOW AND SUBSEQUENT GROUNDING

**TUG *ANDRE H.* TOWING THE BARGE *I.V. NO. 8* AND THE
VESSELS *I.V. NO. 9* AND *I.V. NO. 10*
GROS-MORNE, QUEBEC
15 DECEMBER 2013**

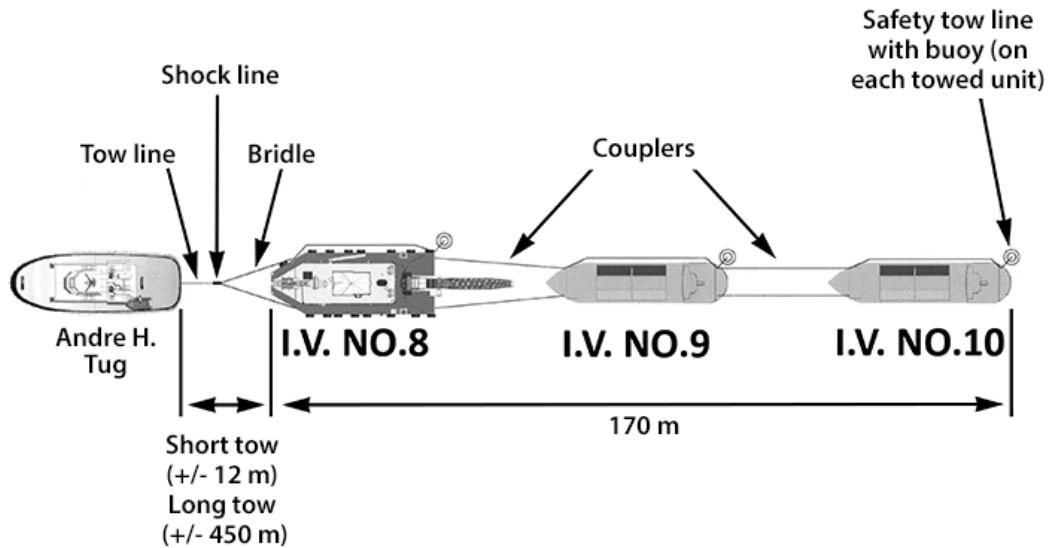
Figure 1. Towing arrangement

the tug proceeded downbound the St. Lawrence River, stopping in Rimouski, Quebec, to take under tow the vessels *I.V. NO. 8*, *I.V. NO. 9* and *I.V. NO. 10* that were required to complete a dredging contract in Dalhousie, New Brunswick. The 3 vessels were connected by the dredging crew in a tandem⁴ tow configuration with polyolefin fibre rope couplers,⁵ each approximately 37 m in length and 88 mm in diameter: the *I.V. NO. 8* was followed by the *I.V. NO. 9* and then the *I.V. NO. 10* (Figure 1).

The 3 service vessels were connected in a tandem tow configuration with polyolefin fibre rope couplers (2 per tow). Each coupler was approximately 37 m in length and 88 mm in diameter. In the arrangement, the *I.V. NO. 8* was followed by the *I.V. NO. 9* and the *I.V. NO. 10*. The *Andre H.* tow line was a wire cable of approximately 455 m in length and was equipped with a steel cable bridle and a synthetic spring. It was attached to the towing winch at the bitter end,⁹ so that it would be easily disconnected by the momentum of the wire if it were to detach from the drum.

In this occurrence, contrary to accepted industry standards for towing, the towing arrangement employed synthetic fibre rope couplers, despite the exposed waters in the area, time of year, and expected weather conditions.

In exposed waters, industry standards prescribe the use of a long all-wire towing arrangement, where the steel cables allow for a catenary effect to absorb the shock from the sea movement and traction of the tug. Synthetic ropes offer no catenary effect and do not dampen the movement of the tow, as the ropes float and are relatively short. In addition, TSB Laboratory analysis determined that the recovered rope couplers that were in use had reduced breaking strength, likely caused by abrasion, contamination, and exposure to sunlight. Thus, the rope couplers were unable to withstand the forces created by the tow and movement of the waves, which caused them to part.
