# MARINE INVESTIGATION REPORT

## M16A0140

### **Capsizing and loss of life**

Small fishing vessel C19496NB  
Salmon Beach, New Brunswick  
16 June 2016

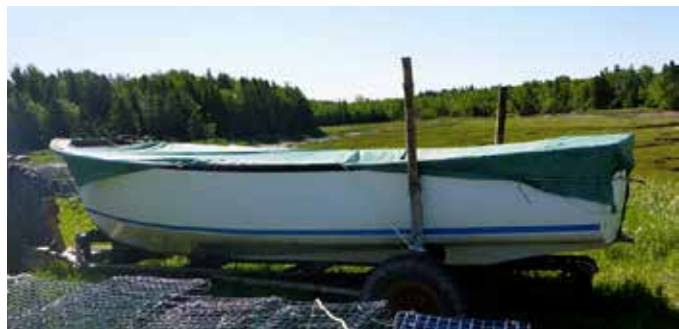
Figure 1. Vessel C19496NB (profile view)

C19496NB (Figures 1 and 2) was a 7.1 m open speedboat built of fibreglass with a small open wheelhouse near the bow. It was powered by a 90 hp 4-stroke outboard motor and equipped with a magnetic compass, a citizens band (CB) radio, and an on-board electronic sounder. There was a radar reflector, a 7-inch LED rear deck light, and navigation lights mounted on top of the wheelhouse, and a handheld search light on the console. The vessel had 3 lifejackets, flares, a steel fire bucket, a handheld aerosol horn, and a dry chemical fire extinguisher located in the forward cuddy (Appendix A). A lifebuoy and a steel trawl anchor were located aft of the cuddy.

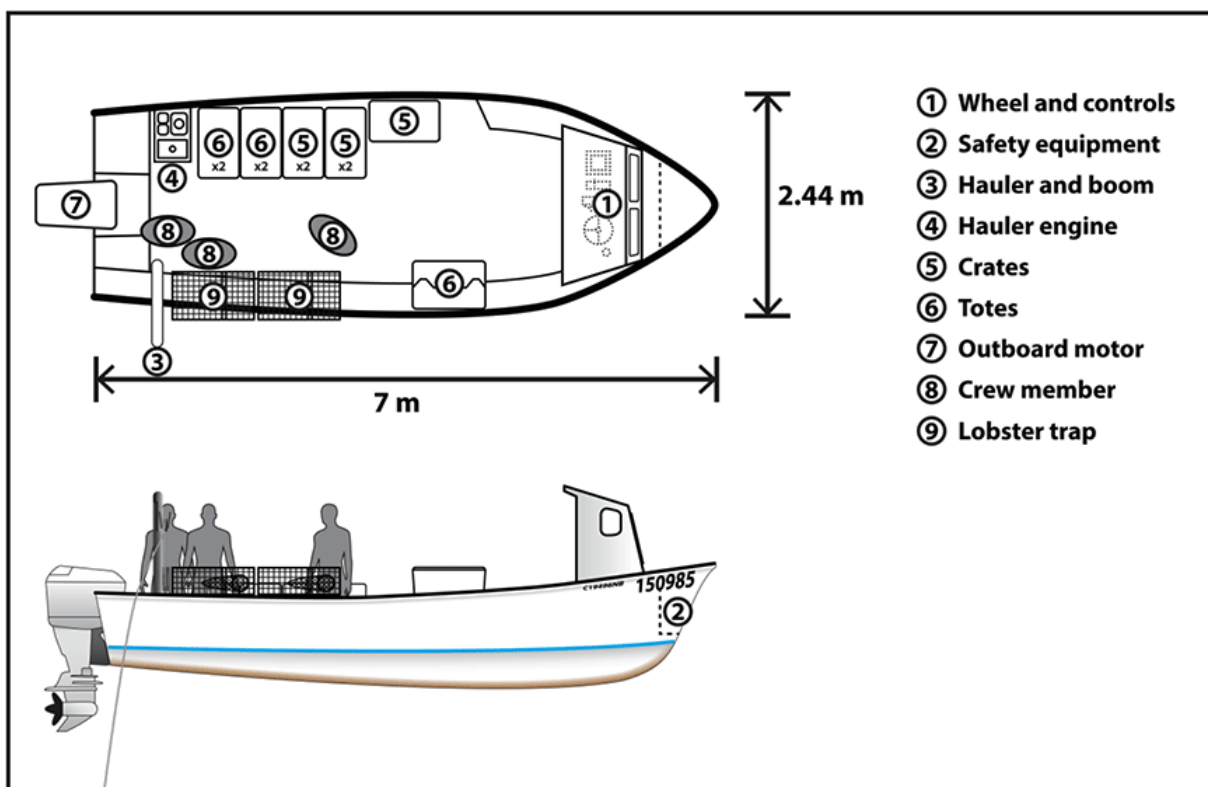
Figure 2. Arrangement of the occurrence vessel

Two stern scupper plugs were secured in the hull. It was common for wave spray and water running off the gear to cause water to accumulate on the vessel's deck to a depth of up to several inches. When too much water accumulated, the master would remove a scupper plug and manoeuvre the vessel in a continuous turn towards the side that the plug was on. Once the water had drained out into the ocean, the master would reinsert the plug.

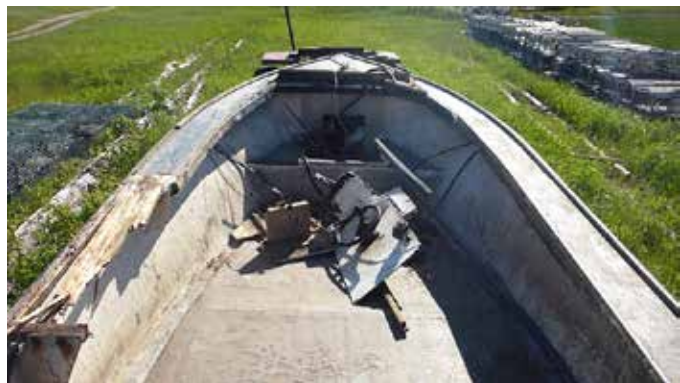
Figure 3. Detail of the damage to C19496NB

The vessel's small open wheelhouse, aft port gunwale, lobster trap hauler, and boom were torn off when the overturned vessel was being towed in to Miller Brook Wharf (Figure 3). The outboard motor, hydraulic hauler engine, and electronic equipment were contaminated by saltwater.

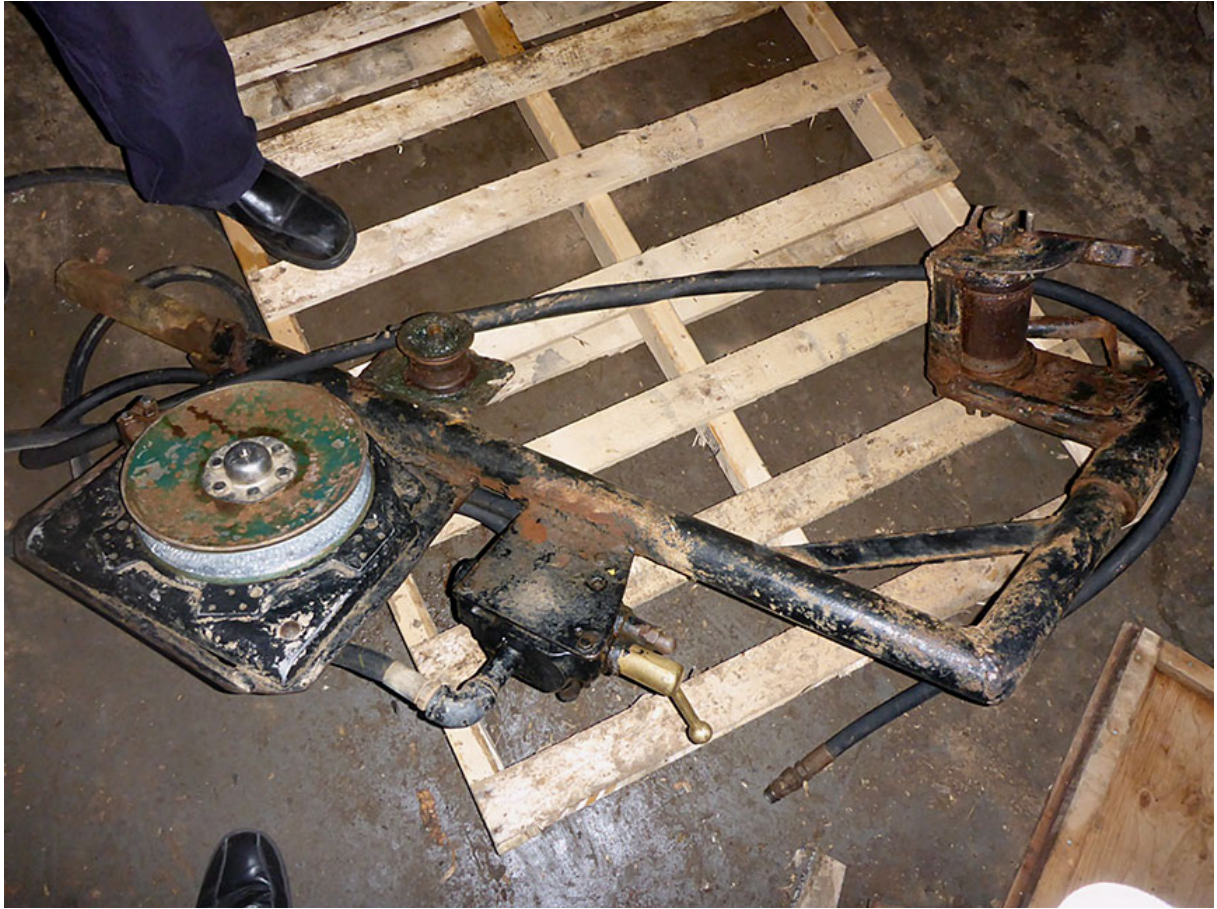
*Appendix B – Lobster trap hauler and boom*

However, in this case the entangled trap was not hauling up to the vessel; instead, it was acting like an anchor on a short rode.<sup>28</sup> The strain caused by the entangled trap line in the hauler drew the starboard aft gunwale of the vessel downwards, lowering the freeboard on that part of the vessel. The vessel began taking on water.
