MARINE TRANSPORTATION SAFETY INVESTIGATION REPORT M18C0240

Crew member seriously injured

Passenger vessel *Amadea*

09 September 2018

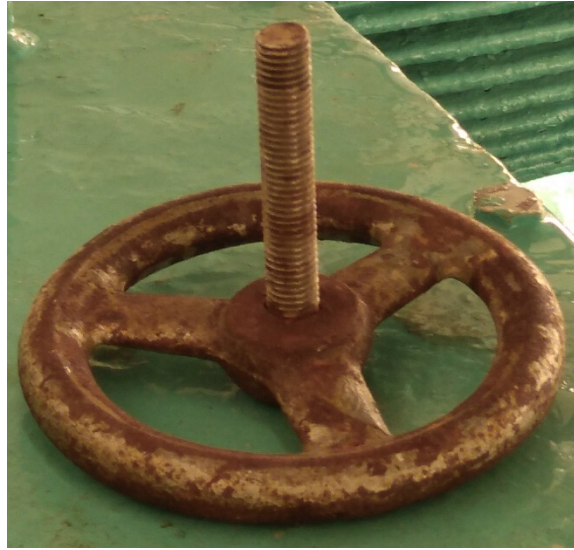
The electromagnetic brake is manually released using a tool consisting of a small-radius hand wheel attached to a threaded rod (Figure 3). The brake release tool is screwed into the brake casing at the free end of the winch motor, partially compressing the electromagnetic brake's spring. The winch instruction manual warns that the brake release tool is the only tool that should be used, that the tool must be turned only by hand, and that using "extreme power"¹³ could damage the internal components of the electromagnetic brake.

Figure 3. Brake release tool for the winch motor's electromagnetic brake (Source: TSB)

During the lifeboat stowage trials, the TSB observed that the crew used a lever-type tool³⁵ in the spokes of the electromagnetic brake release tool's hand wheel to create additional torque when releasing the electromagnetic brake. Using this lever on the hand wheel allowed crew members to disengage the electromagnetic brake further than what would normally be accomplished by hand alone, because some drag within the electromagnetic brake is required to prevent or control backlash in the system. Using the lever-type tool was routine practice, including during the occurrence.

It became an informal practice among crew members to manually over-torque the electromagnetic brake release tool to reduce the physical effort involved in manually winching lifeboat No. 4. This would result in the winch's gear train freewheeling if the operator(s) let go of the crank handle. The crew members were unaware of the hazard related to over-torquing the brake release tool.

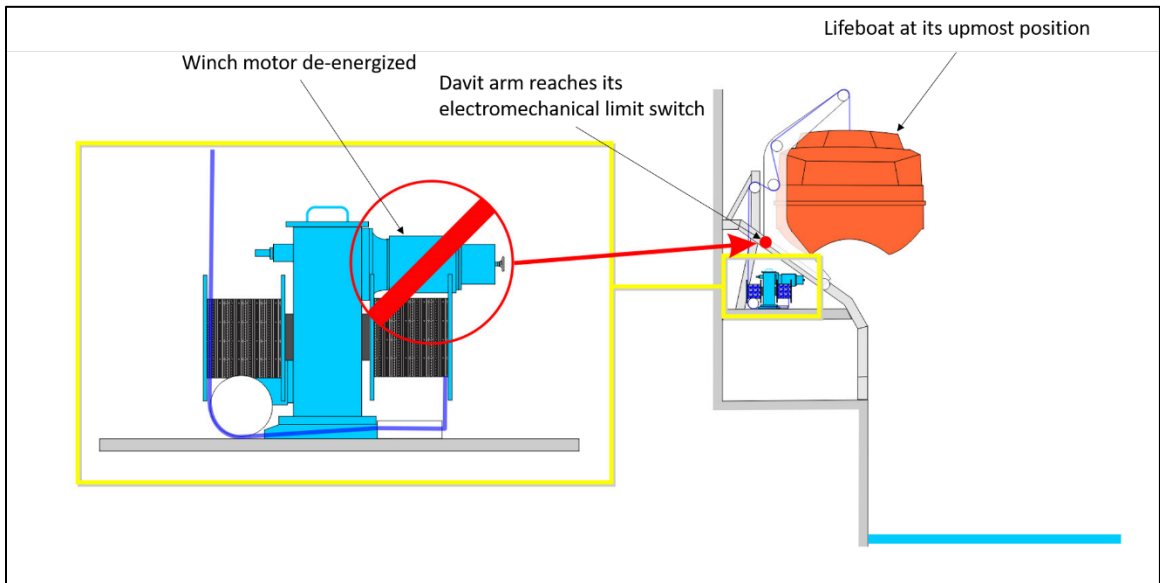
Both electromechanical limit switches are adjustable, and their levers can be repositioned to vary the point at which the winch motor de-energizes before the davit arms reach their stops. At the time of the occurrence, the switches were adjusted so that the winch motor would de-energize 20 cm before the davit arm reached its stop.

Figure 7. Diagram illustrating the lifting of the lifeboat: when the lifeboat is in its uppermost position and the davit arms reach the levers of the electromechanical limit switch, the winch motor is de-energized automatically (Source: TSB)

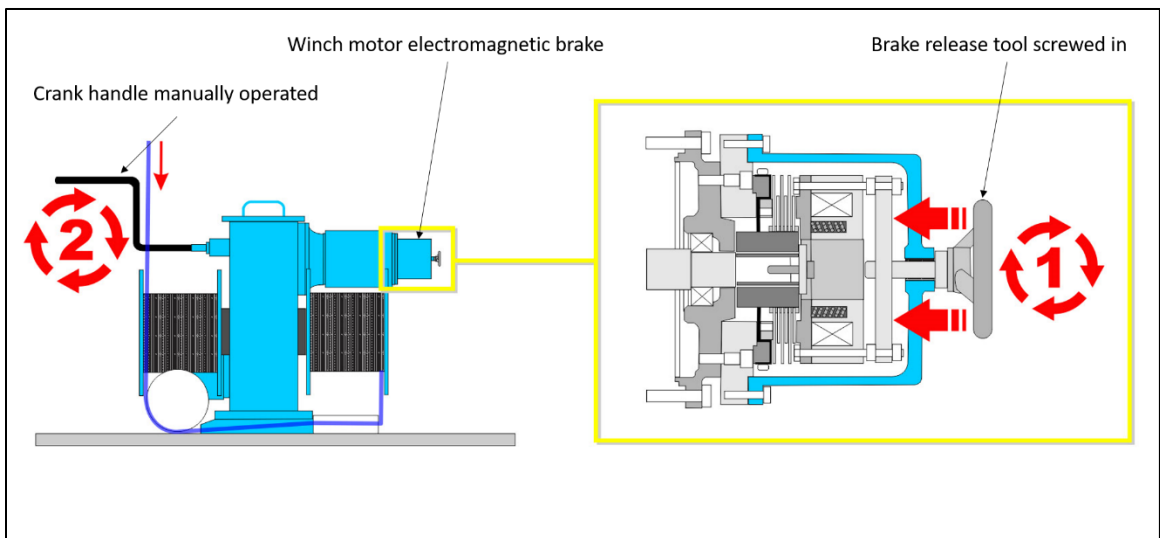
Operators must then secure the lifeboat by manually winching it up to its final stowed position. To facilitate manual winching, the electromagnetic brake is manually disengaged using the brake release tool, which is screwed into the winch motor (Figure 8, Step 1), and the crank handle is installed to its coupling on the winch gearbox and turned by hand (Figure 8, Step 2).

Figure 8. Diagram illustrating Steps 1 and 2 of the sequence of operation for manually disengaging the electromagnetic brake so that the lifeboat can be winched manually (Source: TSB)

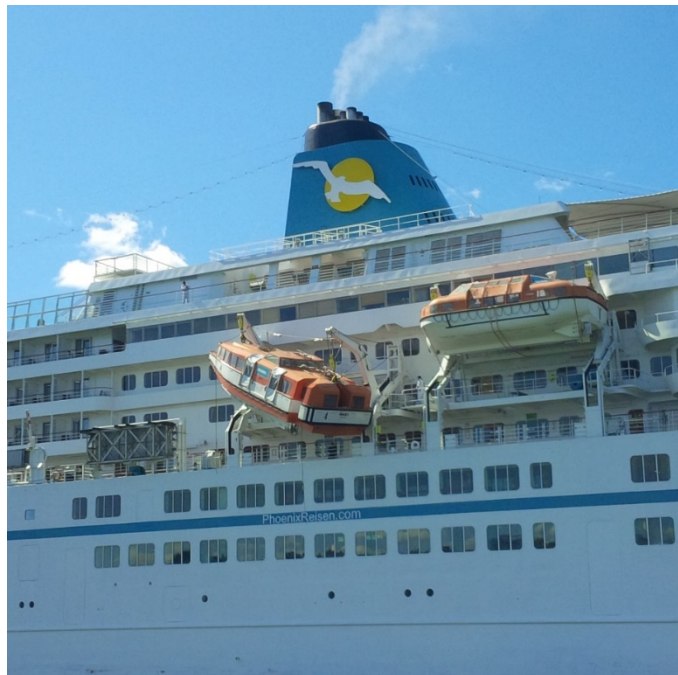
Figure 10. Lifeboat No. 4 following the uncontrolled lowering of the davit's aft arm (Source: TSB)

About a minute later, the relief OS and the AB lost their grip on the crank handle. The crank handle kicked back and freewheeled in a counter-clockwise rotation, hitting the relief OS on the head and knocking him unconscious. The davit's aft arm lowered uncontrollably and the lifeboat's stern lowered with it, eventually coming to a stop (Figure 10).

The relief OS and the AB continued manual winching and the excessive tension on the winch system caused them to let go of the crank handle. Because the electromagnetic brake was released, the crank handle suddenly kicked back and spun backwards, hitting the OS on the head. The OS was not wearing protective headgear and sustained serious head injuries.

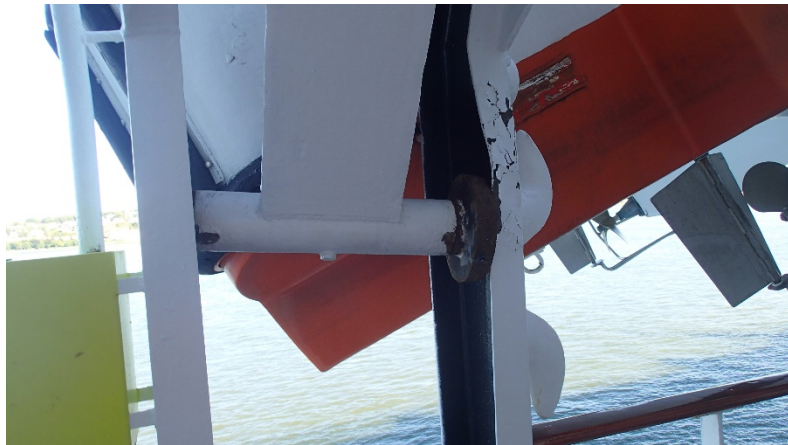
Following the uncontrolled lowering of lifeboat No. 4's aft davit arm, one of the arm's roller tracks was bent close to the shipside handrail (Figure 11).

Figure 11. Damage sustained to lifeboat No. 4 davit aft roller track (Source: TSB)

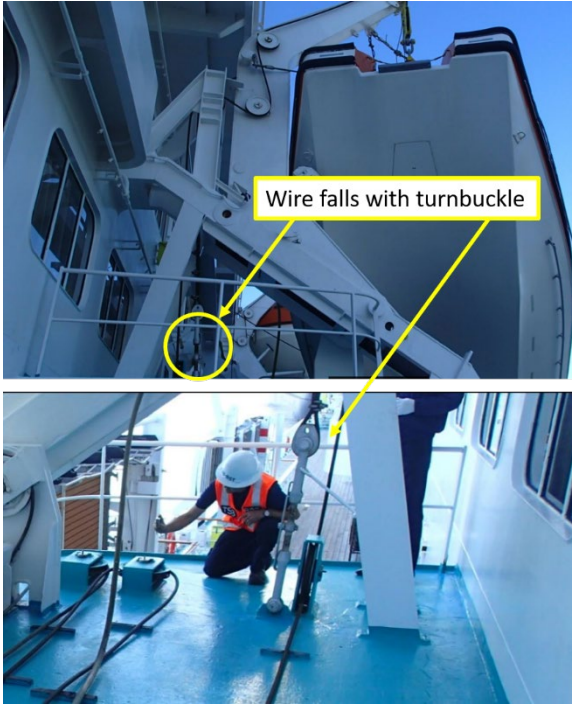
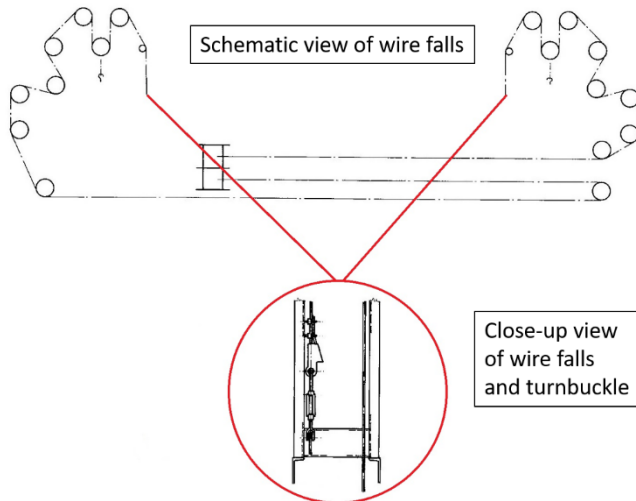
Appendix D – Photographs and technical drawing of the wire falls and turnbuckle on the davit of lifeboat No. 4

The fixed end of the wire falls of the *Amadea's* lifeboat davits is fitted with a turnbuckle so that adjustments can be made to ensure that the davit arms remain aligned while they are moving (Appendix D). Overloading of the wire falls and damage to the mechanical components of the davit (Figure 2, Figure 7, and Appendix C) is prevented by means of an electromechanical limit switch to each davit arm.
