MARINE TRANSPORTATION SAFETY INVESTIGATION REPORT M22A0312

LOSS OF STEERAGE AND GROUNDING

Roll-on/roll-off ferry *Confederation*
Caribou, Nova Scotia
04 September 2022

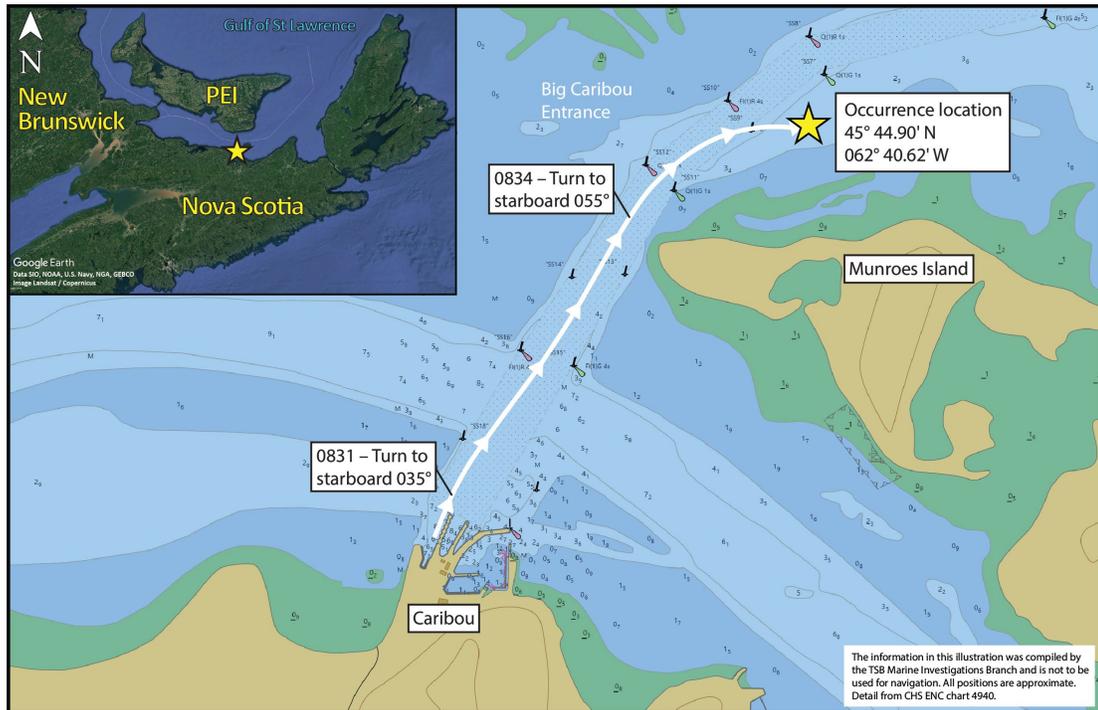
At the same time, the quartermaster began a turn to starboard (Figure 3). Once the vessel reached the desired heading, he applied the rudder to port to straighten the vessel course on a heading of 055 degrees.

Figure 3. Map of the occurrence, showing where the vessel left the channel (Source of main image: Canadian Hydrographic Service chart 4940, with TSB annotations. Source of inset map: Google Earth, with TSB annotations)

At 0835, the quartermaster told the master that the vessel was continuing to turn rapidly to starboard and was not responding to the hard-to-port rudder command.

From the centre bridge console, the master confirmed that the rudder angle indicator was hard to port. At 0835:14, the master put the propellers astern and ordered the standby crew to drop both anchors. The vessel continued to starboard and started moving out of the channel at 0835:44.
