MARINE TRANSPORTATION SAFETY INVESTIGATION REPORT M22A0355

BOTTOM CONTACT

Passenger vessel *Kawartha Spirit*
Halifax, Nova Scotia
26 October 2022

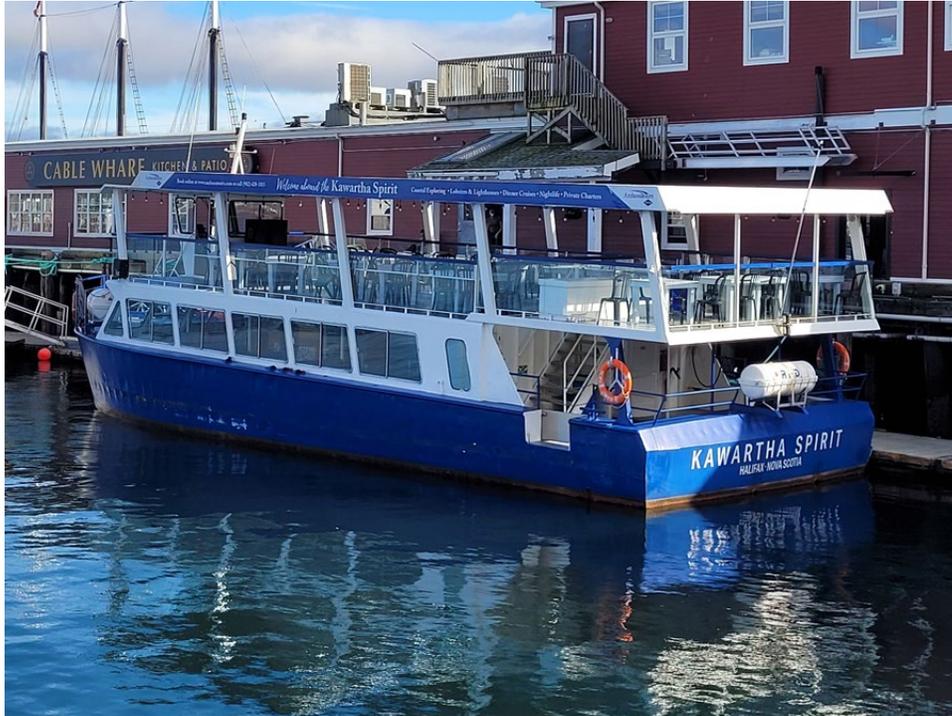
Figure 1. The *Kawartha Spirit*, docked at Cable Wharf, Halifax Harbour (Source: TSB)

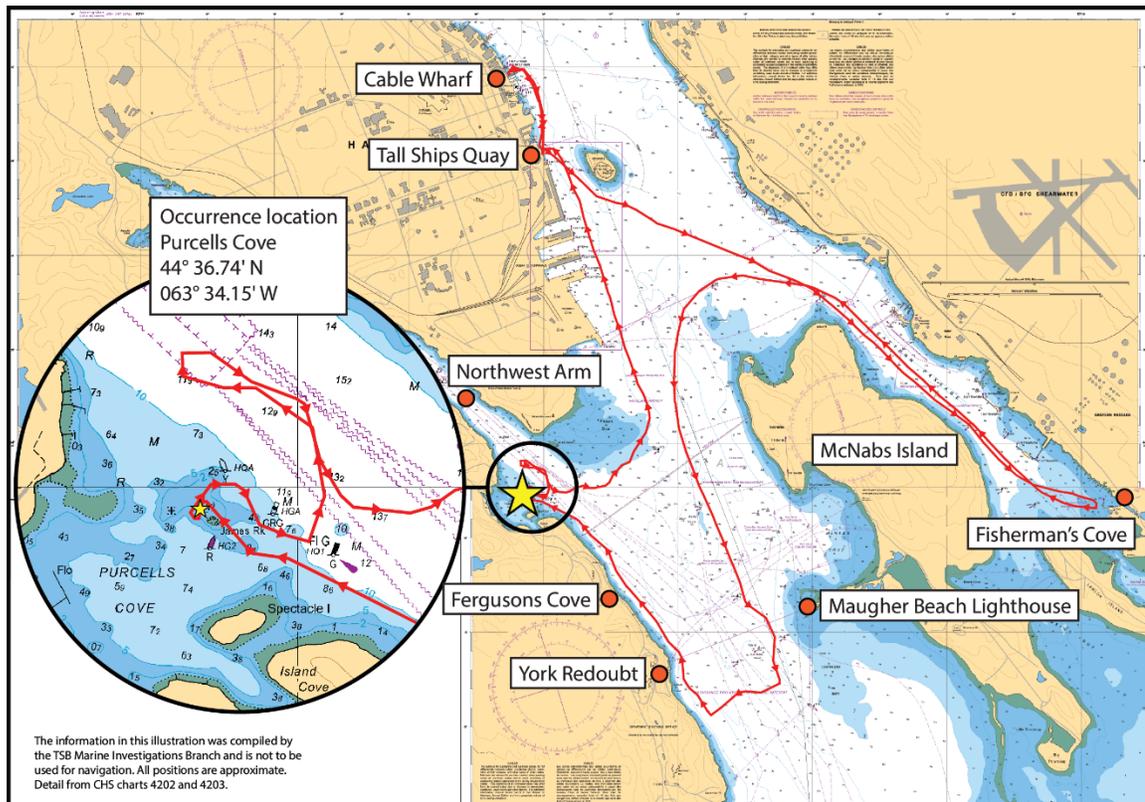
Figure 2. Occurrence location and vessel track (Source: Canadian Hydrographic Service, charts 4202 and 4203, with TSB annotations)

At 1258, just before Purcells Cove, the master sighted a port hand (green) buoy on the starboard side of the *Kawartha Spirit*. The master looked at the chart plotter to assess the vessel's position, but could not locate the green buoy on the display. At 1259, the master altered the vessel's course to starboard in an attempt to position the vessel so that the green buoy was on the port side. However, less than 30 seconds later, the *Kawartha Spirit* touched bottom at a speed of 7 knots in position 44°36.44' N 063°34.07' W (Figure 2) and lost propulsion. At this time, the tide height was 0.8 m.
