# MARINE TRANSPORTATION SAFETY INVESTIGATION REPORT M22C0335

## CREW MEMBER INJURY

Self-propelled barge *Rivière Saint-Augustin*  
Chevery, Quebec  
13 October 2022

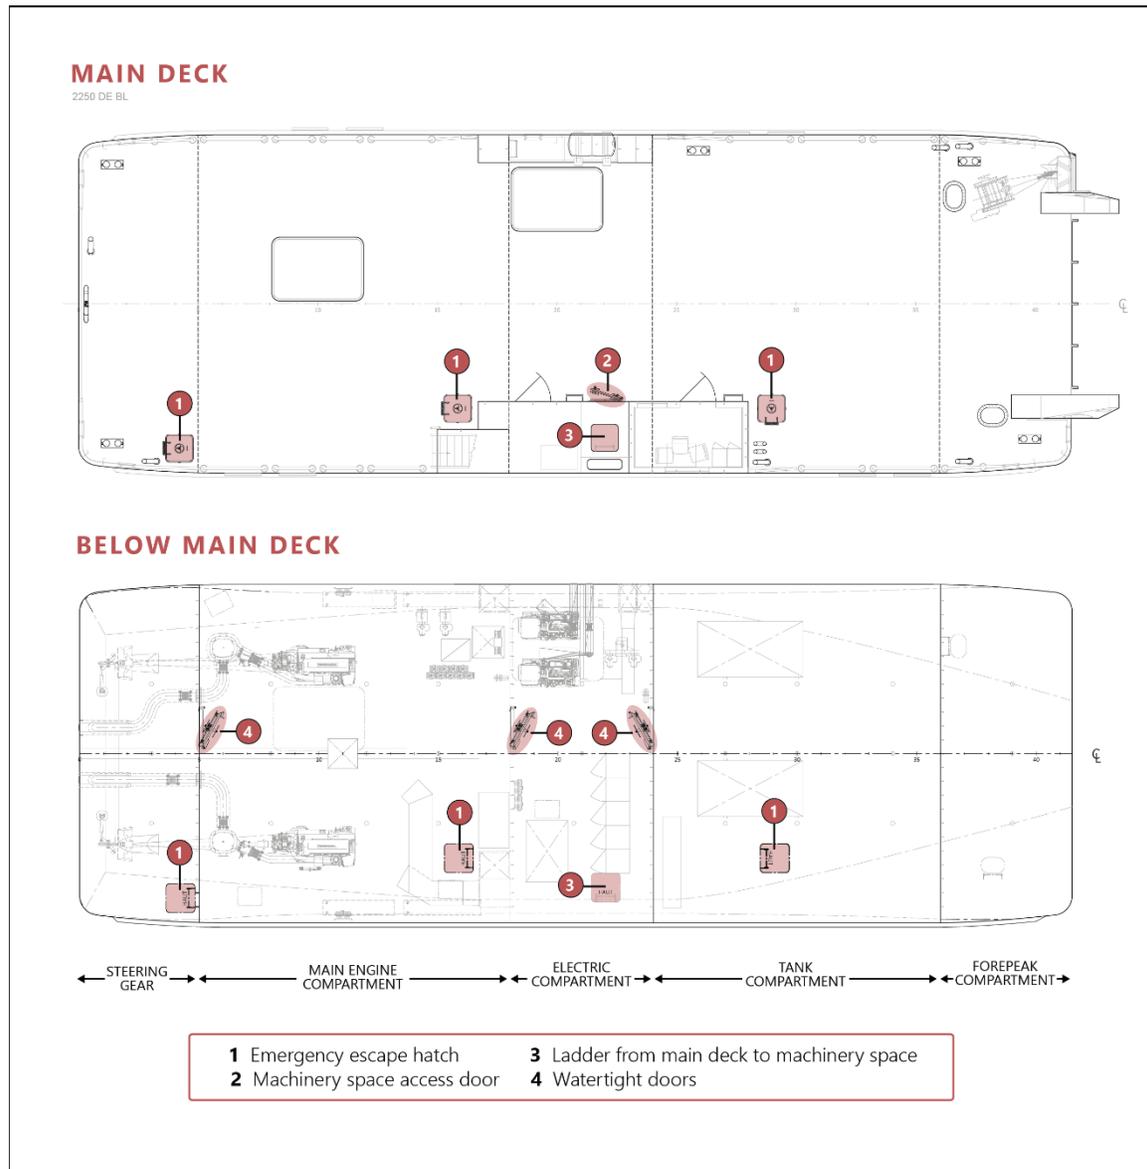
The 3 transverse bulkheads between the machinery space compartments are each equipped with a watertight door to allow access between compartments. Each of these compartments also has an emergency hatch leading to the main deck. To ensure vessel safety, crew must close all watertight doors and escape hatches on the main deck and in the machinery space when the vessel is at sea.

Figure 2. Layouts of the main deck and the lower deck, showing the compartments of the machinery space and watertight doors and hatches that are usually closed when the vessel is operating (Source: Ocean Group, with TSB modifications and annotations)

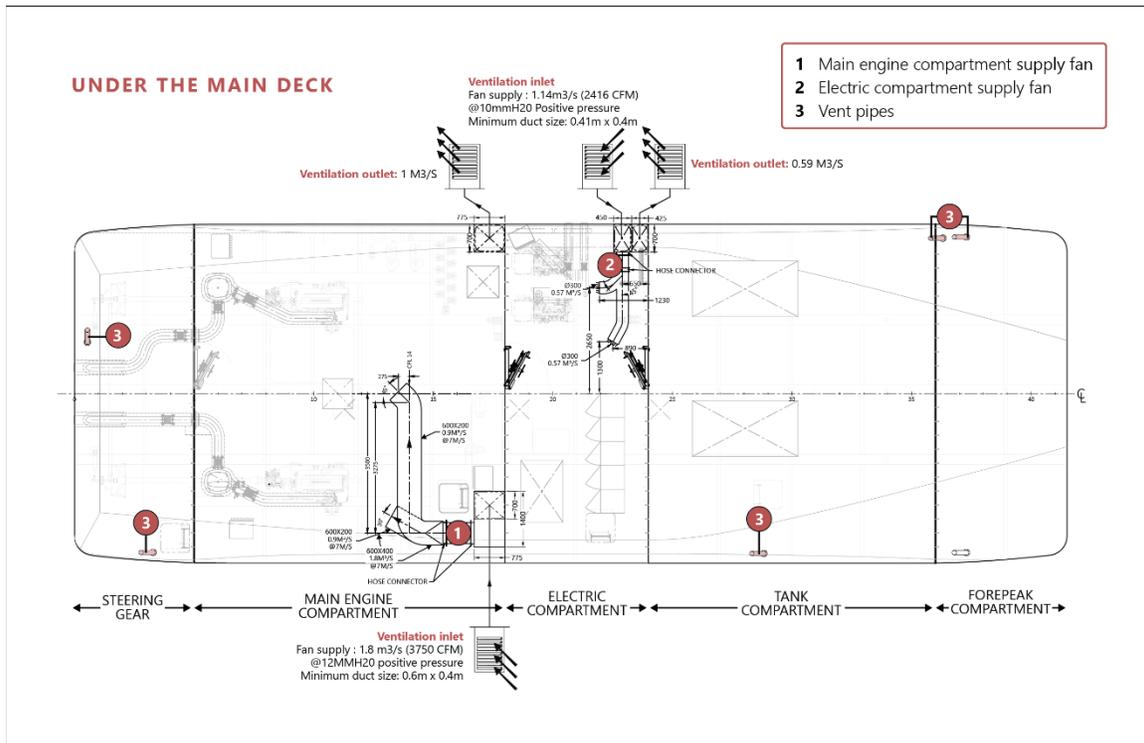
Air is supplied through the ventilation system (Figure 4) to support the internal combustion of the main engines and ship service generators, to remove excess heat, and to prevent the accumulation of exhaust fumes and chemical vapours. Air is supplied to the main engine and electrical compartments by supply fans. At maximum continuous rating, the air consumption of the main engines is 25 m<sup>3</sup>/min each. Openings for air supply and exhaust are located on trunking above the main deck and on the side of the superstructure. The steering gear and tank compartments and the forepeak are ventilated through inverted vent pipes and natural circulation. Non-return valves are fitted on the vent pipes to prevent water ingress.

Fire dampers are installed in the air supply and exhaust ducts at the main deck level and can be closed to cut off the air supply in the main engine and electrical compartments. The fire dampers are operable from the main deck. When the vessel is winterized, specially designed blanks are installed on the outboard-facing exhaust outlets to keep the space warm and prevent water ingress.

Figure 4. Ventilation of the main engine and electrical compartments (Source: Ocean Group, with TSB modifications and annotations)

In this occurrence, when the watertight access door was closed, air supply to the main engine compartment was cut off. When the chief officer increased the vessel speed and brought the engines to full load, the air demand required to sustain main engine internal combustion increased. A pressure differential between the machinery space and the outside resulted, causing the exterior door and emergency escape hatches to become stuck closed.
