# MARINE TRANSPORTATION SAFETY INVESTIGATION REPORT M23F0012

## MOORING ACCIDENT

Naval auxiliary supply vessel *Asterix*  
Busan, Republic of Korea  
28 May 2023

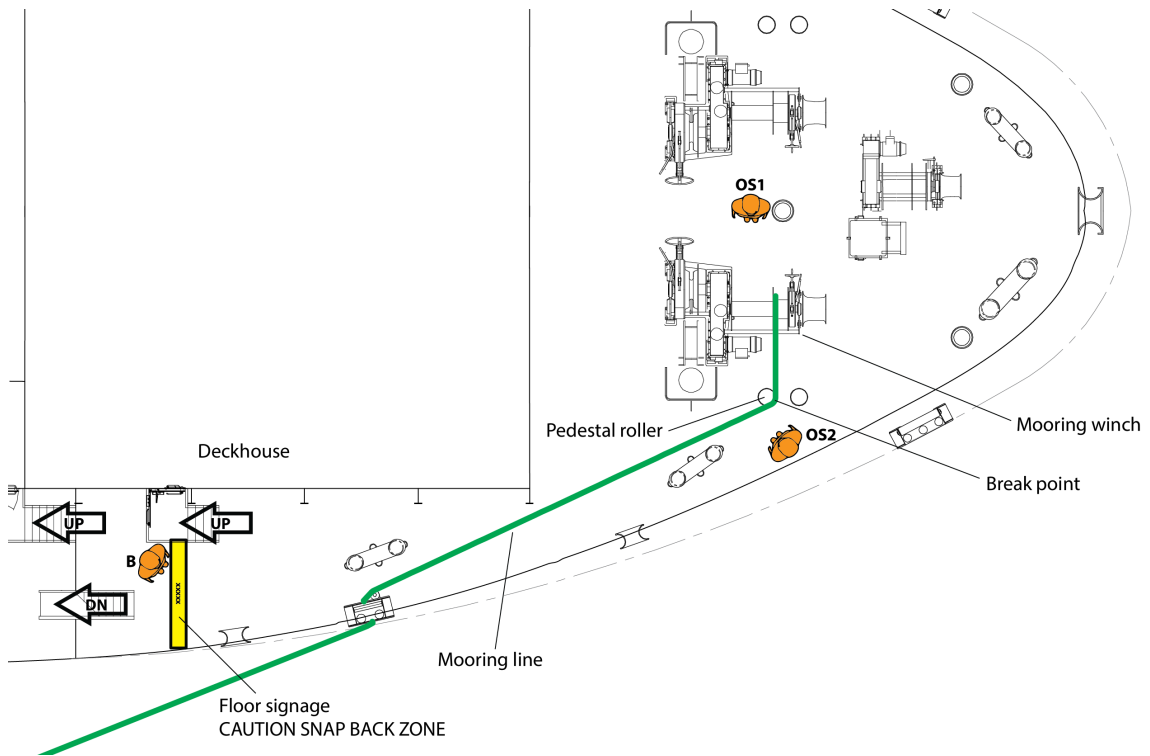
At 0850:48, with the vessel still making about 0.5 knots over ground, the engine telegraph was set to dead slow astern. Shortly thereafter, the deckhand relaying the bosun's hand signals directed the deckhand operating the winch (the winch operator) to stop and then resume paying out the line. At approximately 0850:56, the forward line parted at the pedestal roller, snapping back and striking the bosun in the chest. About a half second later, the engine reached dead slow astern.

The controls for the vessel's forward mooring winches are located on the centreline, and the vessel's forward deckhouse is located just aft of the forward mooring winch (Figure 2). The controls and the deckhouse can obstruct the forward winch operator's view over the vessel's side and of the spring line's fairlead. To accommodate this, the forward winch operator relies on another deckhand to relay signals from the bosun to tension or slack the line as needed.

The winch operator was paying out the mooring line as directed by the other members of the forward mooring party while the vessel was moving ahead. The investigation was unable to determine if the winch was stopped when the mooring line parted.

Figure 2. Illustration of the *Asterix*'s forward mooring station, showing the positions of the mooring line, winch operator (OS1), deckhand (OS2), and bosun (B) as well as the location of the break point by way of the pedestal roller (Source: TSB, based on the ship's drawing, Arrangement mooring, document n° 370-00-433-001 [2018])

Following the occurrence, Federal Fleet Services Inc. indicated that it had modified its operating manuals to forbid crew from making changes to the mooring plan after it had been agreed to with the pilot. Further, vessels in the fleet are required to come to a complete stop alongside a dock before mooring lines are sent ashore, and tug assistance must be used for any vessel movement.
