Pipeline Transportation Safety Investigation Report P20H0023

RELEASE OF CRUDE OIL INCIDENT

Trans Mountain Pipeline ULC
Sumas Pump Station
Abbotsford, British Columbia
12 June 2020

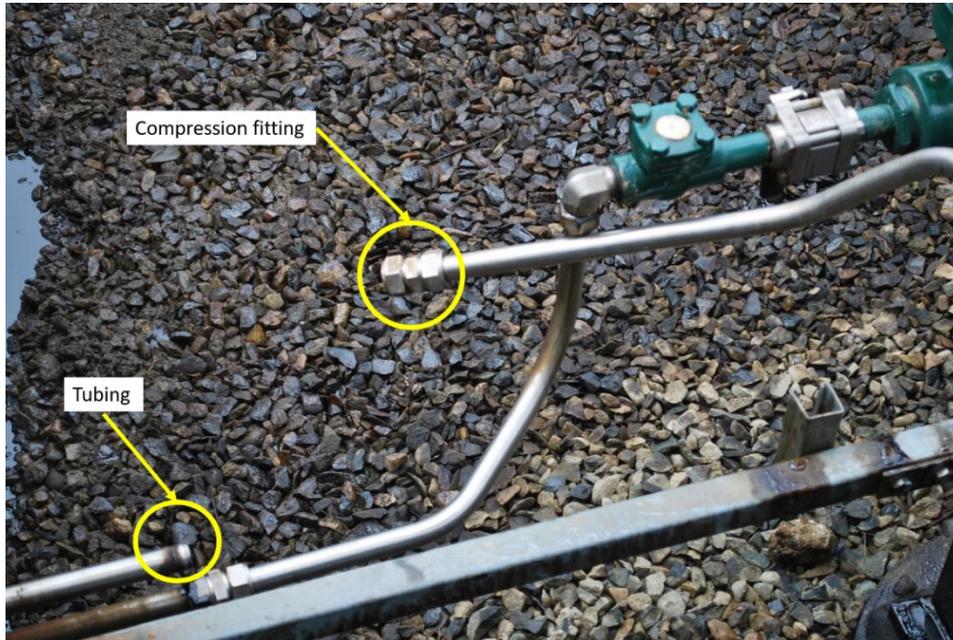
Figure 2. Occurrence compression fitting (Source: TSB)

The crude oil released from a 1-inch compression fitting that had separated from tubing on a section of above-ground piping adjacent to the building that houses the equation-of-state (EOS)² system (Figure 2).³ The failed compression fitting was used to join tubing from the discharge mainline to the EOS system.

In this occurrence, the tube had pulled free from the compression fitting. A preliminary analysis determined that the occurrence tube had marks of progressive sliding between the two ferrules, which suggested insufficient tightening of the compression fitting at the failure location.

The laboratory analysis concluded that the compression fitting failed because of a loss of ferrule grip due to improper tightening during installation.

- Develop a procedure to verify the integrity of the existing tubing systems.
- Develop an internal standard outlining the requirements for the construction and quality assurance of new tubing systems, as well as a procedure for the installation of tubing systems by Trans Mountain personnel.

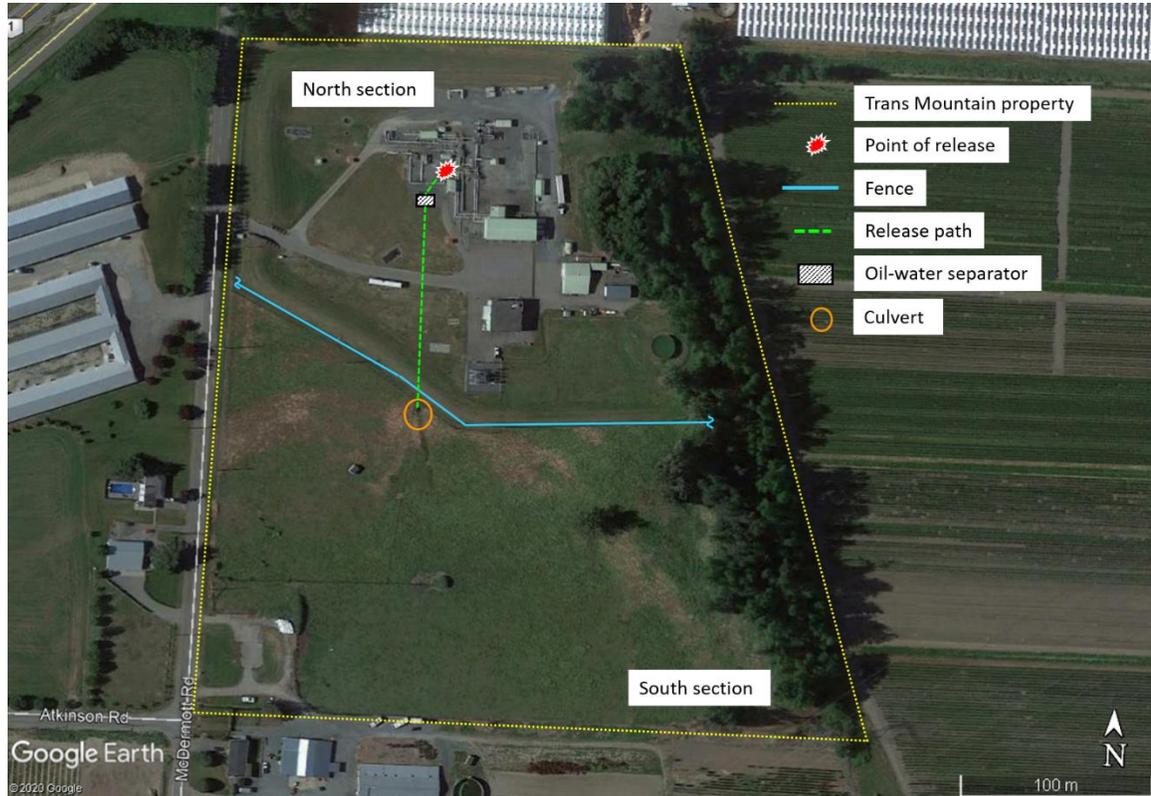
Figure 3. Path of the released oil (Source: Google Earth, with TSB annotations)

From the point of release, the oil had followed a path into the pump station's surface drainage system, through an oil-water separator, and into a culvert that discharges surface water into the south section of the property (Figure 3). As a result, 7 m³ of the released oil had migrated to the agricultural field in the south section.

In this occurrence, by the time the oil releasing from the EOS system reached the oil-water separator and triggered an alarm at 2342, the Sumas Pump Station was already in emergency shutdown. The oil, which was still flowing from the failure location, continued to accumulate in the separator until it could no longer be trapped effectively.¹¹

The separator is not equipped with an automated isolation system, nor does it have manual isolation valves. Therefore, once oil began flowing into the agricultural field, there was no means to stop it until operators could isolate the source of the release on the EOS system.

- Initiate a project, to be completed by summer 2021, to upgrade the Sumas Pump Station, including the installation of:
 - containment and drainage features;

- a new oil-water separator, which will discharge to a new PVC culvert, manhole and collection basin system before ultimately discharging through a final isolation valve; and

- a lined containment area around the station's above-ground piping.

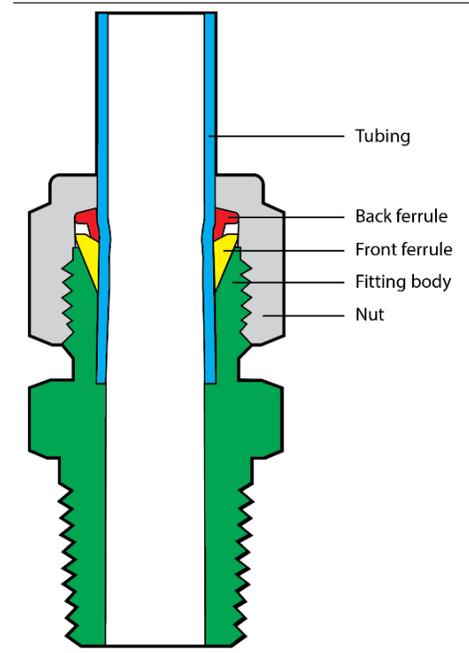
Figure 4. Schematic showing the components of a double-ferrule mechanical grip compression fitting (Source: TSB)

The failed fitting was a 1-inch stainless steel double-ferrule mechanical grip compression fitting manufactured by Swagelok (part number SS-1610-6). This type of fitting consists of an outer nut, a front ferrule, a back ferrule, and a fitting body (Figure 4).

Installation consists of fully inserting a tube into the bottom of the fitting and turning the nut. As the nut turns, the double-ferrule design creates a seal between the fitting body and the tubing, while also compressing against the tubing to ensure that the fitting is tight. The manufacturer's installation instructions for this type of compression fitting specify a 1¼ turn on the nut after finger tightening.

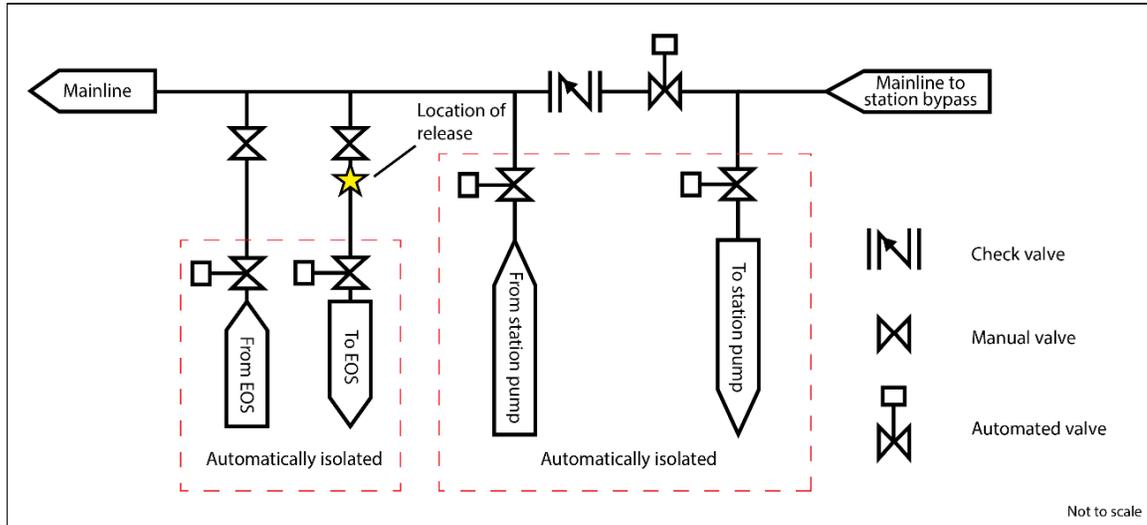
Figure 5. Schematic of bypass valves in an emergency shutdown at the Sumas Pump Station (Source: TSB)

When the combustible gas reached its lower explosive limit of 20% in the pump building, an ESD of the Sumas Pump Station was automatically initiated. In an ESD, the relevant valves are automatically set to allow the flow from the mainline to bypass the station and, once set, they are locked into position.⁹

The ESD procedure isolated the EOS system building by closing the automatic valves at the inlet and outlet tubing of the building. However, the compression fitting that failed in this occurrence was in a section of above-ground tubing between the building and the station bypass line. The valves required to isolate this section of tubing were manual valves, and therefore were not part of the automatic shutdown sequencing (Figure 5). They remained open, allowing the product to continue to release from the failed compression fitting. To stop the release, the valves for that section of EOS system tubing had to be closed by hand, which Trans Mountain personnel did when it was safe to enter the site, approximately 5 hours after the CCO received the initial alarm.

- Add an automated isolation valve on the inlet of the EOS tubing system and a check valve on the outlet.
- Reconfigure the ESD logic to allow select automated valves to be actuated remotely after an ESD.
