RAILWAY INVESTIGATION REPORT

R98V0148

REAR-END TRAIN COLLISION

CANADIAN PACIFIC RAILWAY  
TRAIN NO. 839-020 AND TRAIN NO. 463-11  
MILE 78.0, SHUSWAP SUBDIVISION  
NOTCH HILL, BRITISH COLUMBIA  
11 AUGUST 1998

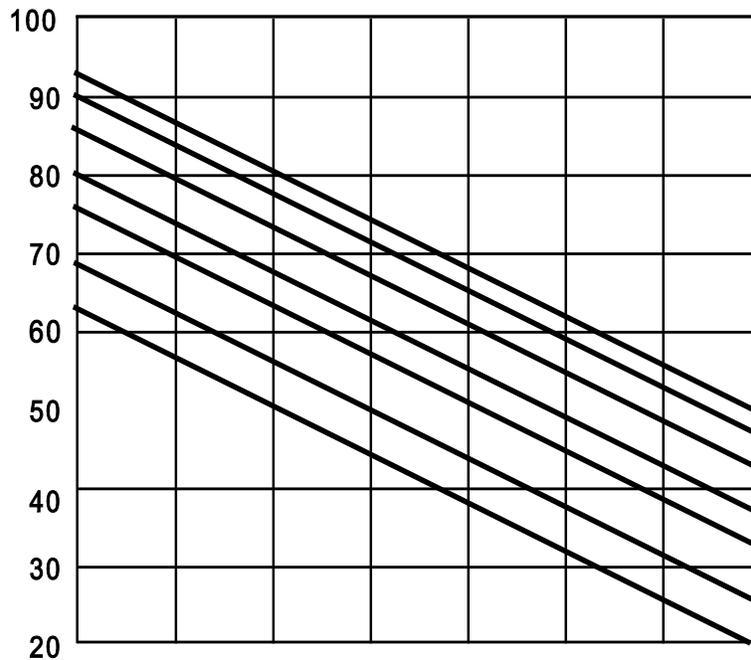
The necessary voice effort for reliable communication increases with the distance between the talker and the listener and with increasing SIL. Figure 3 shows the relationship between SIL for satisfactory communication and maximum distance between the speaker and listener, for seven levels of speaker vocal effort<sup>6</sup>.

The maximum distance at which two individuals can effectively voice communicate can be determined using Figure 3, after correcting for ambient noise levels (dBA) and hearing protectors. The ranges are presented in Table 2.<sup>7</sup>
