RAILWAY INVESTIGATION REPORT

R99D0159

RUNAWAY CARS

CORNWALL, ONTARIO

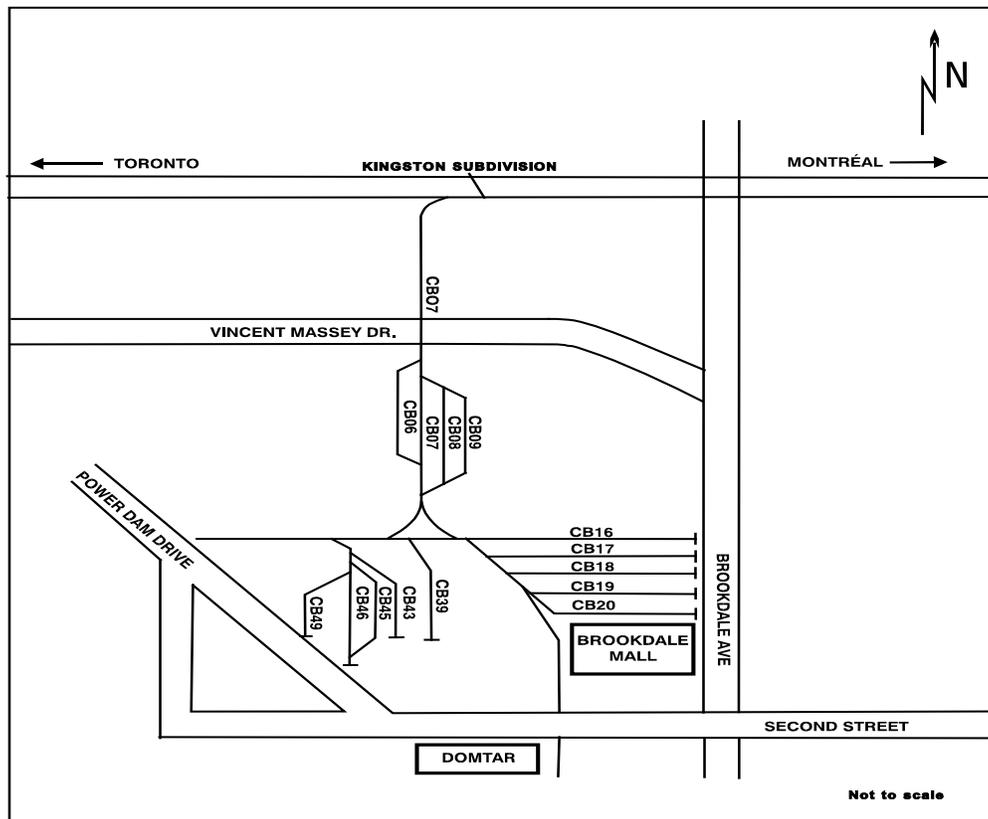
Yard CB (see Figure 1) has five storage tracks; it runs east-west through a business area between a shopping centre and a restaurant. The tracks in yard CB are used to store cars awaiting delivery to local companies.

Track CB17 is 1 500 feet long, has a 1 per cent descending grade eastward, and curves slightly left one degree over approximately 1 000 feet starting at the switch. It consists of 85-pound rails laid in 39-foot bolted lengths. It is a dead-end track equipped with an end stop block.

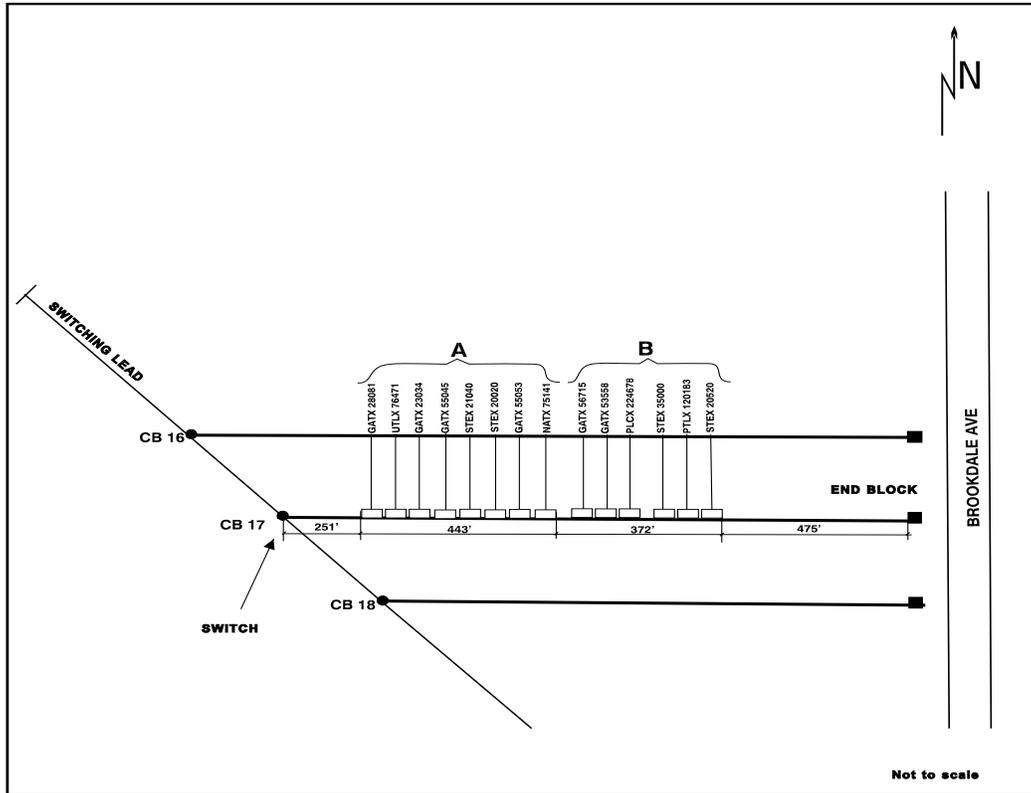
On the day of the accident, the crew had to push a draft of eight cars (draft A) onto the switching lead, place the two leading cars in the draft just ahead of the locomotive, then couple to the six tank cars (draft B) standing at the east end of track CB17 in yard CB (see Figure 2). The 14 cars were then to be delivered to various clients. This was a routine operation typically performed several times a week.

Draft A was 443 feet long and was standing 251 feet from the switch (see Figure 2). With the six cars coupled, draft B was 356 feet long. The marks made by the wheels of car STEX 20520 indicate that the east end of draft B was 475 feet from the stop block; therefore, draft B only had 372 feet. Since the cars in draft B were not in cuts, the theoretical maximum distance between draft A and draft B must have been less than 16 feet.
