RAILWAY INVESTIGATION REPORT
R05E0059

DERAILMENT

CANADIAN NATIONAL
FREIGHT TRAIN M30351-03
MILE 49.4, EDSON SUBDIVISION
WABAMUN, ALBERTA
03 AUGUST 2005

Report Number R05E0059

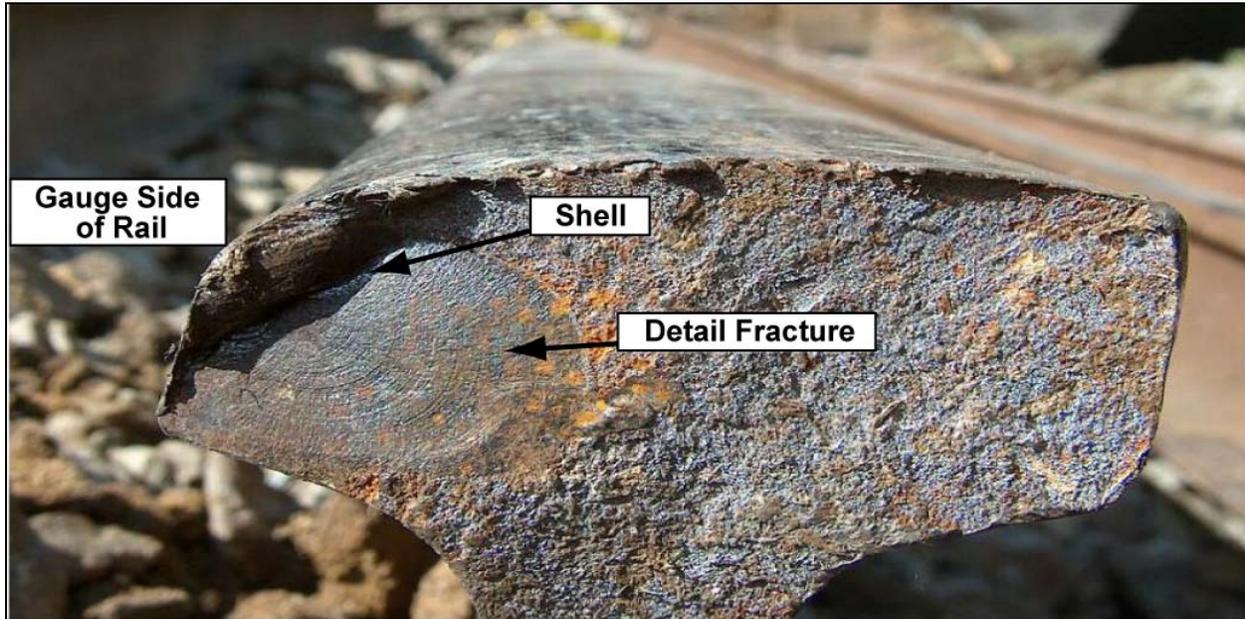
Following the derailment, a number of rail pieces were recovered and an attempt was made to reconstruct the high rail of the curve. A defect, known as a detail fracture, was observed on the fracture face of a piece from the curve's high rail (see Photo 1). As more pieces of the high rail were recovered, more detail fracture defects were observed on the fracture faces. No defects were observed on the fracture faces of pieces from the low rail.

Photo 1. Detail fracture in rail recovered in Wabamun

Photo 1 shows a detail fracture in a rail recovered at Wabamun. The detail fracture is in the gauge side of the head. There is a shell (the longitudinal separation) above the transverse defect, as well as rings indicating the progressive growth of the detail fracture with each fatigue cycle. As the size of the detail fracture increases, less of the head area is available to support the load. The critical size is reached when the remaining head area can no longer support the load; the result is sudden and complete failure.

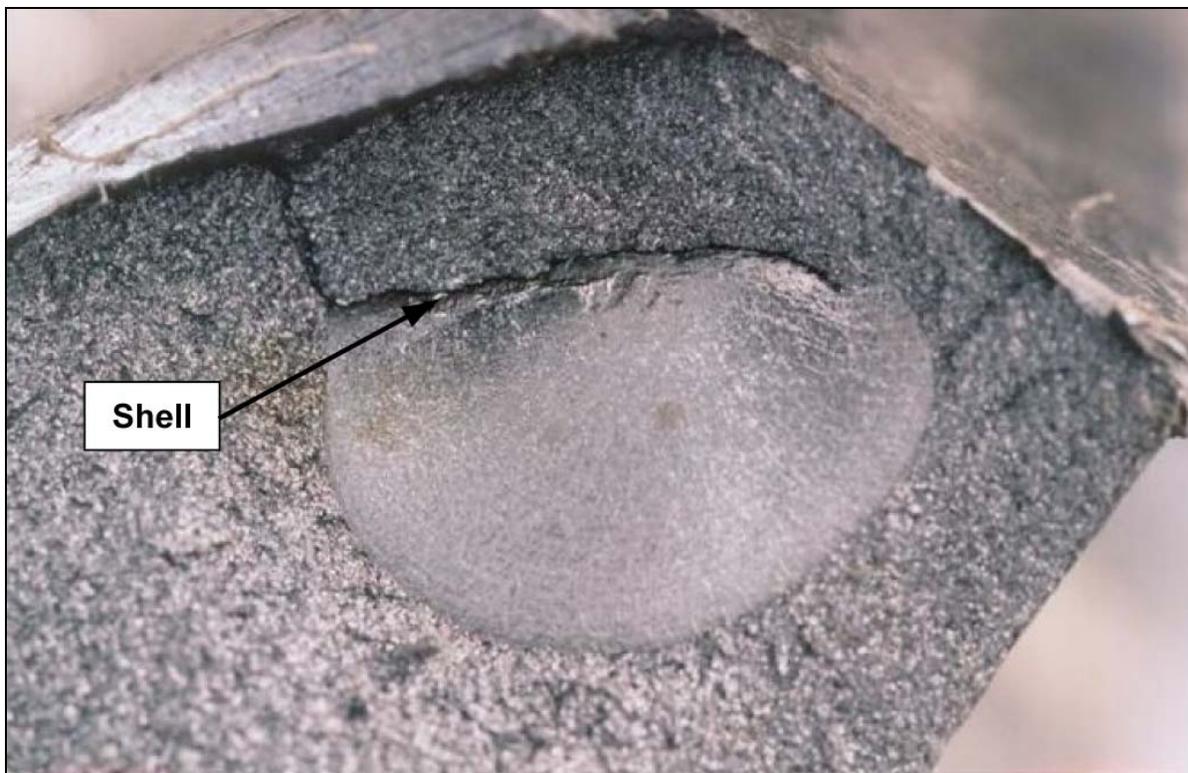
Photo 2 clearly shows the presence of the shell above the detail fracture.

Photo 2. Close-up of detail fracture

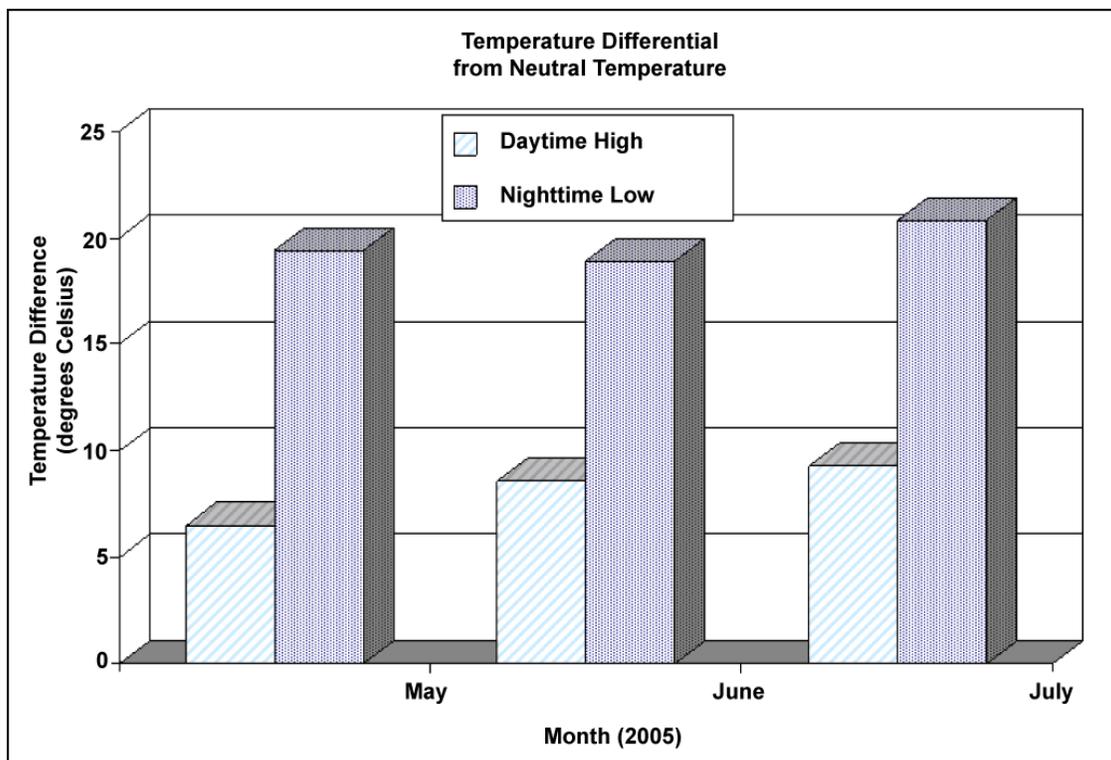
Plotted below in Figure 1 is the temperature differential for the rail at this location since the May 2005 test. The daytime differential averaged 6 to 9 degrees and 19 to 21 degrees at night. At the time of the derailment, the differential temperature was 21 degrees.

Figure 1. Differential from neutral temperature
