RAILWAY INVESTIGATION REPORT
R07D0111

CROSSING COLLISION

VIA RAIL CANADA INC.

PINCOURT/TERRASSE-VAUDREUIL, QUEBEC

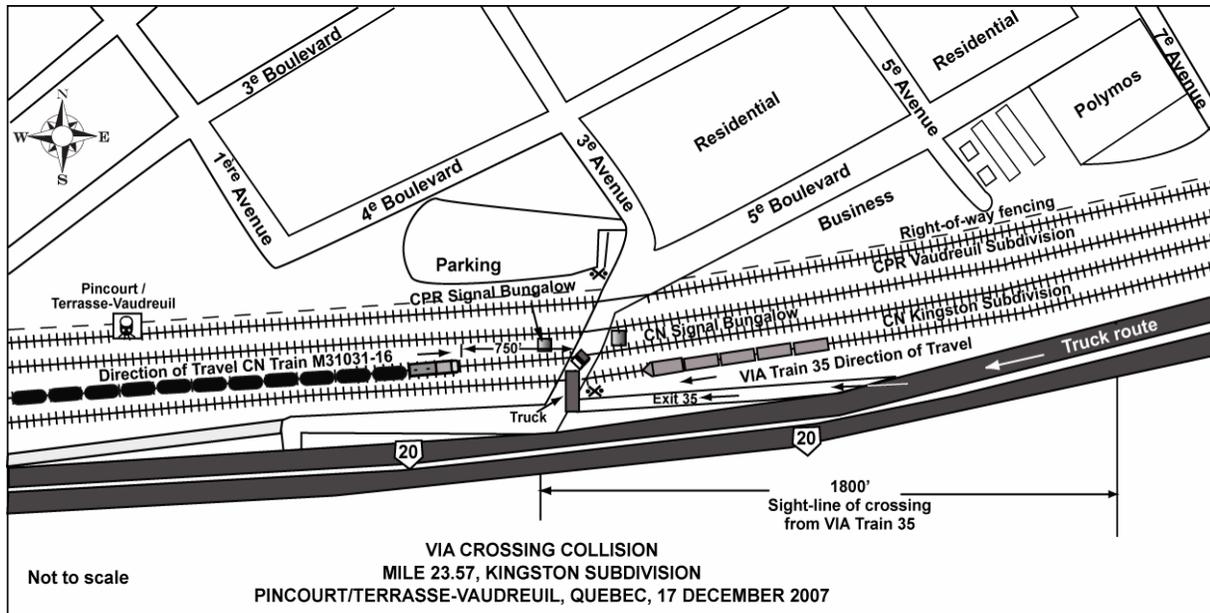
As VIA 35 rounded the curve, the crossing came into view approximately 1800 feet to the west. The VIA locomotive engineer observed a northbound tractor-trailer (the truck) stopped on the crossing, while eastward CN train M31031-16 (CN 310) appeared to be stationary on the north track, west of the crossing (see Figure 2).

Figure 2. Diagram of accident site

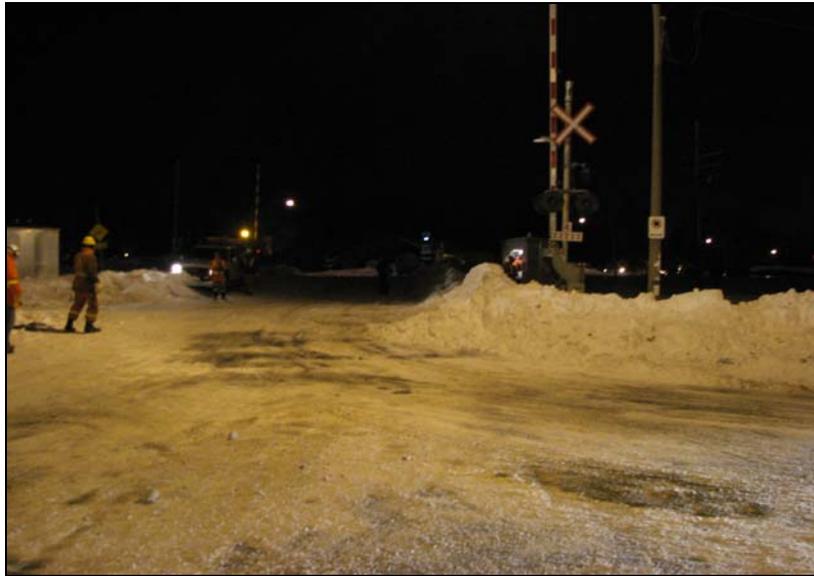
During snow-clearing operations, most of the snow was pushed to the side of the road and formed snow banks that were up to four feet high. The 3^e Avenue roadway width was reduced due to the presence of snow banks. The crossing surface was snow covered and icy. Tire marks were observed on the side of a snow bank located on the southeast corner of Exit 35 and 3^e Avenue near the CN crossing mast and gate (see Photo 1).

Photo 1. Snow banks on the southeast corner of the crossing

Following the severe winter storm the day before the accident, the snow had been pushed to the side of the roads and a large snow bank was left on the southeast corner of Exit 35 and 3^e Avenue. Furthermore, the driver had never used this crossing and was unaware of the angle of the crossing. Consequently, while making the turn onto 3^e Avenue, the rear undercarriage of the trailer became hung up on the snow bank. The tractor required additional traction to continue to move. However, in the absence of de-icing and abrasive materials, the tractor's rear tires began to spin on the icy crossing surface, and the truck was immobilized and was struck by the VIA train 3 minutes 40 seconds later. The presence of an activated event data recorder in the truck permitted a precise determination of its time of immobilization and an accurate reconstruction of the accident timeline.

1. VIA 35 struck the tractor-trailer that had become stuck on the crossing when the rear undercarriage of its trailer hung up on a snow bank. The configuration, the reduced width, and the icy surface condition of the roadway contributed to the immobilization of the tractor-trailer.

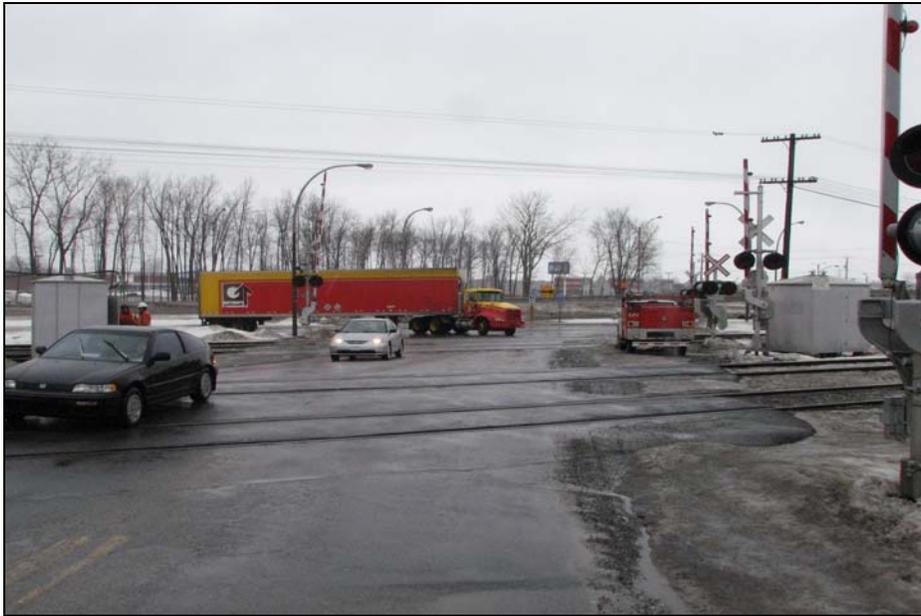
The crossing is the primary access to the commuter train station and the town of Terrasse-Vaudreuil. Both CN and CPR tracks are located between the residential area of Terrasse-Vaudreuil and Highway 20. The crossing is identified as Mile 23.57 of the CN Kingston Subdivision and Mile 18.07 of the CPR Vaudreuil Subdivision. Westward traffic accessing Terrasse-Vaudreuil via 3^e Avenue from Highway 20 must take Exit 35, continue to a stop sign then turn right. The 3^e Avenue runs north/south and intersects the Exit 35 ramp and the tracks at a 70-degree angle. To make this turn, even in ideal conditions, a tractor-trailer must pull wide into the opposing lane of 3^e Avenue (see Photo 2).

Photo 2. Right turn onto 3^e Avenue from Exit 35

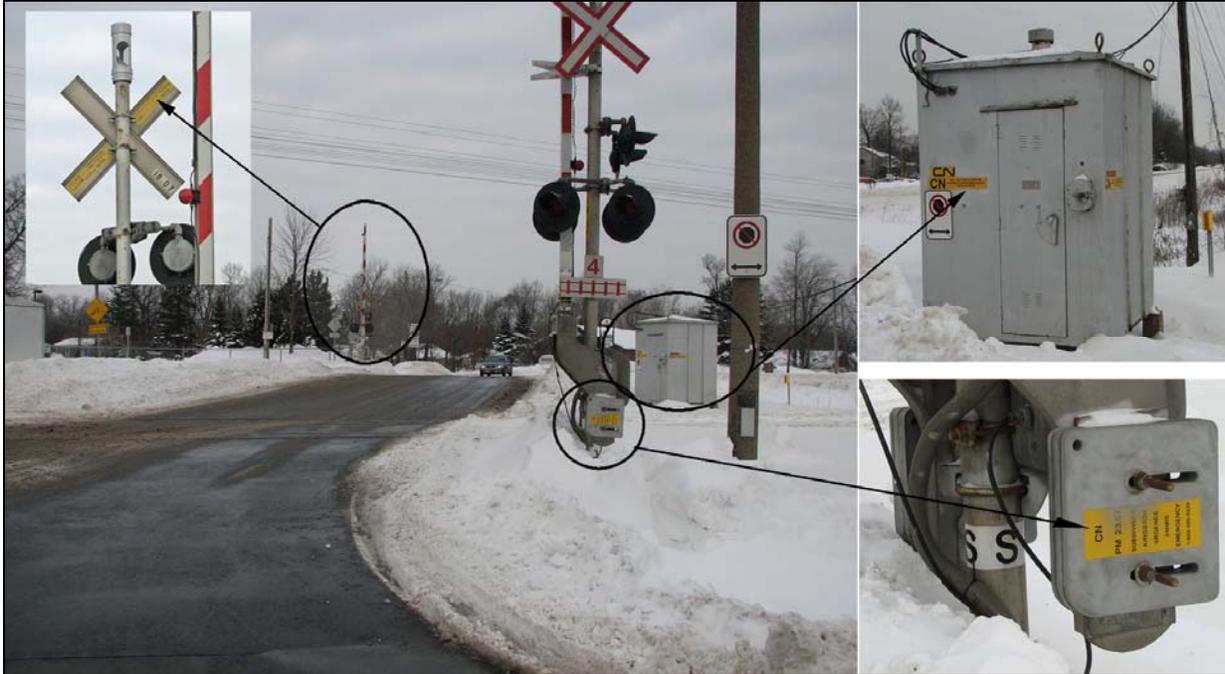
CN places an emergency contact phone number (1-800-465-9239), the mileage and subdivision of the crossing location on a sign (4 inches by 24 inches) located on the back of crossbucks at passive public crossings and on the gates and signal bungalows at automated public crossings. CPR places an emergency contact phone number (1-800-716-9132) and the five-digit TC crossing number on a similar sign located on the back of crossbucks at all public crossings (see Photo 3).

Photo 3. Location of emergency contact information at the crossing, looking northward

2. The lack of standardization and conspicuity of railway emergency contact information signage at crossings does not allow uninformed drivers to immediately identify emergency contact information and alert railways.

Transport Canada implement standards to improve the visibility of emergency contact signage at railway crossings in Canada.
