RAILWAY INVESTIGATION REPORT
R09V0235

MAIN-TRACK DERAILMENT

CANADIAN NATIONAL
FREIGHT TRAIN NUMBER J31753-15
MILE 7.9, YALE SUBDIVISION
KOMO, BRITISH COLUMBIA
17 NOVEMBER 2009

Report Number R09V0235

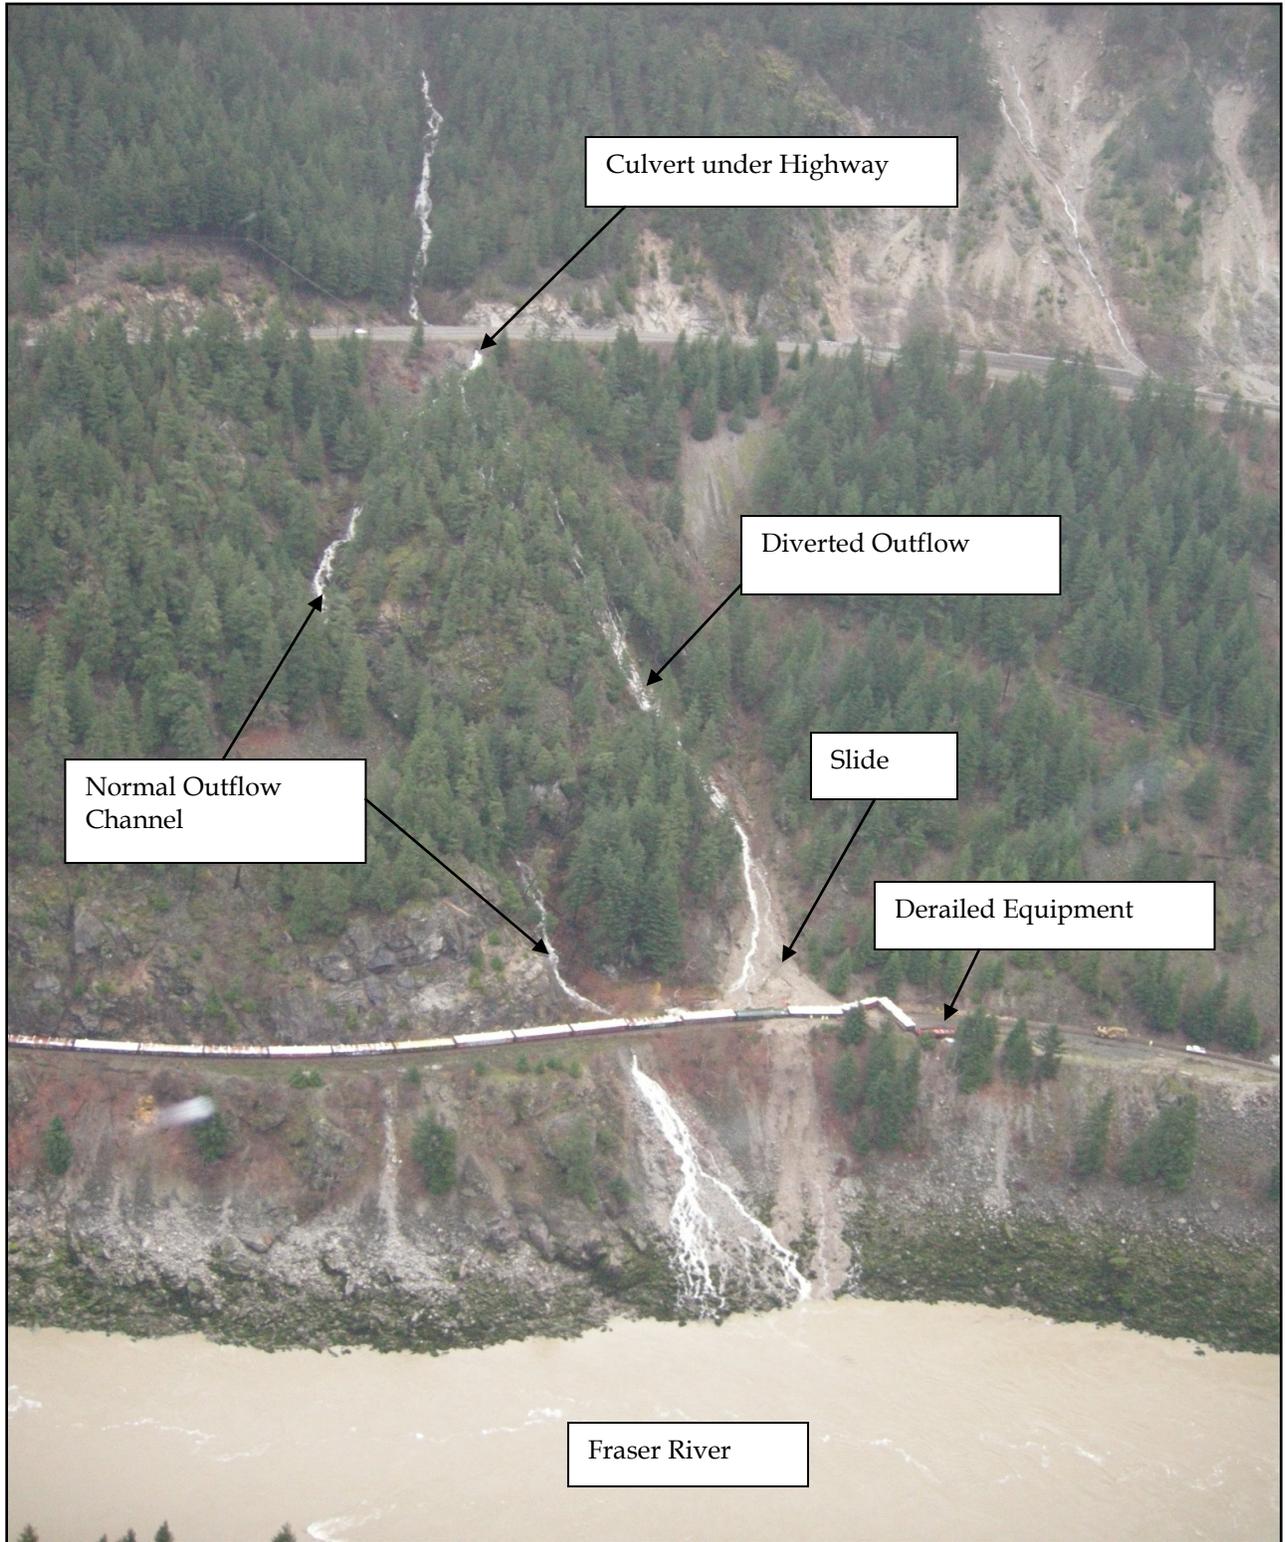
In this occurrence, the highway culvert was not plugged as it handled the surface run-off water without damaging the highway. At the outflow channel below the highway culvert, rock had been placed to direct the surface water down the established drainage course towards the river. Water following this established drainage course is directed towards another culvert under the track. On the day of the accident, the large volume of surface run-off water partially overflowed the normal outflow channel of the highway culvert. The overflowing water then established a different drainage course down the mountain slope (see diverted outflow indicated on Photo 1).

Photo 1. Slide and derailment, mile 7.9 of the Yale subdivision.

The train derailed when it struck a slide of rock, mud and trees covering the track. The slide occurred during a period of heavy rain when a large volume of surface water run-off flowed through a highway culvert above the track, breaching the normal outflow channel and partly diverting into a new channel. This diversion resulted in rock debris, mud and trees being carried down slope to the track below. Rock placed along the outflow channel below the

highway culvert was insufficient to ensure all of the water was directed down the established drainage course toward the track. The highway culvert functioned as intended. It was not plugged and handled the run-off flow without damaging the highway.

CN installed an Emergency Slope Washout and Detection System (ESWOD) at Mile 7.9 shortly after the slide.
