**RAILWAY INVESTIGATION REPORT  
R11D0075**

**MAIN-TRACK DERAILMENT**

**CANADIAN NATIONAL RAILWAY  
FREIGHT TRAIN M310-31-23  
MILE 2.03, MONTREAL SUBDIVISION  
NEAR POINTE-SAINT-CHARLES, QUEBEC  
24 SEPTEMBER 2011**

Report Number R11D0075

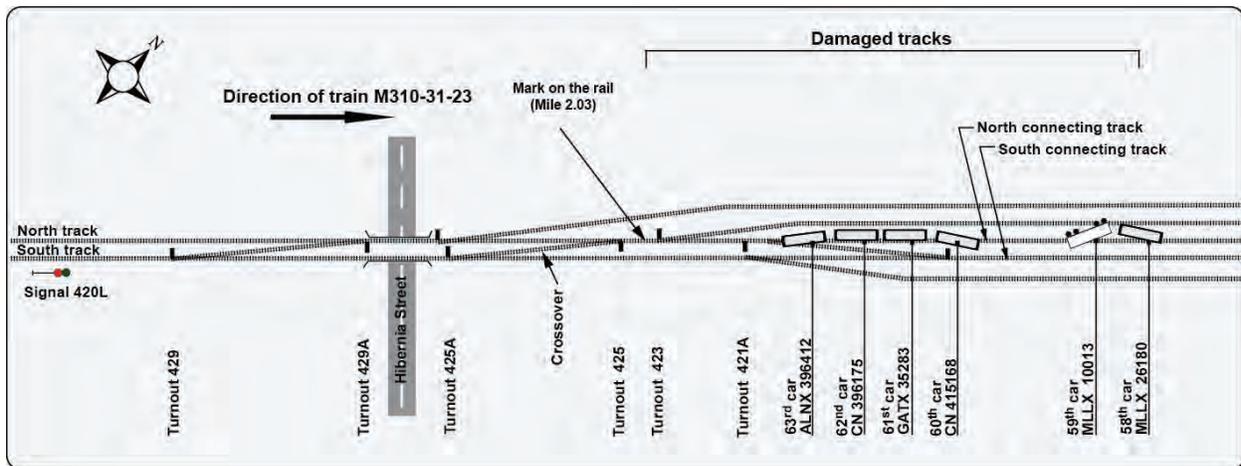
Figure 2. Derailment location (diagram not to scale)

The cars derailed to the east of the crossover that connects the south and north connecting tracks through turnouts 425 and 425A. Immediately to the east of turnout 425 (Figure 2), at Mile 2.03, a 7-foot-long mark was observed on the north rail of the south track.

The first signs of damage to the track coincided with the end of this mark, and the damage extended toward the derailed cars. No wheel marks or dragging equipment marks were observed west of turnout 425.

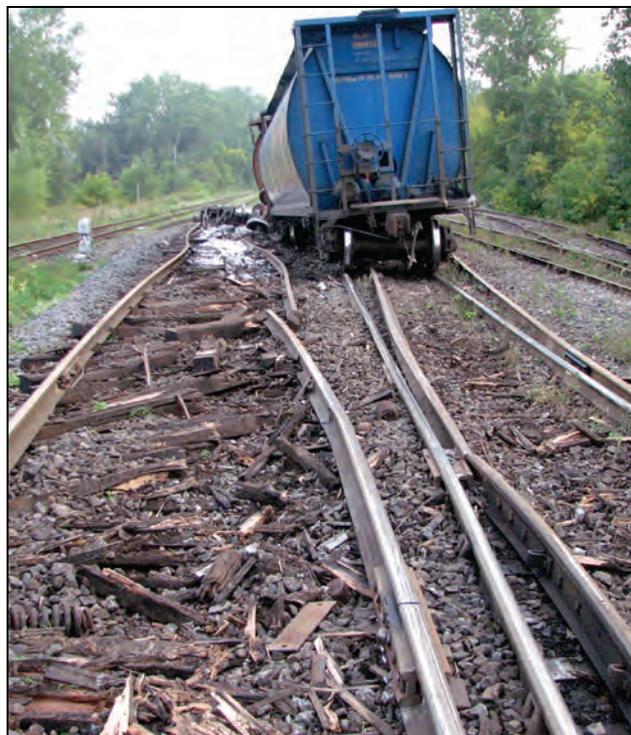
The structures of both the south main track and the north connecting track were destroyed over a distance of approximately 325 feet (Photo 1). Up to the first derailed car, or 300 feet further east, the north rail of the north connecting track was displaced laterally and had rolled over. Dwarf signals and a number of components of turnouts 423 and 421A, including operating mechanisms, were damaged or destroyed.

Photo 1. Damage to tracks and turnouts
