## **RAILWAY INVESTIGATION REPORT R13W0257**

### **MAIN-TRACK DERAILMENT**

**CANADIAN NATIONAL  
FREIGHT TRAIN G84042-09  
MILE 73.6, FORT FRANCES SUBDIVISION  
NICKEL LAKE, ONTARIO  
10 NOVEMBER 2013**

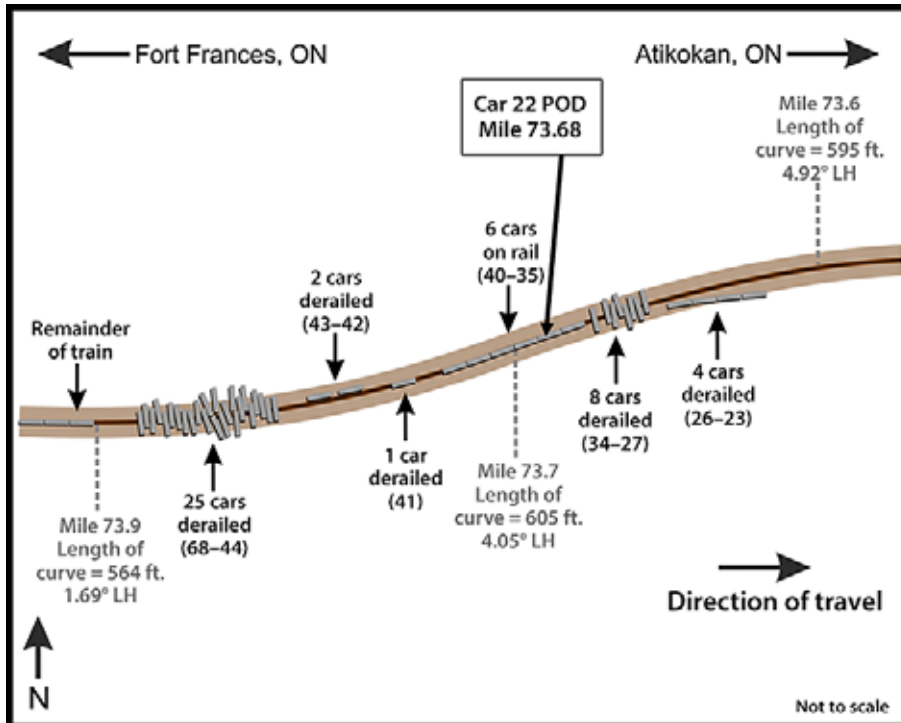
Figure 2. Derailment site diagram

- A total of 40 cars had derailed in 2 blocks (Figure 2).
- The first block involved 12 derailed cars (23rd to 34th cars). The 23rd to the 26th cars had derailed to the south, losing their trucks but remaining upright, straddling the south rail

near the beginning of a 4.92° right-hand (RH) curve. The 27th to 33rd cars were jackknifed across the roadbed. The lead set of wheels on the 34th car had derailed.

- About 30 feet west, the next 6 cars, (35th to 40th cars) had remained on the track.
- About 60 feet west, the second block involved 28 derailed cars (41st to 68th cars). The trailing truck of the 41st car had derailed to the south and was straddling the rolled south rail. The next 2 cars, ALNX 396156 and CN 389268, had derailed onto their sides to the north side of the track. The following 25 cars (44th to 68th cars) had jackknifed between a 4.05° left-hand (LH) curve and a 1.69° curve, and were positioned within an area of approximately 10 car lengths.

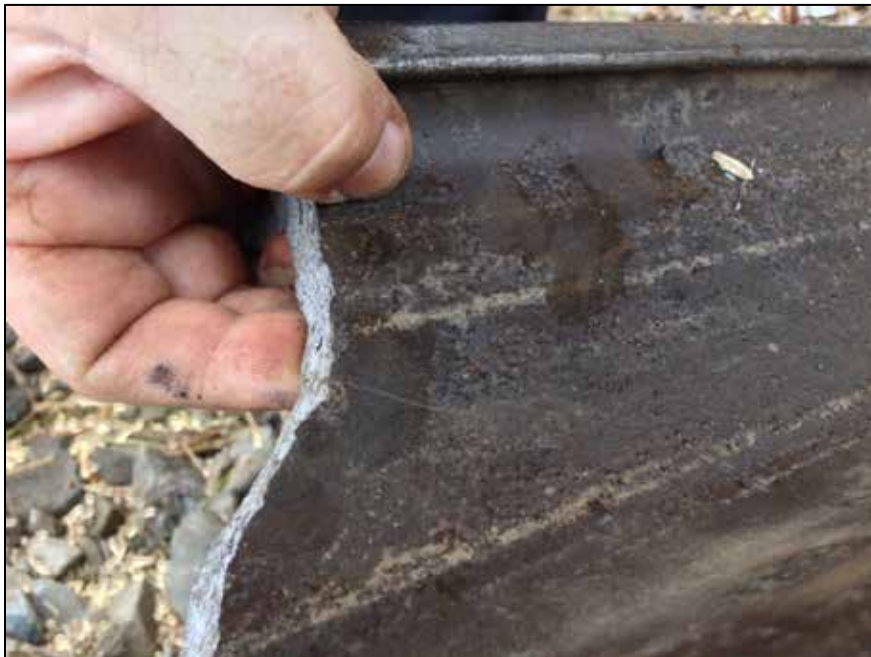
- There was a broken knuckle between the 41st car and the 42nd car.
- Approximately 1100 feet of track was destroyed.
- There were wheel flange marks on the web of the high rail of the 4.05° LH curve (Photo 1).

- The 115-pound high rail, laid in 1991, had 14 mm of head wear and 6 mm of flange wear. CN's track standards<sup>3</sup> indicate that the sum of the vertical and flange wear for 115 pounds rail shall not exceed 21 mm.

Photo 1. Wheel flange marks on the web of the high rail

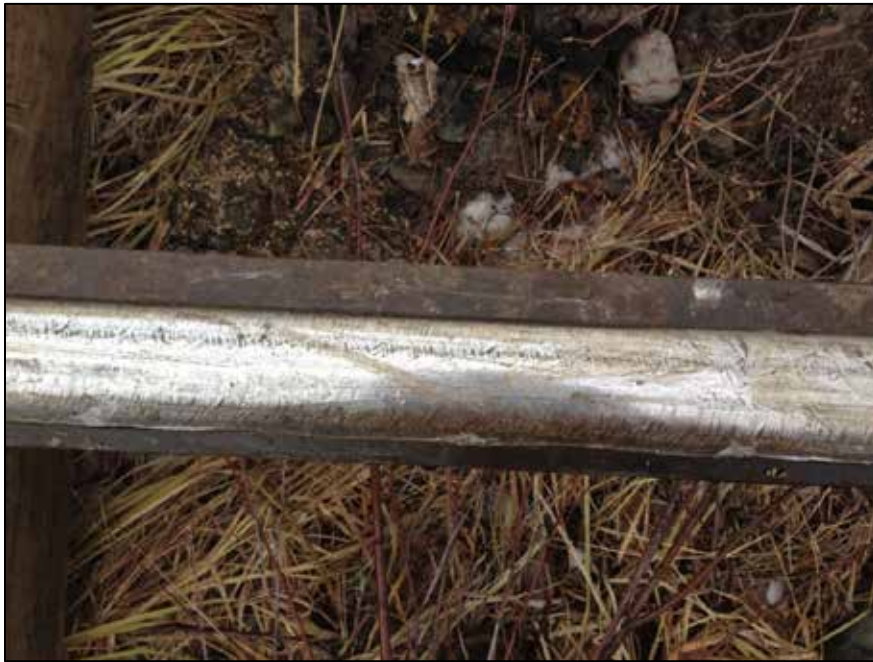
- There were wheel flange marks on the head of the low rail of the 4.05° LH curve (Photo 2).
- The reported point of derailment (POD) was at Mile 73.68, between the 4.05° LH curve and the 4.92° RH curve, approximately 3 miles west of the Nickel Lake siding.

- The 115-pound low rail, laid in 1994, had 13 mm of head wear and no flange wear. CN's track standards indicate that vertical wear for 115-pound rail shall not exceed 16 mm.

Photo 2. Wheel flange marks on the head of the low rail

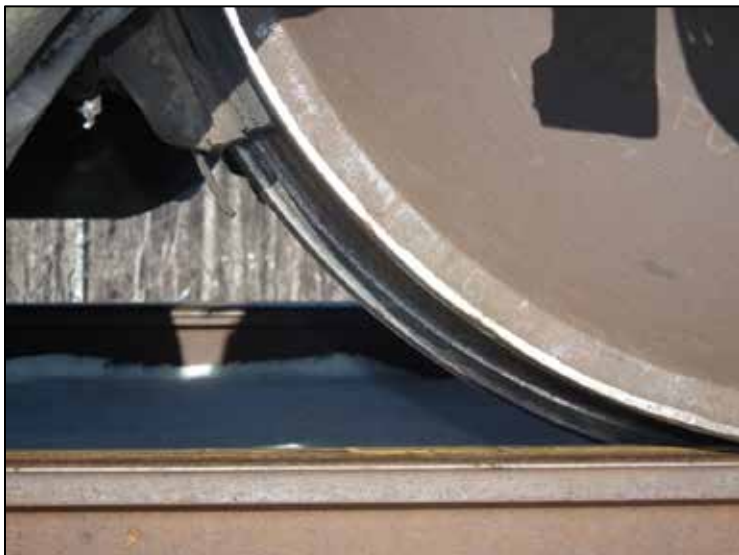
- The A-end truck was in like-new condition with little to no wear in the constant contact side bearings, side wedges, bolster gibs and bolster bowl.
- There was no indication that the truck had been binding or skewing.
- The wheels had a good tread profile.
- Impact marks were present on the L-4 wheel flange and tread (Photo 3). The marks were consistent with the wheel impacting a broken rail and/or rail anchors.
- On the L-4 wheel, there was abrasion throughout the rim face circumference and flange (Photo 4).

Photo 4. Abrasion on rim face of the L-4 wheel

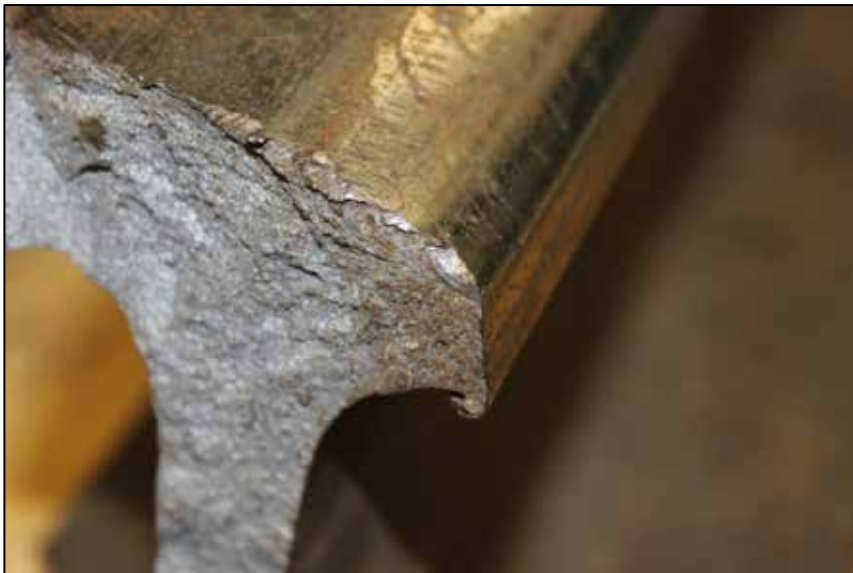
- All rail fractures were due to overstress.
- There was a small fatigue crack on the gauge side of the larger piece of rail (Photo 5). This crack was about 7 mm wide by 3 mm deep.
- The small fatigue crack was likely associated with the light shelling on the rail-head gauge side. This small fatigue crack had acted as the initiation site for the overstress failure.
- The rail head had ½-inch vertical wear and ¼-inch flange wear.
- On the smaller piece of rail (Photo 6), which was from the high rail of the curve, there were signs of batter and wheel strike marks.

Photo 5. Small detail fracture on gauge corner

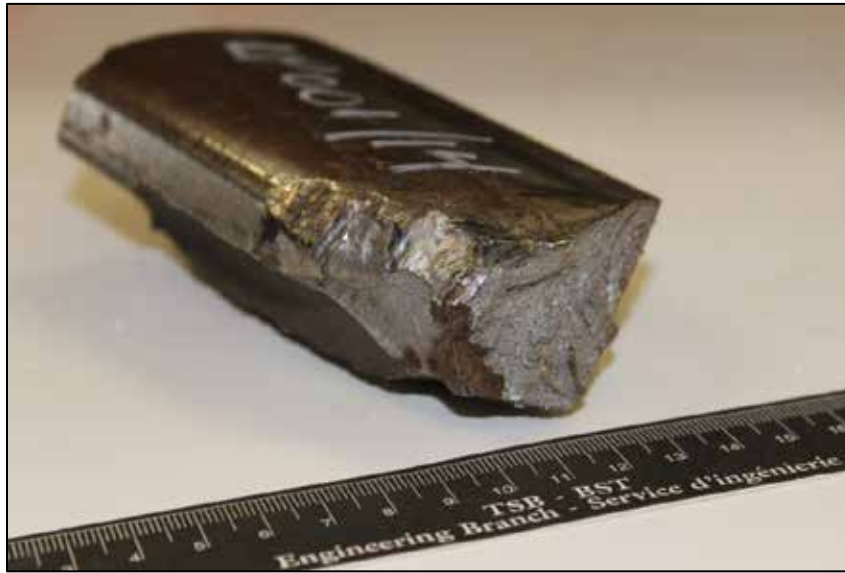
Photo 6. Piece of high rail showing batter and wheel strike marks
