## **RAIL TRANSPORTATION SAFETY INVESTIGATION REPORT R18T0006**

### **CROSSING COLLISION**

Canadian National Railway Company

Mile 77.66, Dundas Subdivision

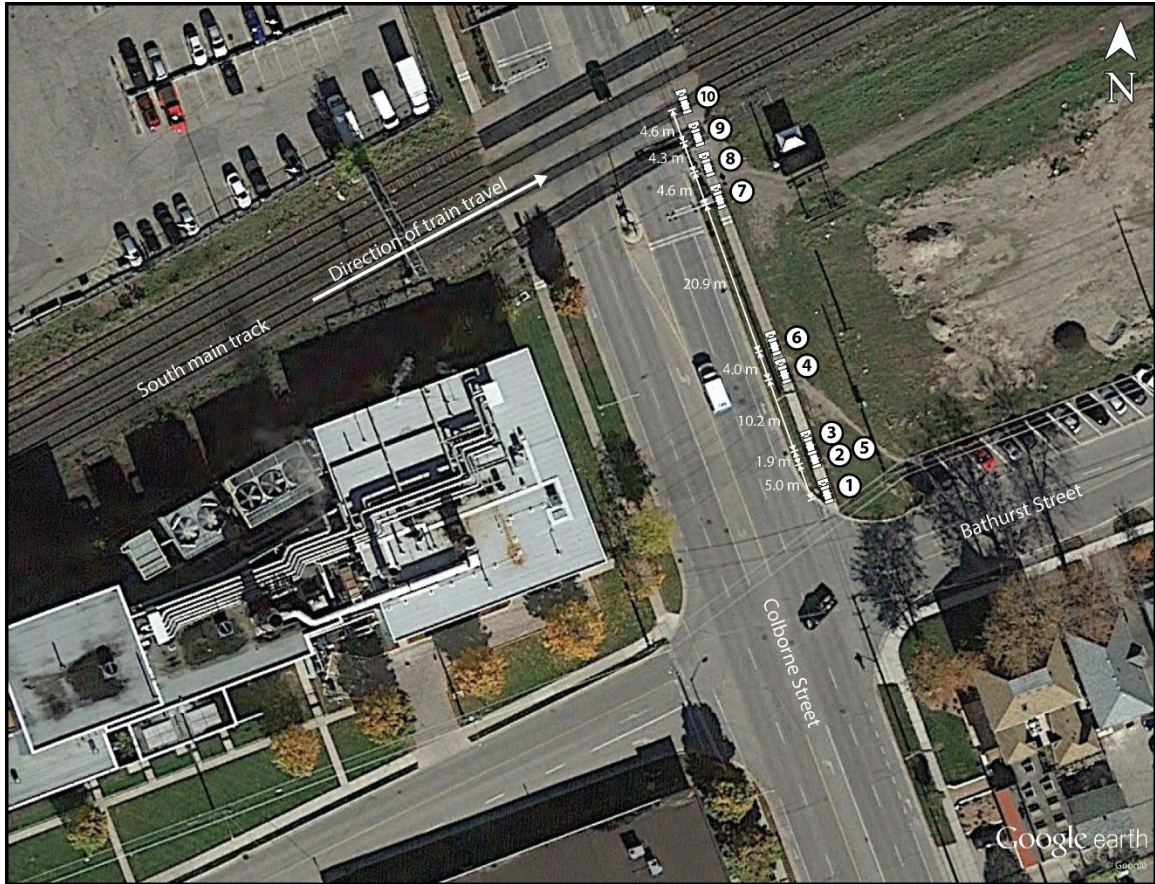
Figure 2. Movement of the snowplow as it approached the Colborne Street public crossing (Source: Google Earth, with TSB annotations)

- The snowplow approached the Colborne Street public crossing on the east sidewalk from the south while clearing snow with the blower (Figure 2).
- The snowplow approached the crossing while travelling at a speed that varied between 2.6 km/h and 7.3 km/h.
- The snowplow was adjacent to the crossing warning system mast and gate when the lights on the grade crossing warning devices (GCWDs) began to operate.
- The snowplow was about 4.6 m beyond the crossing mast when the gates began to descend.

- The snowplow continued onto the crossing while travelling at about 1.4 km/h and continued to blow snow.

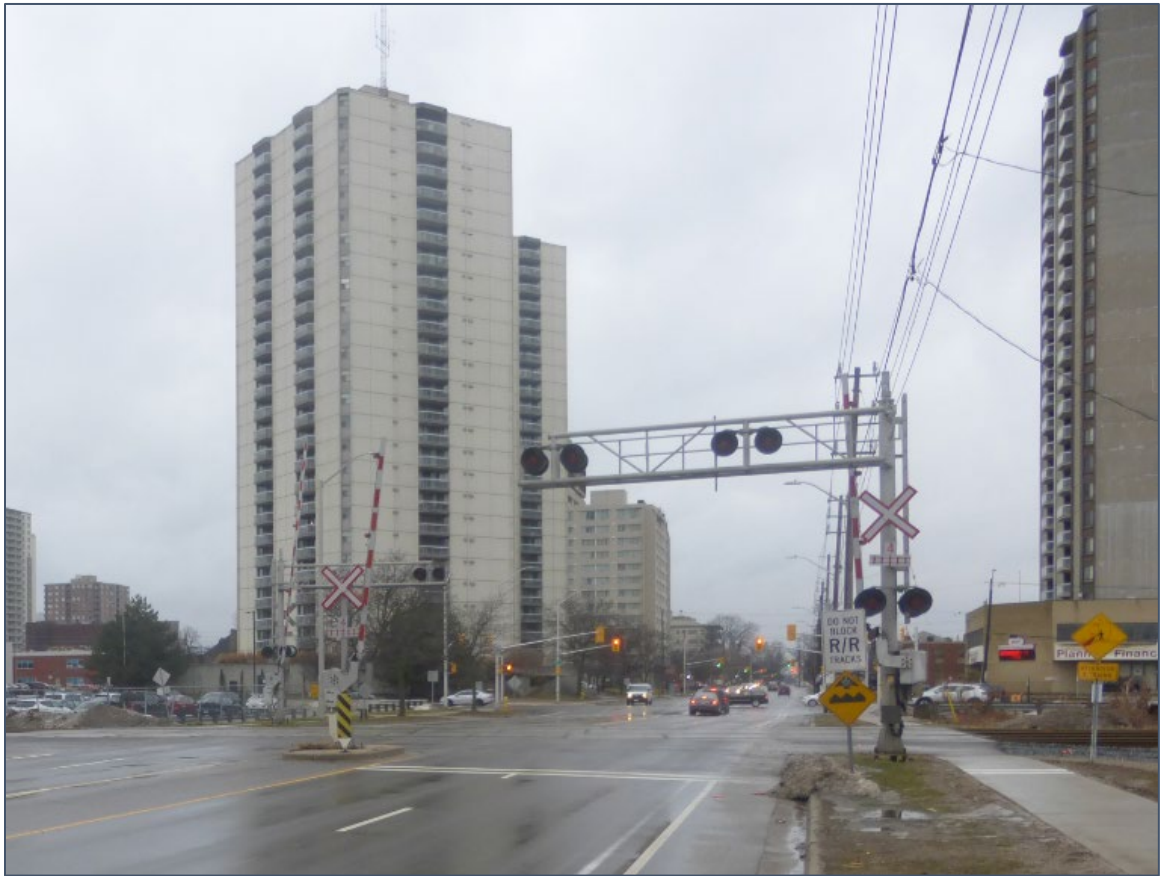
Figure 3. Colborne Street public crossing, looking north (Source: TSB)

At the Colborne Street public crossing, road traffic on both the north approach and the south approach is protected with flashing light signals (some on cantilevered structures), a bell, standard reflectorized crossing signs, and gates (Figure 3). The gate at the north approach is installed at the roadside and extends across 2 lanes of traffic. The south approach has 2 gates, with 1 gate installed on the boulevard in the middle of the roadway extending across 1 lane of traffic, and 1 gate installed at the roadside extending across the other lane of traffic.

In all 4 quadrants, there is a sidewalk approach to the crossing. There are no gates to specifically protect pedestrians at this crossing. The crossing surfaces between the sidewalks are paved with asphalt extending at least to the outside edge of the sidewalks, and are in compliance with Part B of the Transport Canada (TC) *Grade Crossings Standards*.

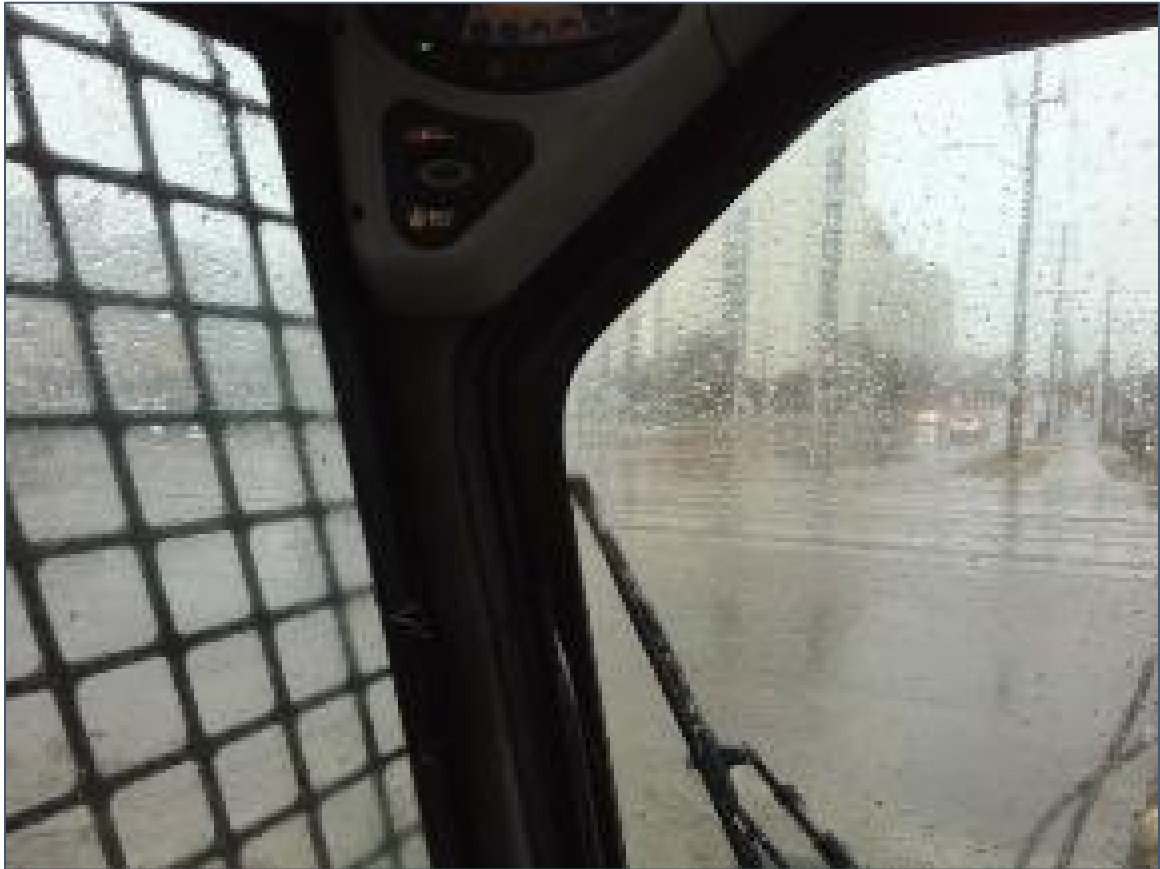
When the snowplow operator was adjacent to the crossing mast in the southeast quadrant of the crossing, the lights and gates in the northwest quadrant were more than 30° from the forward view (Figure 6).

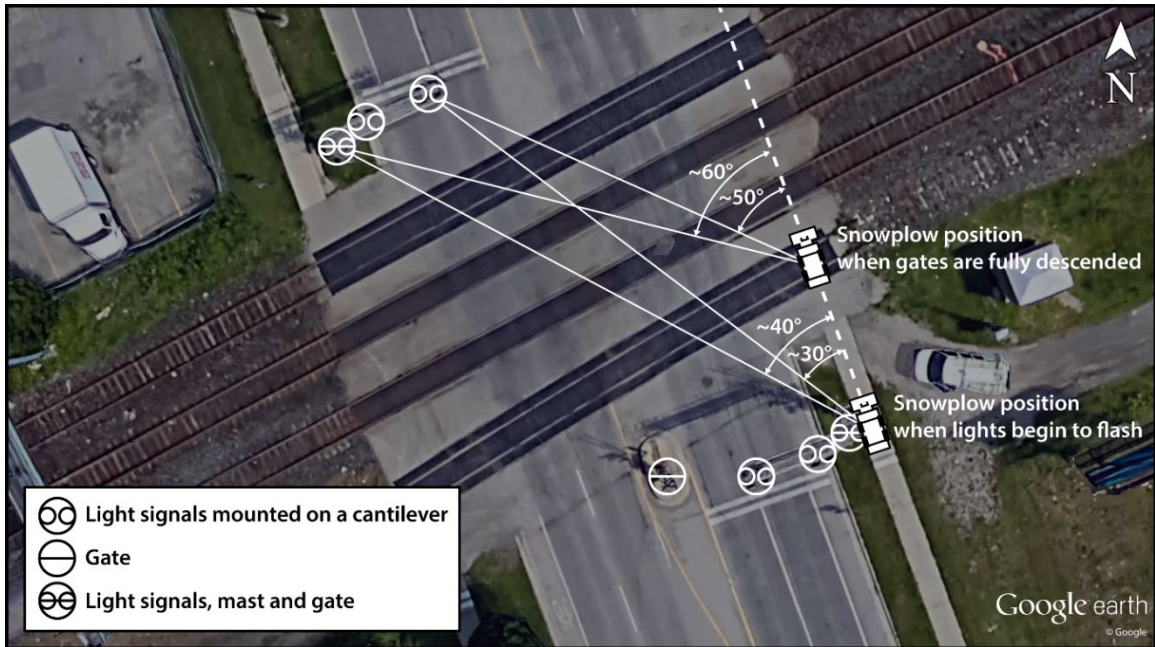
Figure 6. Location of the snowplow and viewing angles from the cab to the grade crossing warning devices (Source: Google Earth, with TSB annotations)

The viewing angles of the crossing lights and gates in the northwest quadrant from the snowplow cab were more than 50° from the forward view when the snowplow occupied the 1st set of tracks.
