# Rail Transportation Safety Investigation Report R18W0133

## MAIN-TRACK TRAIN DERAILMENT

Canadian Pacific Railway  
Freight train 112-27  
Mile 13.4, Carberry Subdivision  
Rosser, Manitoba  
29 May 2018

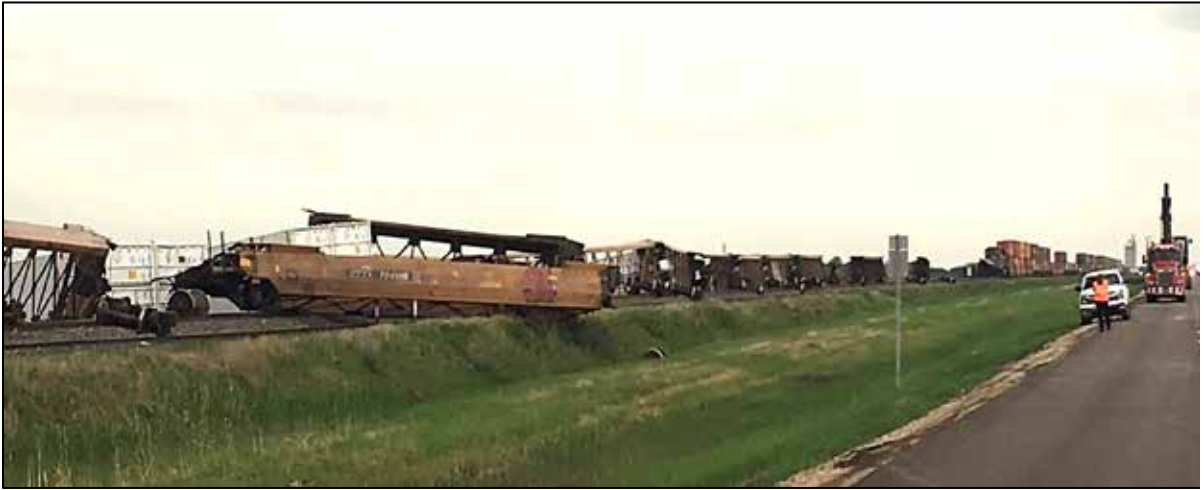
Figure 2. Derailed intermodal cars

The derailment site was well preserved and all access points to the site were controlled by the Rosser Fire Department. The first derailed car (17th car from the head end) was located immediately behind the mid-train remote locomotive. Most of the cars had derailed on their sides, to the north of the track (Figure 2).

Numerous freight car truck sets were on top of the roadbed, adjacent to their mating car bodies. No wheel marks led up to the derailed cars, which suggested that a sudden event had occurred. There was no indication that any pre-existing mechanical defect, track defect, or track condition played a role in the occurrence.

The first 3 derailed platforms behind the mid-train locomotive, the last 5 derailed platforms, and all cars behind the derailed cars that remained on the track carried loaded containers. With the exception of a single empty platform and 2 loaded containers on a 3-platform car, the remaining 14 platforms in the middle of the derailed cars were loaded with empty double-stack containers. This configuration made that portion of train more susceptible to lateral movement from severe winds.

On 01 June 2018, CP implemented a new loading configuration for moving large numbers of empty containers to help lessen the impact of high wind events.
