Rail Transportation Safety Investigation Report R19C0038

NON-MAIN TRACK TRAIN COLLISION AND DERAILMENT

Canadian Pacific Railway
Freight train 118-09 and locomotive control system yard assignment CR01-09
Mile 172.0, Brooks Subdivision
Calgary, Alberta
09 March 2019

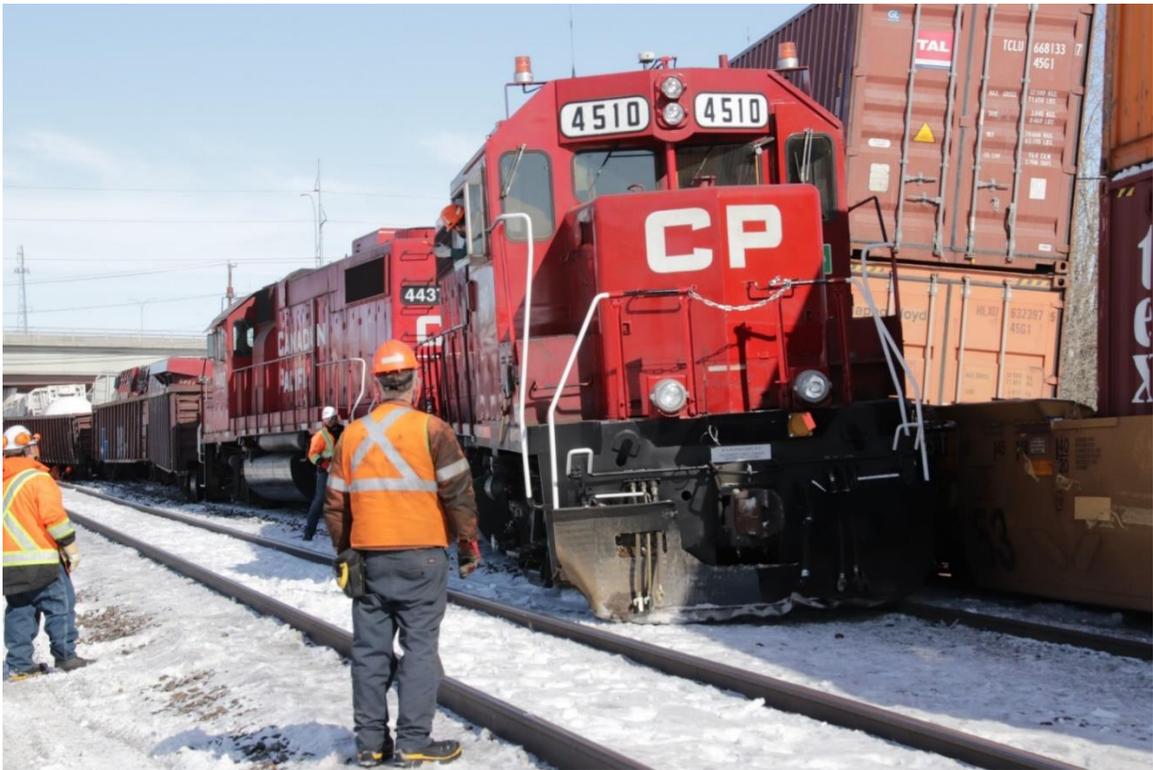
At approximately 0905¹ on 09 March 2019, eastbound Canadian Pacific Railway (CP) distributed power freight train 118-09 was departing Alyth Yard in Calgary, Alberta, at approximately 10 mph when it was struck by eastbound locomotive control system (LCS)² yard assignment CR01-09 at the 50th Avenue crossover, Mile 172 of the CP Brooks Subdivision. The train and the yard assignment both derailed upright (Figure 1). As a result of the collision, 5 cars and 2 locomotives of the yard assignment derailed, as did 4 cars and 1 locomotive of the train. There were no injuries and there was no release of dangerous goods. The weather was clear and the temperature was approximately -4 °C.

Figure 1. Collision and derailment of train 118-09 (right) and yard assignment CR01-09 (left) (Source: TSB)

The collision occurred at 0905 when the lead locomotive of the assignment struck the side of train 118 that was proceeding through the crossover onto track PT02 East.

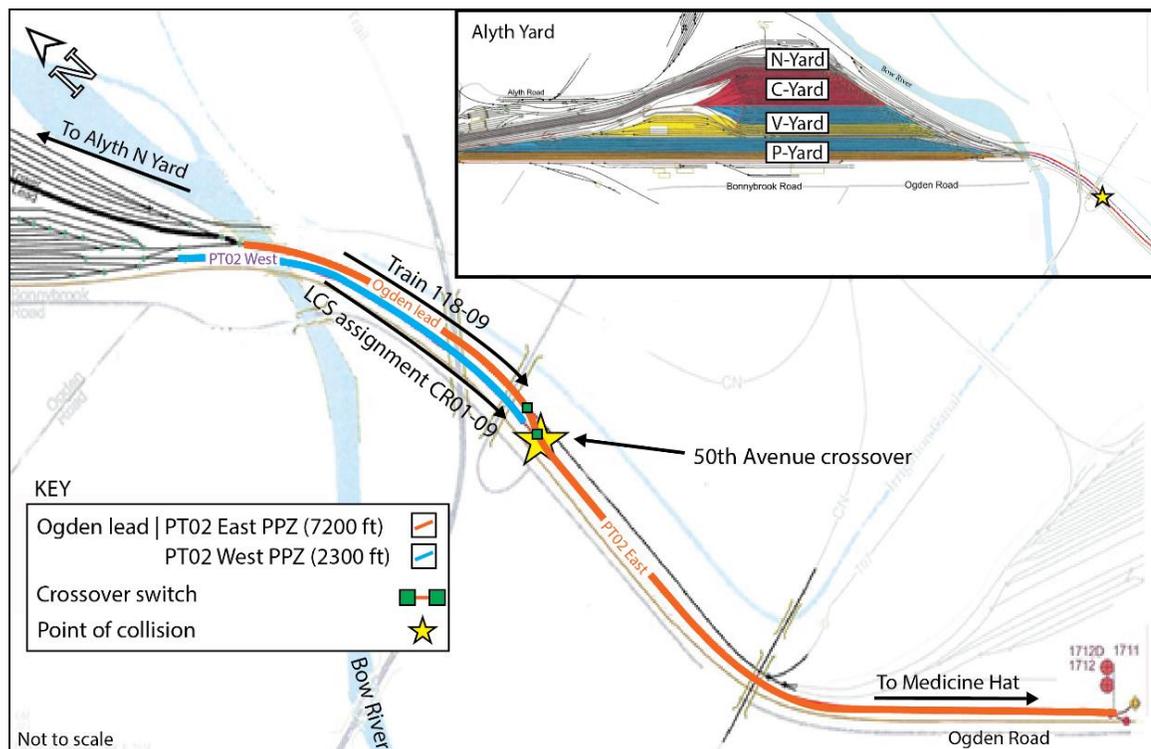
On the morning of the occurrence, the assignment crew was in possession of 2 different PPZs (Figure 2):

- The **PT02 West** PPZ, which extends 2300 feet from the west end of P-yard to the fouling point with the crossover switch at 50th Avenue.
- The **Ogden lead/PT02 East** PPZ, which extends 7200 feet from N-yard, through the crossover switch at 50th Avenue, and onto the east end of track PT02 as far east as Signal 1712B, where a positive stop protection system⁴ prevents an LCS from proceeding past the signal.

Figure 2. Map showing point protection zones, direction of movements, and point of collision. (Source: Canadian Pacific Railway, with TSB annotations)

In this configuration, different sections of track PT02 belong to different PPZs: PT02 track west of the 50th Avenue crossover is part of the PT02 West PPZ, while PT02 track east of the crossover is part of the Ogden lead/PT02 East PPZ.

the 50th Avenue crossover. Since this section of track is part of the Ogden lead/PT02 East PPZ, these movements must in fact occupy both PPZs simultaneously. However, there is no track signal or other physical means to alert crews of the crossover switch position.
