RAIL TRANSPORTATION SAFETY INVESTIGATION REPORT R19W0050

MAIN-TRACK TRAIN DERAILMENT

Canadian National Railway Company
Freight train U73451-11
Mile 197.47, Rivers Subdivision
St. Lazare, Manitoba
16 February 2019

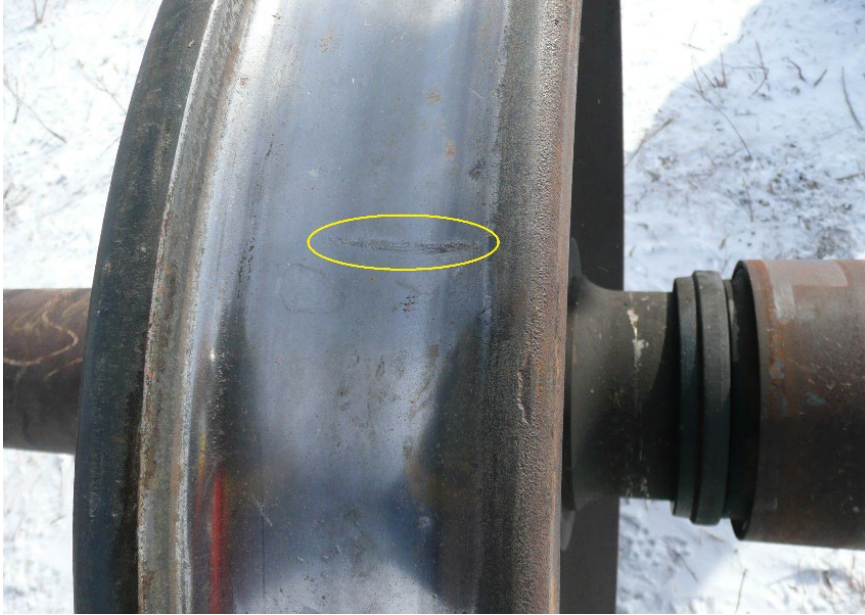
Figure 2. Impact mark on VMSX 280746 R4 wheel tread (Source: TSB)

Although the leading no. 4 wheel set of the 5th car remained on the rail, the R4 wheel tread on the south rail displayed an impact mark that is consistent with contacting a broken rail (Figure 2). The 3 remaining wheel sets of VMSX 280746 were derailed. Similar impact marks were observed on the south-side wheel treads of the 1st to 4th cars behind the locomotives, but no marks were observed on the wheels of the locomotives.

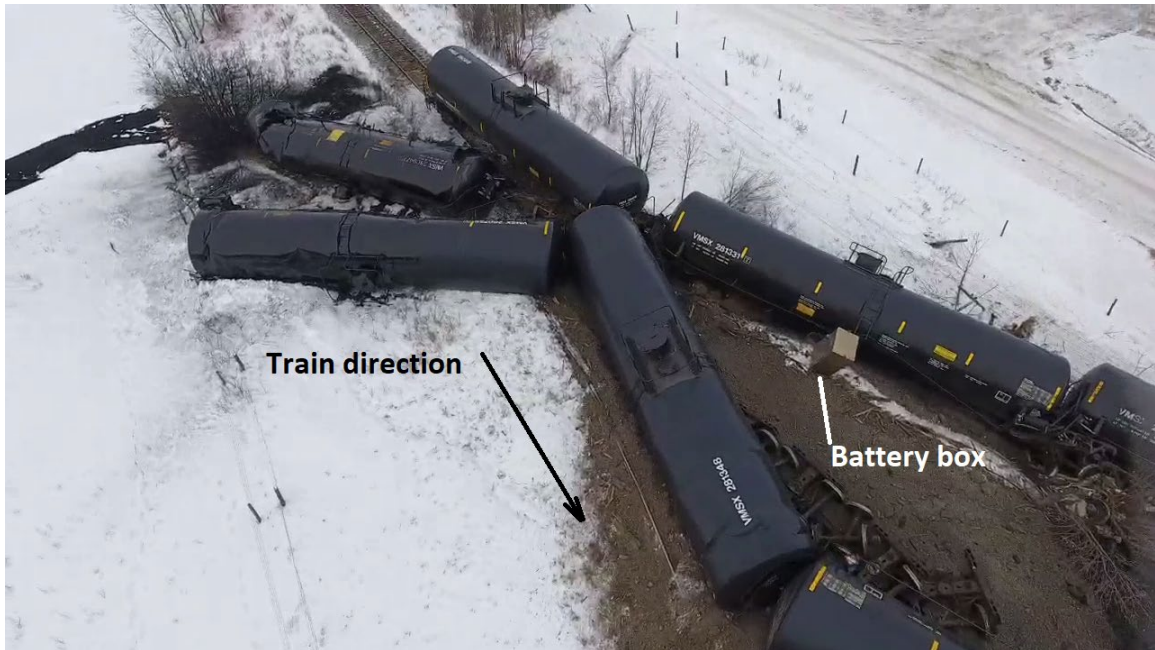
Figure 5. West end of derailment site (Source: Curtis McLeod and Amon Rudolph, with TSB annotations)

The initial track damage was observed at about Mile 197.47 (Figure 5). A battery box was positioned about 75 feet east of the initial track damage on the south side of the track. Extending eastward from Mile 197.47, approximately 1000 feet of the track was either damaged or destroyed.

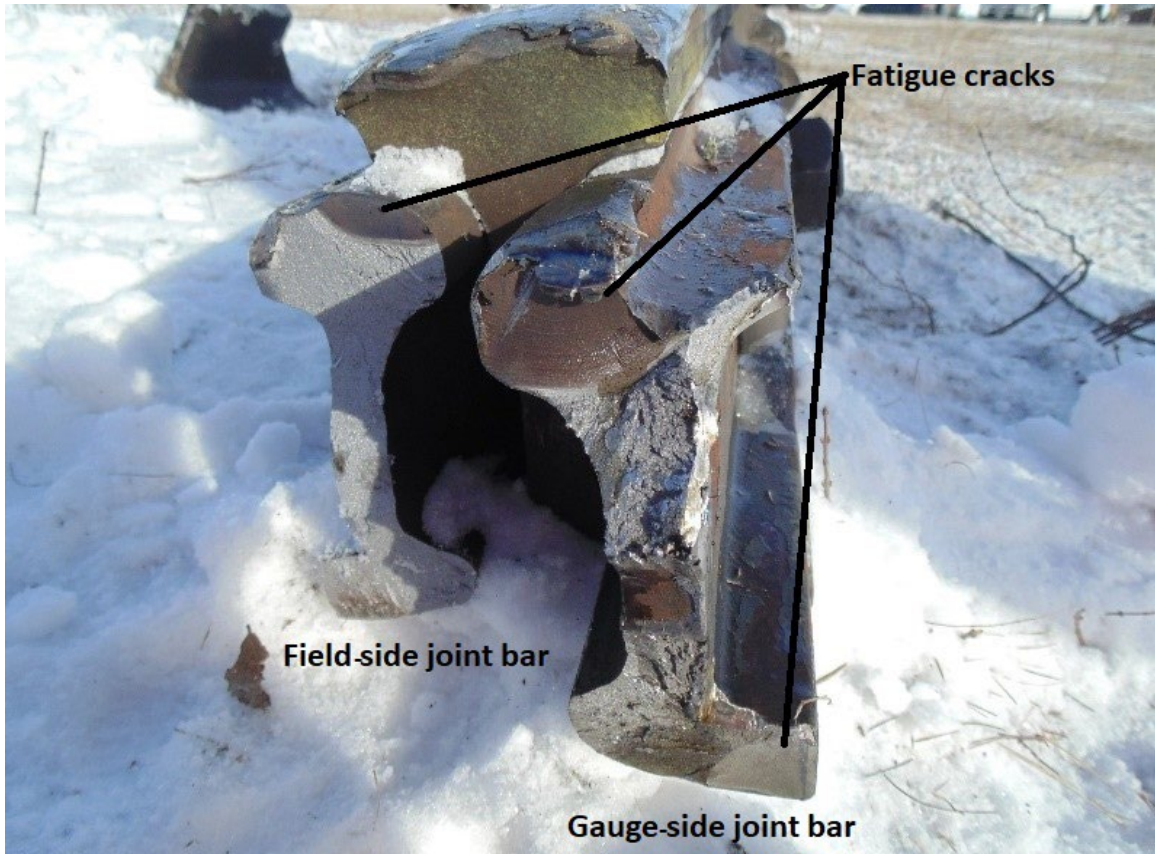
Figure 6. Recovered joint bars with pre-existing fatigue cracks (Source TSB)

Over a 6-week period, the misalignment of joint 1 led to a loosening of the joint, which initiated fatigue cracking in the joint bars. The joint bars failed when instantaneous overstress fractures occurred from the extremities of the fatigue cracking and extended through the remaining joint bar cross-sections which could no longer withstand the normal service loads applied as the train traversed the area.

In the vicinity of Mile 197.47, pieces of the south rail, joint bars and joint bar fasteners were recovered. Among the recovered pieces of rail, there were 5 joints, all located within a distance of 49 feet. Two of the joints had broken joint bars while the remaining 3 joints were still intact. The fracture surfaces of 1 set of broken joint bars from about Mile 197.47 displayed features consistent with fatigue cracking (Figure 6). The recovered track components were sent to the TSB Engineering Laboratory in Ottawa, Ontario, for analysis.

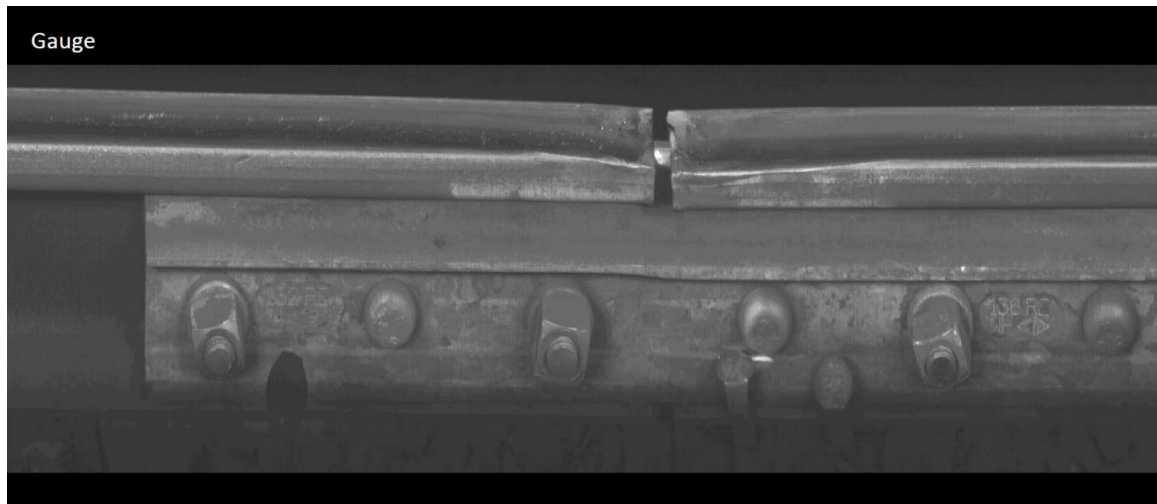
- The second furthest to the east was a glued insulated joint.
- Four of the 5 joints in the south rail, including the insulated joint, were assembled with standard 132/136 RE²⁷ joint bars.
- The remaining joint was the furthest west of the 5 joints and was identified as being located at Mile 197.4751 of the south rail. The joint was assembled with a 132/136 RE compromise joint bar on the GS of the rail and a 132/136 RE standard joint bar on the FS of the rail (Figure 8 and Figure 9). The rail head ends within the joint were battered and deformed.

Figure 8. Gauge-side compromise joint bar (Mile 197.4751) showing rail head end batter (Source: Canadian National Railway Company)

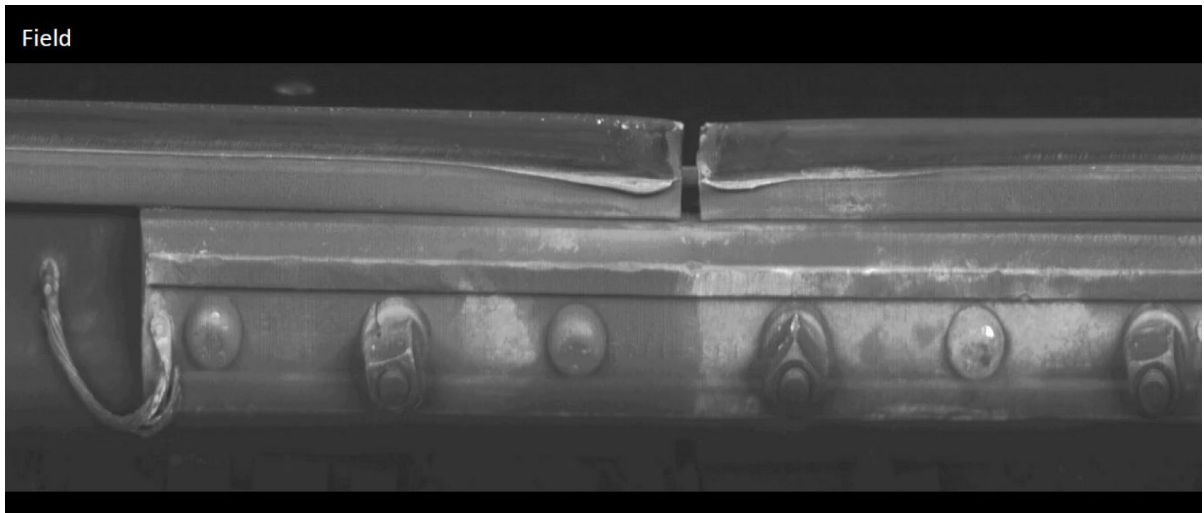
Figure 9. Field-side standard joint bar (Mile 197.4751) showing rail head end batter (Source: Canadian National Railway Company)

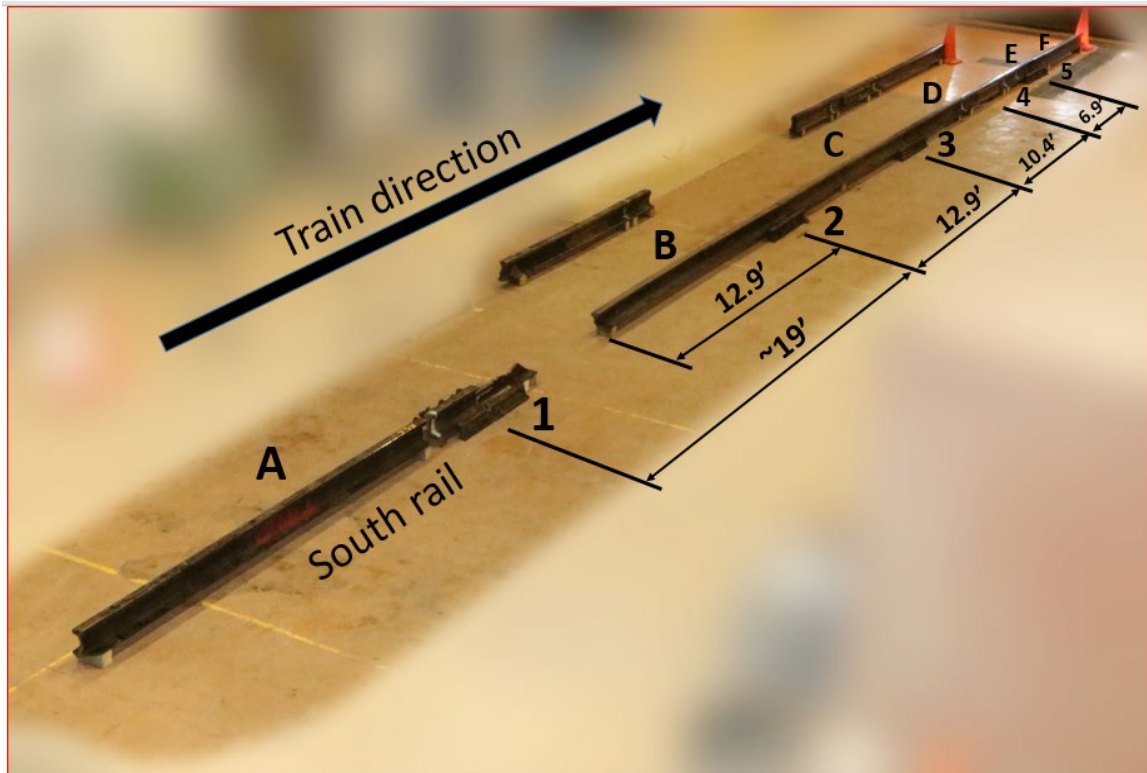
The south rail pieces recovered from the occurrence site were reassembled in the TSB laboratory. For ease of reference, the recovered rail segments and joints were labelled with alphabetic and numeric characters, respectively. The south rail consisted of 6 rail segments and 5 joints located within a distance of 49 feet (Figure 10). The joint bars from joint 1 and joint 5 were broken while the joint bars and rail from the other 3 joints were still intact.

Figure 10. Rails and joints recovered from the south rail. A portion of rail segment B was missing. CN track maintenance records identified 19 feet as the original length of segment B (Source: TSB)

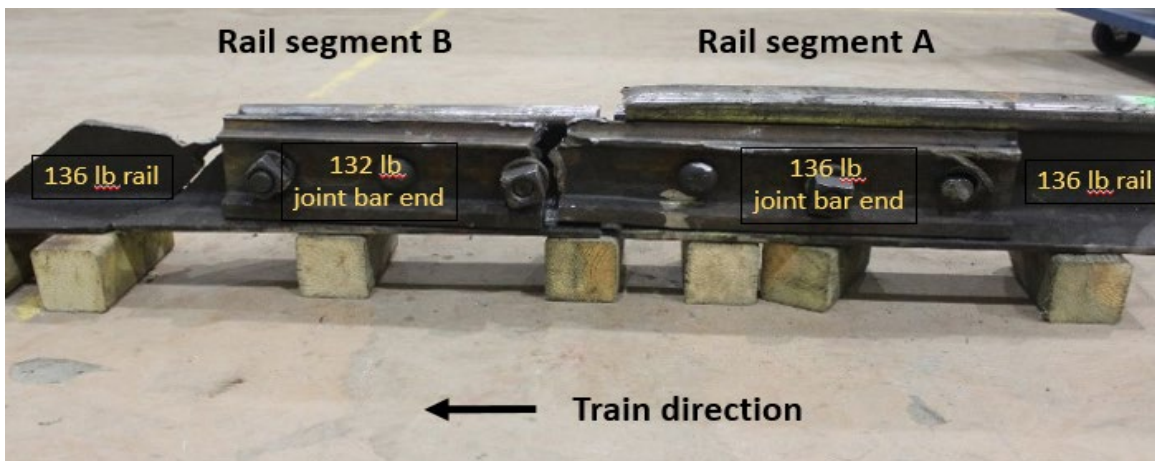
Figure 11. South rail joint 1, gauge-side view with 132/136 RE compromise joint bar (Source: TSB)

The track maintenance crew located the broken 132/136 RE standard joint bar on the gauge side of the south rail, removed it and replaced it with what was perceived to be an unpainted 132/136 RE standard joint bar. However, a 132/136 RE compromise joint bar was inadvertently selected and installed with the 132/136 RE standard joint bar that was already installed on the field side of the rail. The installation of a compromise joint bar with a standard joint bar left the joint 1 assembly in the south rail misaligned and unstable.

The 136-pound side of the GS 132/136 RE compromise joint bar was secured to the 136-pound rail segment A, while the 132-pound side of the GS 132/136 RE compromise joint bar was secured to the 136-pound rail segment B. There was no visible blue or yellow paint on the GS compromise joint bar (Figure 11).

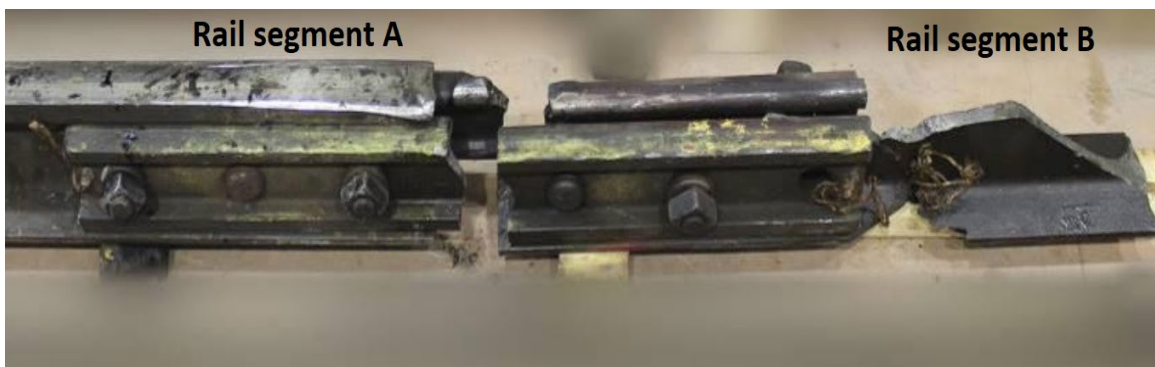
The FS 132/136 RE standard joint bar exhibited yellow paint on its exposed surfaces, which was a pre-existing marking that identified a defective joint for repair (Figure 12).

Figure 12. South rail joint 1, field-side view with 132/136 RE standard joint bar. Note yellow paint marking defective joint for repair (Source: TSB)

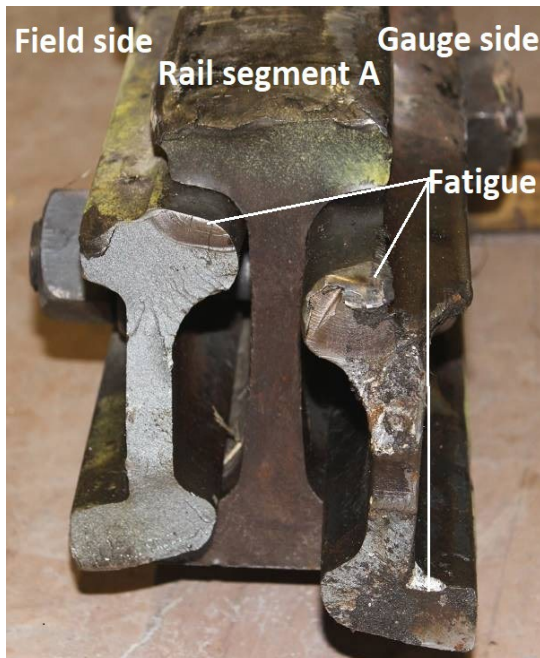
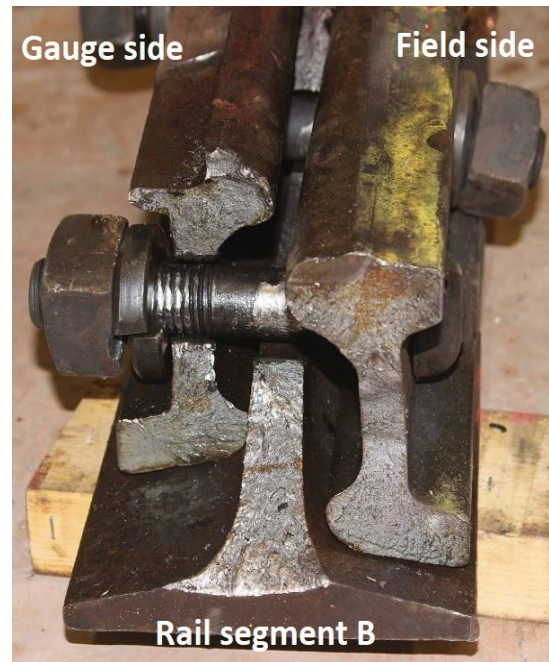
- Rail segment A exhibited rail head end batter while rail segment B had failed within the joint (Figure 13 and Figure 14). Well-defined fatigue cracks were observed in the top shoulder on both joint bars and in the toe of the GS 132/136 RE compromise joint bar. From the extremities of the fatigue cracks of both joint bars, instantaneous overstress fractures progressed through the remaining cross-sections when the joint bars could no longer withstand the applied loads under normal service conditions.
- The fracture surfaces on all recovered rail segment B pieces exhibited a coarse granular appearance characteristic of instantaneous overstress fracture, which suggests that the fractures occurred as a result of the derailment and were not causal.

- A chevron pattern was traced back to the likely rail segment B fracture origin at a bolt hole that was closest to the middle of the joint in the web of rail segment B.

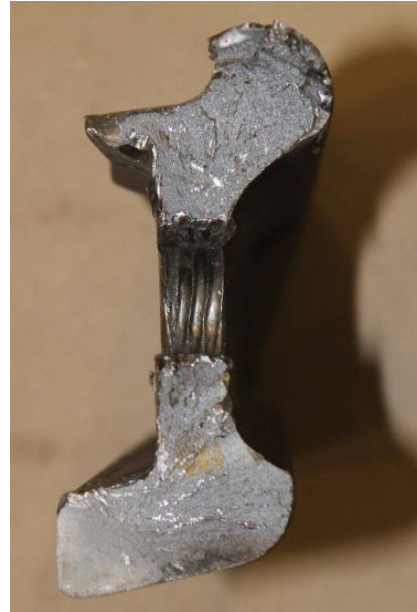
- Imprints of bolt threads were worn into the corresponding GS 132/136 RE compromise joint bar bolt hole, which indicates that the joint was skewed as the bolt was pressed against the bore of the GS joint bar hole (Figure 15).

- Polishing was observed on the GS and FS base of each rail, in the fillet radii that transition from the rail head to the web and on the corresponding top and bottom surfaces of both joint bars. The polished surfaces observed on the bolts, nuts, spring washers, both joint bars and corresponding rail surfaces, are all indicators that joint 1 was loose.

Figure 15. Imprints of bolt threads were worn into a gauge-side 132/136 RE compromise joint bar bolt hole of rail end B

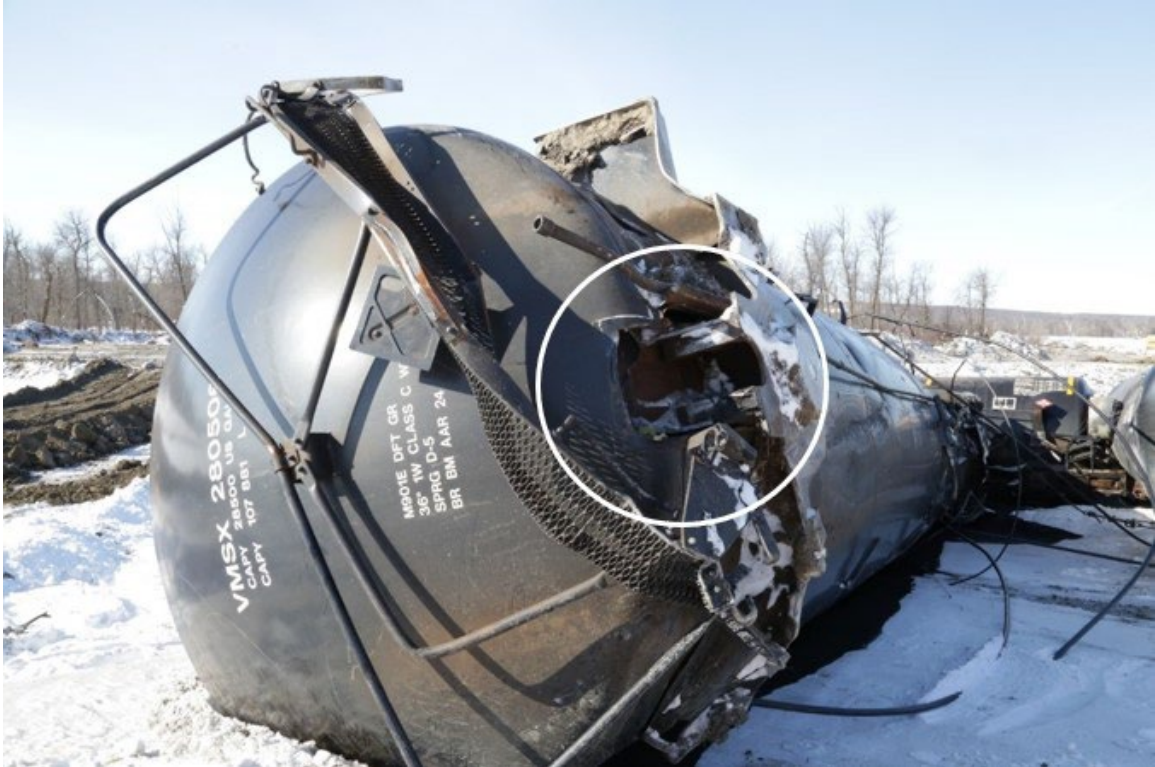
Figure 18. Tank car VMSX 280506 stub sill separation (Source: TSB)

The examination determined that the stub sill from VMSX 280506 was torn off in an upward direction with a twisting force. The separation occurred partially as designed, i.e., at the stub sill re-pad-to-head brace and stub sill re-pad-to-stub sill welds; however, some of the front stub sill re-pad-to-tank head welds failed. In this area, weld defects and slightly larger-than-specified weld beads that secured the head brace to the re-pad were observed. These may have contributed to the cracking of the re-pad-to-tank head weld, but the cracking did not result in a shell breach.

Notwithstanding, the cracking observed in the root of some of the front stub sill re-pad-to-tank head welds at the A-end of VMSX 280506 may have been present before the derailment. As such, this could lead to more progressive weld cracking during normal service operations and potentially lead to the crack extending into the tank head itself, if left undetected.

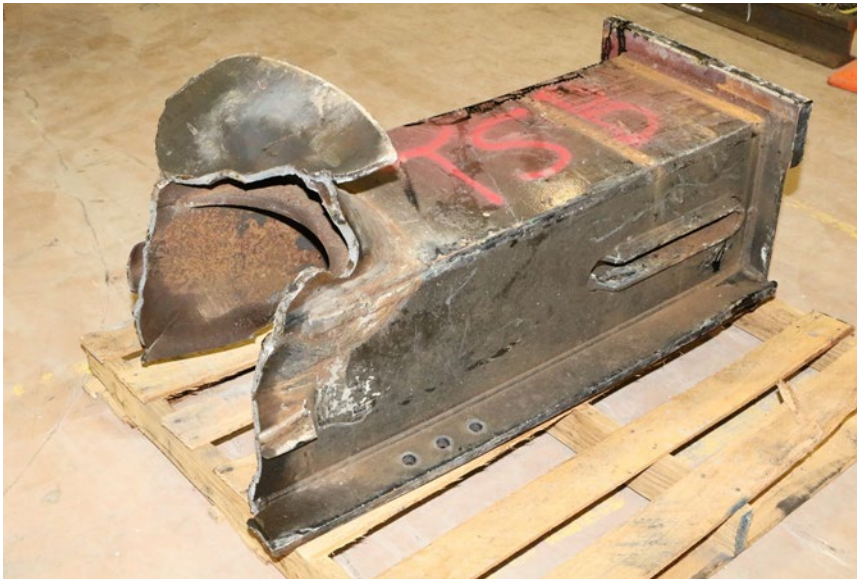
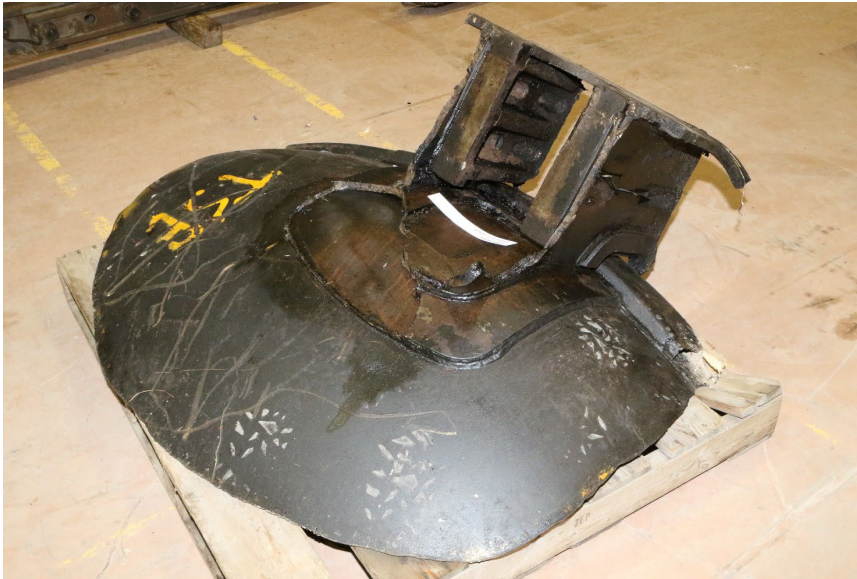
The separated stub sill with portions of the head brace and re-pad still attached (Figure 19) and the matching re-pad fracture surface (Figure 20) were sent to the TSB Engineering Laboratory for detailed examination.

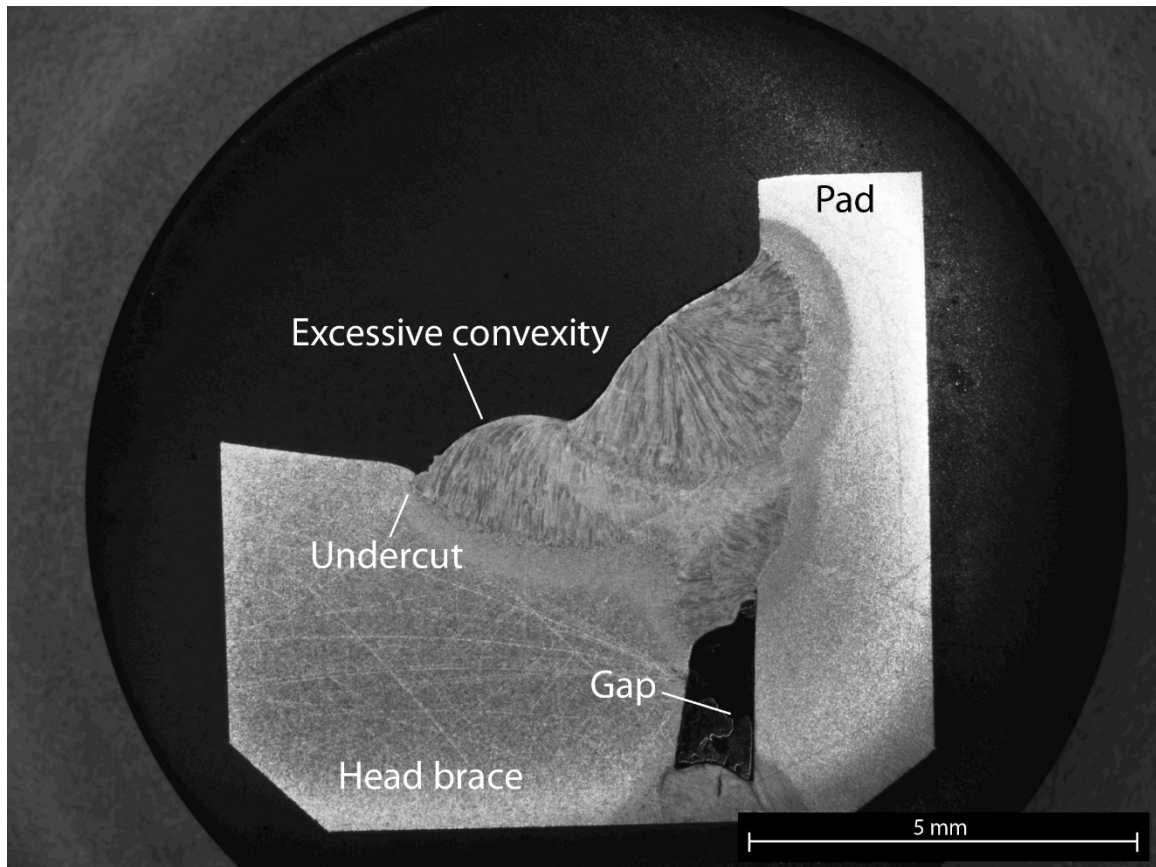
Figure 21. Metallographic sample containing cross-section of weld (Source: TSB)

Examination of one of the weld's cross-sections showed that there was an undercut defect and poor weld bead profile. The gap between the pad and the head brace is approximately 1.8 mm; this is 3 times larger than the gap of 0.6 mm observed at another weld. Undercuts were also present where weld beads ended at the head brace (Figure 21).

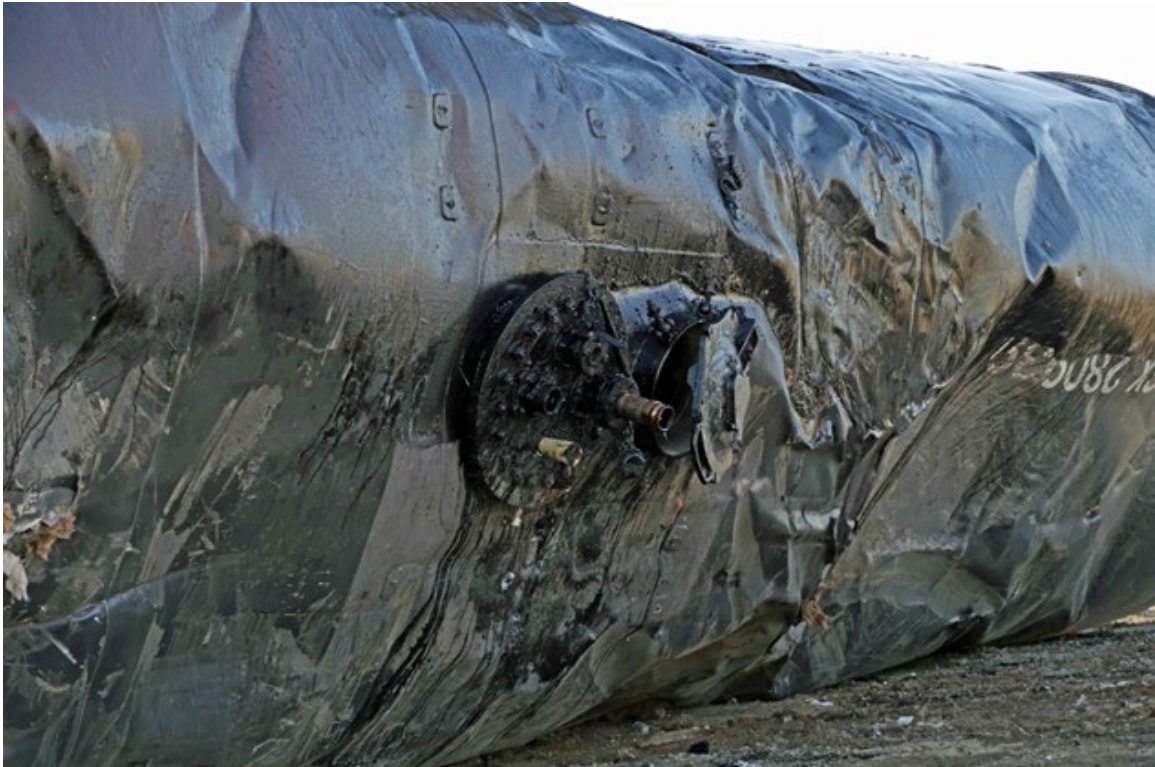
Figure 22. Impact damage on top of VMSX 280939. All 20 bolts securing the top fitting protective housing to the flange cover were sheared and the housing had separated from the car (Source: TSB)

There were no re-pad weld failures observed in the area of the tank top re-pad, top fitting protective housing or manway. Several failed bolts and several intact bolts taken from 2 other tank car housing assemblies were examined metallurgically and found to have nearly identical physical properties. All bolts examined met the Grade B7 specification in

terms of hardness and tensile strength. This suggests that the failure of the protective housing bolts was due to the impact forces rather than poor material properties.

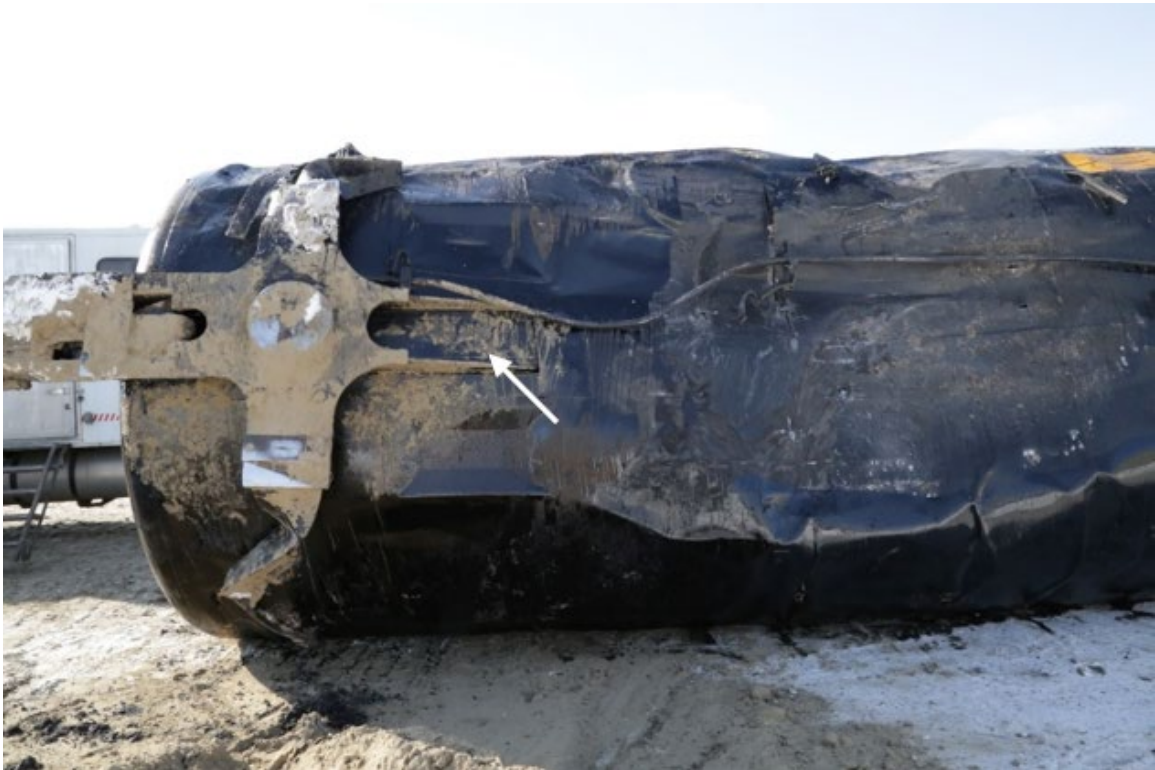
Figure 23. Location of the breach formed by a crack in the A-end stub sill tail piece extension of VMSX 281261. (Source: TSB)

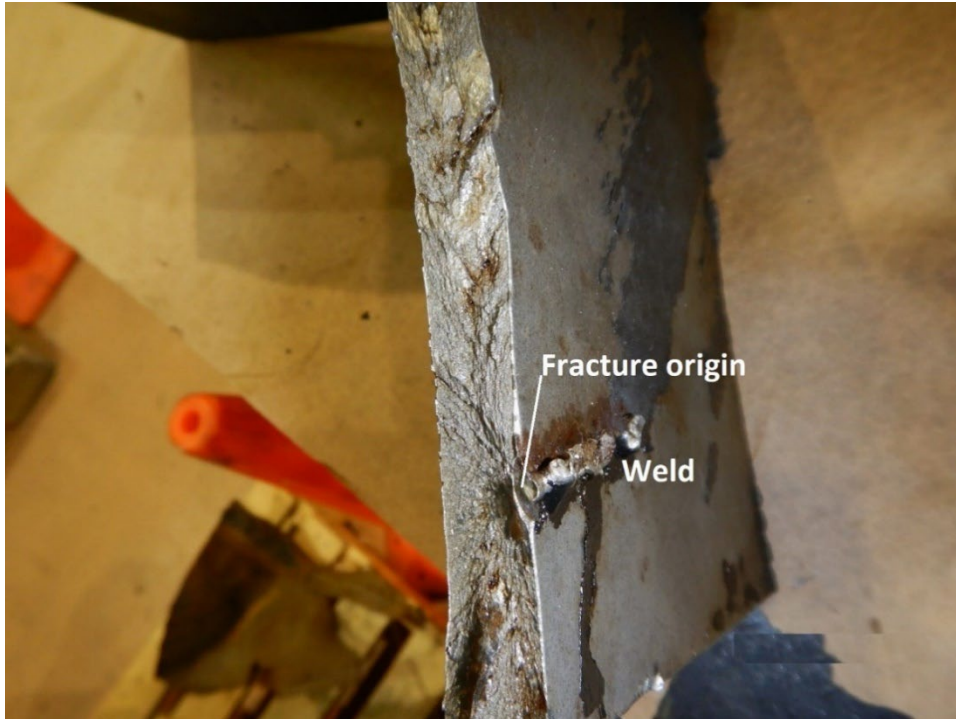
The A-end stub sill tail piece crack on VMSX 281261 was cut open to examine the fracture surface. A fracture origin was identified at a weld bead (Figure 24).

A cross-section through the crack origin and weld bead revealed that the weld bead size was estimated to average $3/16$ inch, which is larger than the specified $1/8$ -inch weld bead. The weld bead profile was also inconsistent and would likely not pass a quality control inspection.

Figure 24. Weld on the stub sill tail piece extension surface and fracture origin (Source: TSB)

The cross-sectional view of the weld indicates that it penetrated approximately 1.8 mm into the tail piece extension steel. This suggests that the cracking observed most likely initiated in the weld or heat affected zone. The weld bead profile was both larger than specified and very inconsistent, resulting in a localized stress concentrator where a crack initiated, subsequently propagated into the tank, and resulted in a breach.

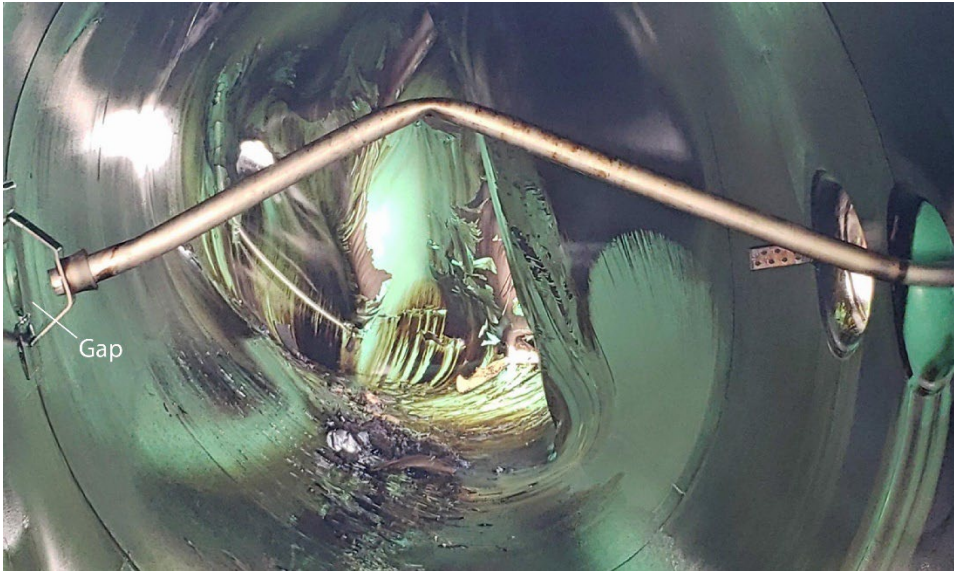
Figure 25. A damaged eduction pipe in situ inside a derailed tank car had pulled out of the sump at the bottom of the tank car (Source: TSB)

The distance between the ends of the bent pipes from the derailed tank cars ranged from 1.8 m to 2.9 m. This suggests that the tank deformation during the derailment ranged from 0.1 m to 1.2 m. This estimation is probably conservative since some elastic rebounding of the pipe likely occurred once the tank deformation bounced back. Although some of the derailed tank cars sustained other breaches, no breach occurred as a result of tank deformation. Despite the buckling, the eduction pipes performed as designed.
