RAIL TRANSPORTATION SAFETY INVESTIGATION REPORT R21V0118

MAIN-TRACK TRAIN DERAILMENT

Canadian National Railway Company
Freight train A47251-02
Mile 547.7, Chetwynd Subdivision
Hodda Station, British Columbia
03 June 2021

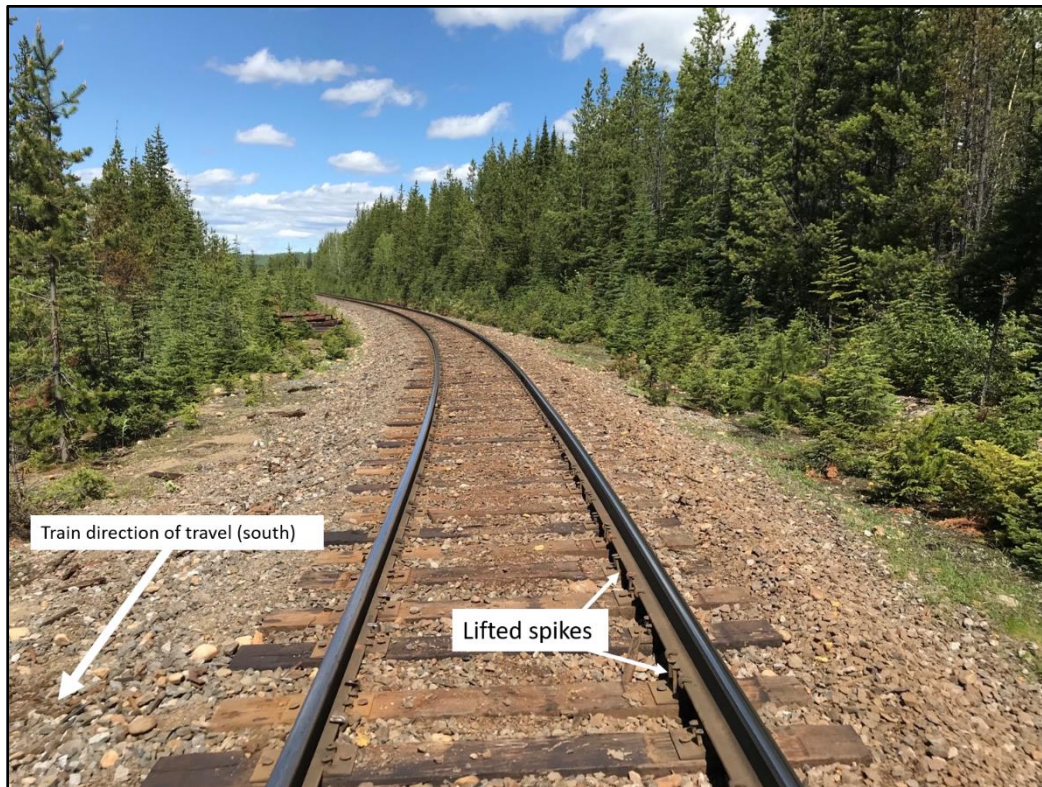
The gauge-side spikes of the high rail of the 8° curve had lifted away from, and out of, the tie plates (Figure 2). The high rail had rolled outward away from the train, thereby increasing the gauge and causing the cars to derail.

Figure 2. Chetwynd Subdivision looking north at Mile 548, showing the lifted spikes on the high rail at the 8° curve (Source: Canadian National Railway Company, with TSB annotations)

Travelling southward, the 8° curve begins at about Mile 548 and extends for 1278 feet. The curve has 3.51 inches of superelevation³ (SE), 1.49 inches less than balanced SE (the SE at which centrifugal forces are fully compensated), which for an 8° curve at 30 mph is 5 inches. CN engineering track standards limit SE to 5 inches and allow for curves to be up to 2 inches less than balanced SE; the TSR allow for up to 3 inches less than balanced SE. However, when curves with high numbers of defective ties are under-elevated, train forces can result in gauge-side spikes lifting as the high rail rolls or lifts out of the plates.

The track in the vicinity of the derailment also underwent inspection by a heavy track geometry test car. The most recent inspection before the occurrence was conducted on 25 May 2021. The inspection recorded 30 feet of 5.68° of near-urgent outward rail cant on the low rail at Mile 547.7 in the 8° curve. Near-urgent defects must be inspected within 72 hours and repaired within 30 days.⁴ The near-urgent condition was inspected the following day on 26 May 2021. During this inspection, no track geometry defects were identified; however, it is likely that signs of gauge widening (such as sliding tie plates, bent spikes or plate cutting) were present, but not observed. There were no repairs made or

Nine days prior to this occurrence, a near urgent defect was identified, but the subsequent track inspection did not reveal track geometry defects, even though signs of gauge widening were likely present. When conducting track inspections in curves, it is important to pay particular attention to both rails for signs of instability, so that repairs or operating restrictions can be put in place.
