REASSESSMENT OF THE RESPONSE TO TSB RECOMMENDATION R95-02

Speed on other than main track

TSB Recommendation R95-02 (July 1995)

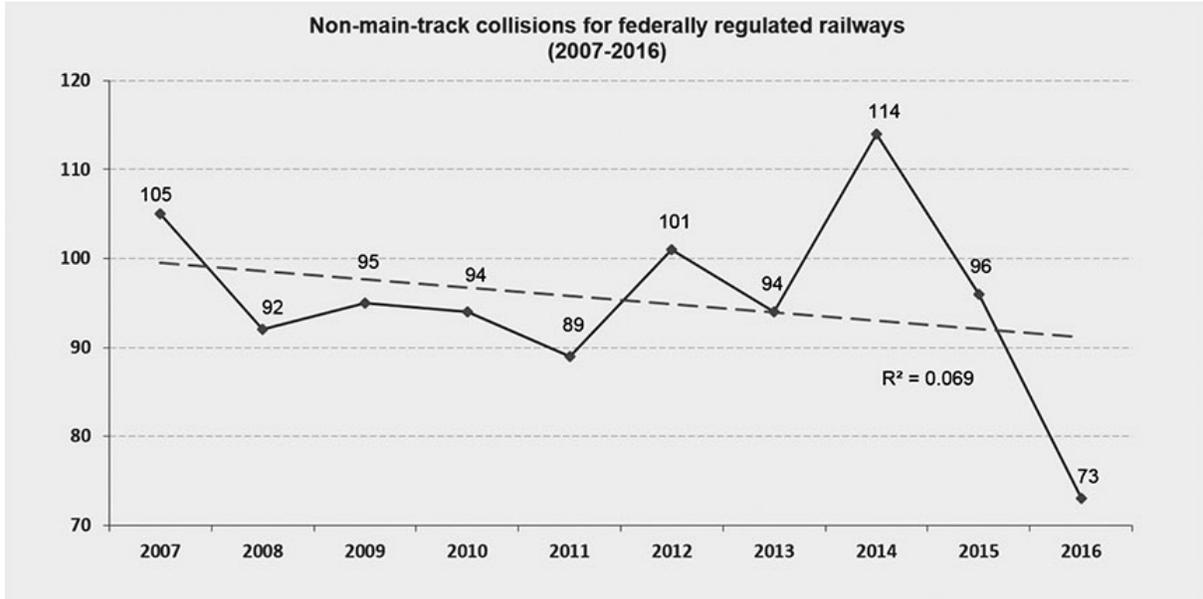
From 2007 to 2016, there was a slight, but non-statistically significant, decrease each year in the number of non-main track collisions – including head-end, tail-end, and side collisions – on federally regulated railways.

The Board believes that TC and the railways must continue to review how Rule 105 is applied with a view to ensuring that appropriate safety margins are maintained. These reviews should be part of on-going risk assessments, audits and safety management initiatives to identify actions that will further mitigate the residual risks when operating trains in Rule 105 territory.
