AIR TRANSPORTATION SAFETY INVESTIGATION REPORT A23Q0069

MID-AIR COLLISION

Richcopter Inc. (dba Select Aviation College)
Cessna 150M, C-FUAE
and
Cessna 150M, C-GRAE
Ottawa/Gatineau Airport, Quebec
20 June 2023

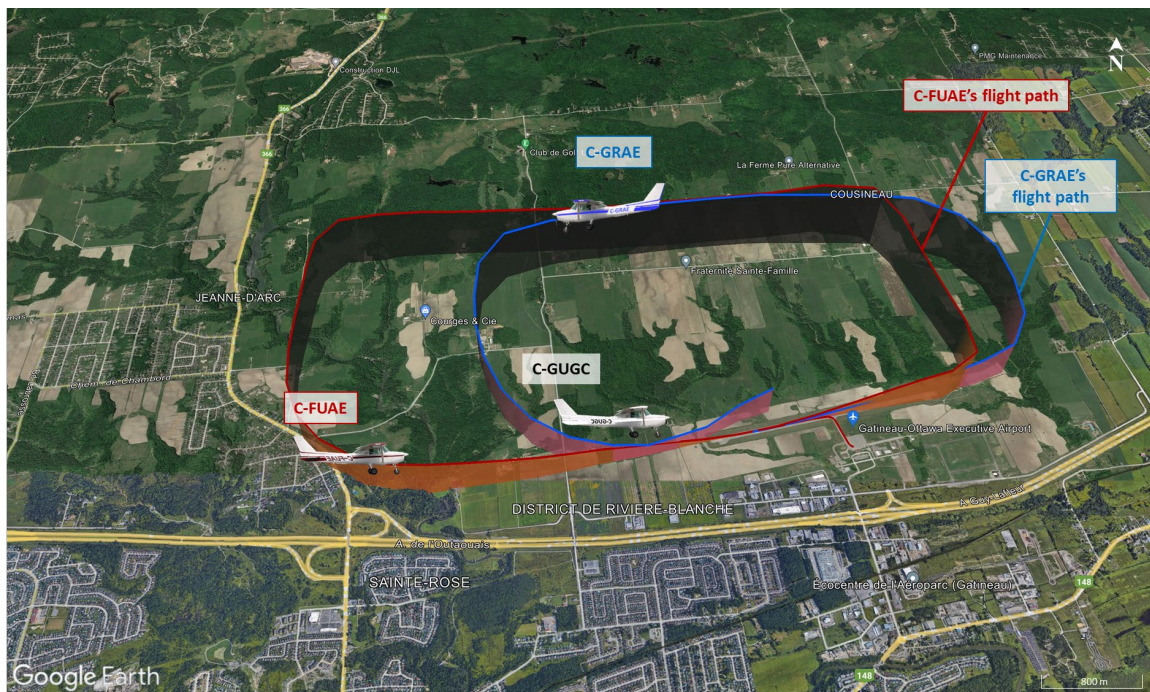
After C-GRAE completed its 1st touch-and-go, the 3 aircraft continued to make the calls indicated above. When the pilot of C-GUGC made his radio call on the final leg, C-GRAE was at the beginning of the downwind leg. When the pilot of C-FUAE made his radio call on the final leg for Runway 09 shortly afterward, C-GRAE was still on the downwind leg, approximately abeam the runway threshold. The pilot of C-GRAE noticed an aircraft on final approach, which he believed to be C-FUAE (number 2 on final). However, it was actually C-GUGC (number 1 on final), ahead of C-FUAE. Because the pilot of C-GRAE did not see C-FUAE, he believed he was number 2 on approach for the runway, began a turn onto the base leg, and made his radio call to report that he was turning onto the base leg (Figure 1).²

Figure 1. Map showing the positions of the 3 aircraft in the circuit in preparation for the 2nd touch-and-go (Source: Google Earth, with TSB annotations)

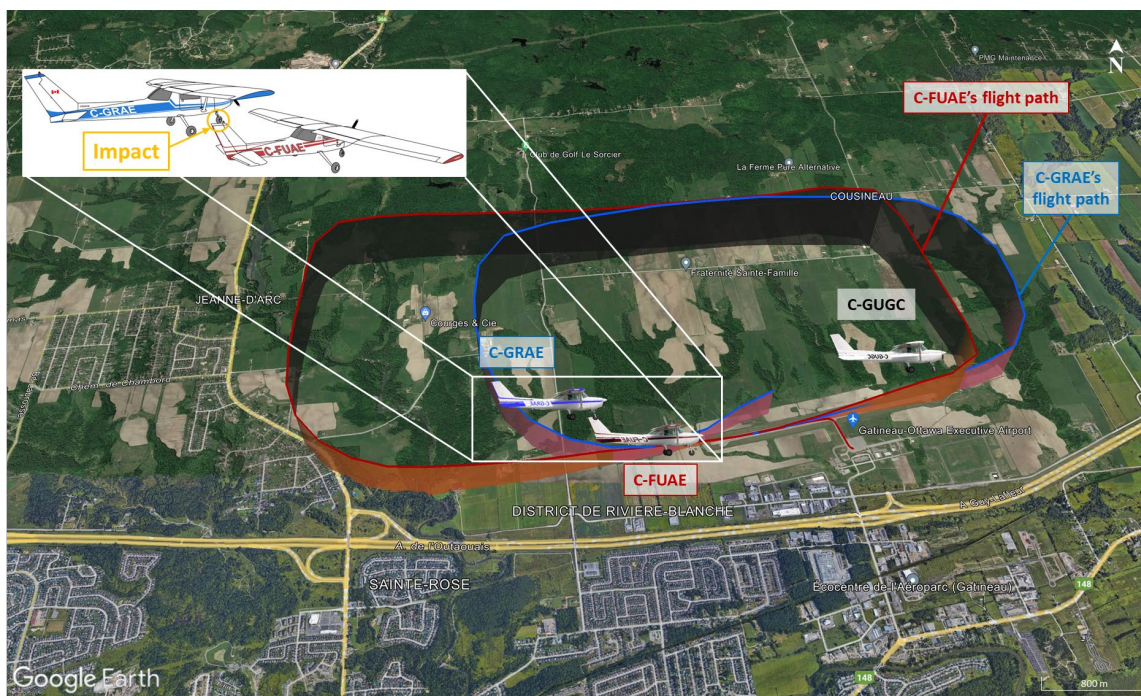
A few seconds later, C-GRAE was directly above C-FUAE. At approximately 2145, when it was between 100 and 200 feet above ground level (AGL), C-GRAE struck the top of C-FUAE's rudder and its vertical stabilizer (Figure 2).

Figure 2. Map showing the positions of the 3 aircraft in the circuit at the time of the collision between C-GRAE and C-FUAE, with a close-up view of the initial point of impact in inset (Source of main image: Google Earth, with TSB annotations. Source of inset image: TSB)

The damage sustained by the 2 aircraft is consistent with the angle of collision, direction of flight, and converging tracks of both aircraft (Figure 2).

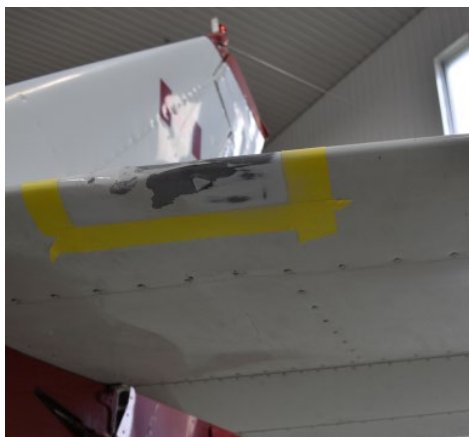
During the collision sequence, C-GRAE's nosewheel and then horizontal stabilizer struck the top of C-FUAE's rudder and its vertical stabilizer, causing minor damage to both aircraft. C-GRAE's horizontal stabilizer sustained only a slight deformation of the left leading edge and a superficial scratch to the lower skin (Figure 3). The upper part of C-FUAE's rudder partially separated, and the upper part of the vertical stabilizer was bent forward and to the left (Figure 4).

Figure 3. Damage to C-GRAE's horizontal stabilizer (Source: TSB)

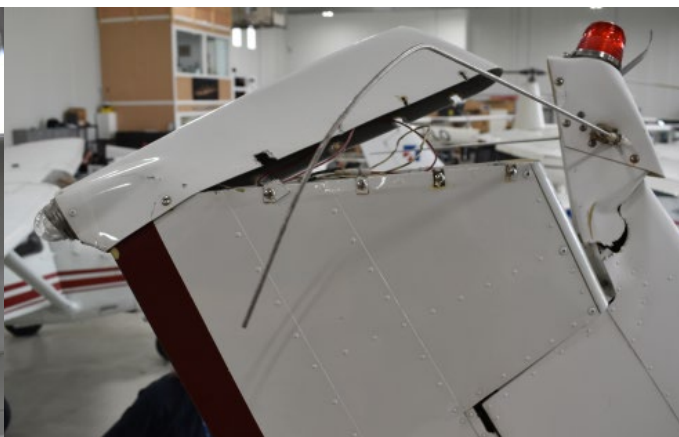
Figure 4. Damage to C-FUAE's rudder and vertical stabilizer (Source: TSB)

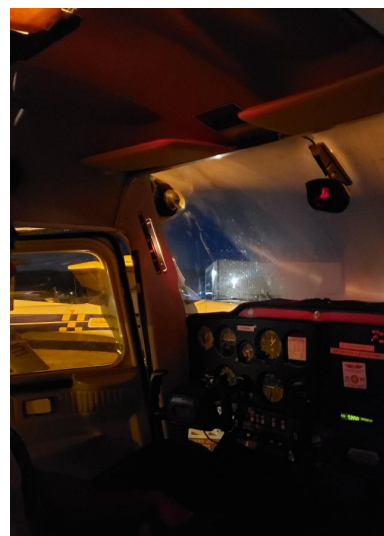
Red light is another way to maintain night vision while enabling pilots to read and understand flight instruments.⁸ The occurrence pilots had a red light on the cockpit's ceiling to illuminate the entire instrument panel (Figure 5). However, in the dark, under a red light, white information against the black background of the aircraft's instrument faces appears red, reducing contrast and readability.

Figure 5. Inside C-GRAE's cockpit at night, with lighting from the red ceiling light (Source: TSB)

In this occurrence, to increase the existing lighting in the cockpit and better see the indications on the flight instruments, both pilots were also wearing a red-light headlamp, which may have exacerbated the loss of contrast even further. Impacts on safety must be taken into consideration when using a headlamp as a source of light. To avoid hindering night vision, it is important not to add too much light, especially white light. Furthermore, using a headlamp as a source of light can cause reflections on glass surfaces and thus reduce visibility outside the aircraft.
