# AIR TRANSPORTATION SAFETY INVESTIGATION REPORT A23W0091

## **CONTROLLED FLIGHT INTO TERRAIN**

Piper Aircraft Corporation PA-32R-301 (Saratoga SP), C-FCCY

28 July 2023

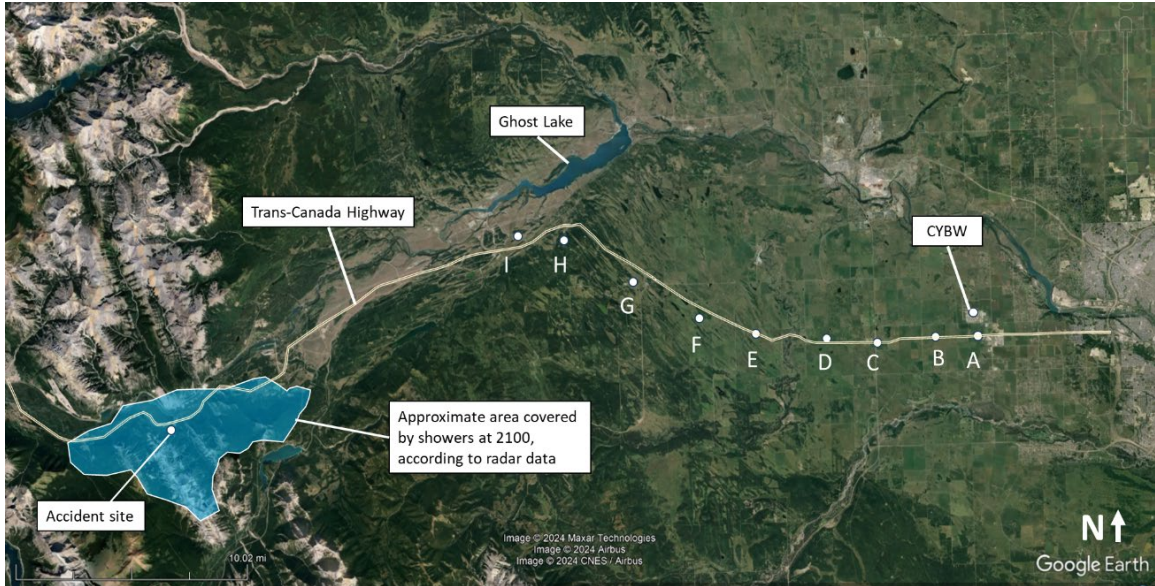
aircraft’s last recorded altitude and ground speed, approximately 50 seconds earlier, were 5800 feet ASL and 150 knots, respectively (Figure 1).

Figure 1. Radar returns for the occurrence flight (labelled A to I and listed in Table 1), with the accident site and the area under rain showers at the time of the occurrence indicated (Source: Google Earth, with TSB annotations)

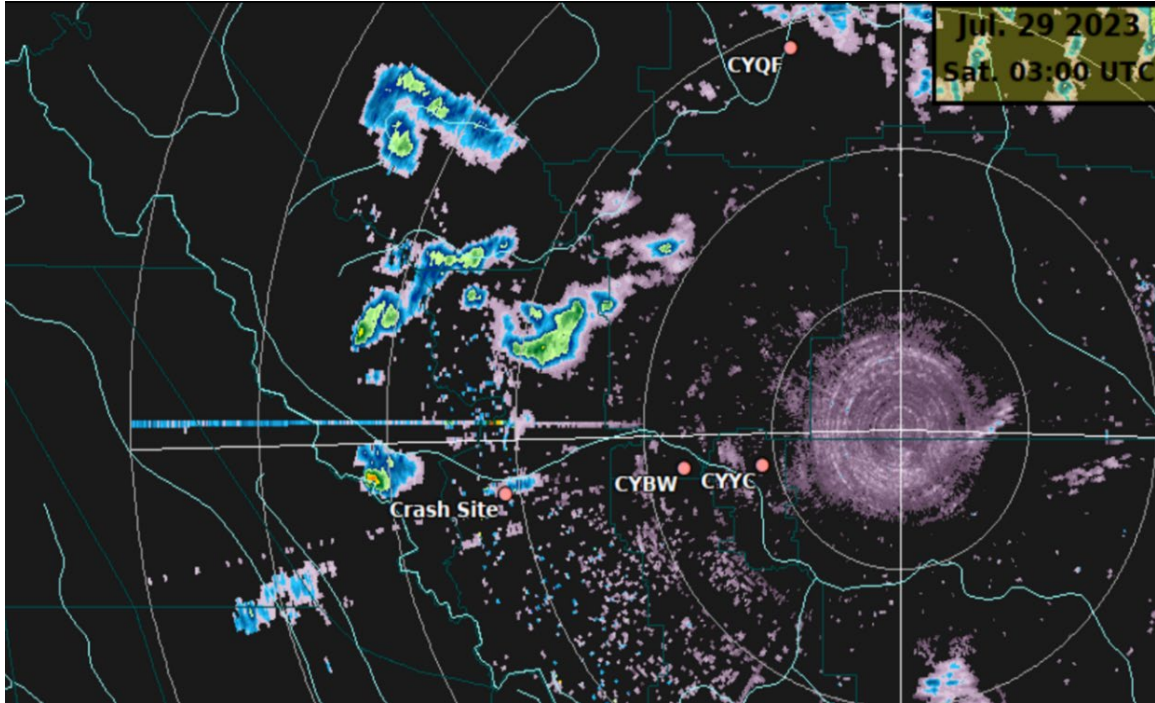
(Figure 3). Radar echoes of light rain showers falling into this air mass near the time of the accident would have provided additional moisture to the lower atmosphere, increasing humidity and allowing clouds to descend further toward the ground.

Figure 3. Weather radar image of the area of the occurrence at 2100 (Source: Environment and Climate Change Canada, Meteorological Service of Canada, Prediction Services Directorate, *Meteorological Assessment July 28, 2023, Kananaskis Village, Alberta* (08 November 2023), p. 18)

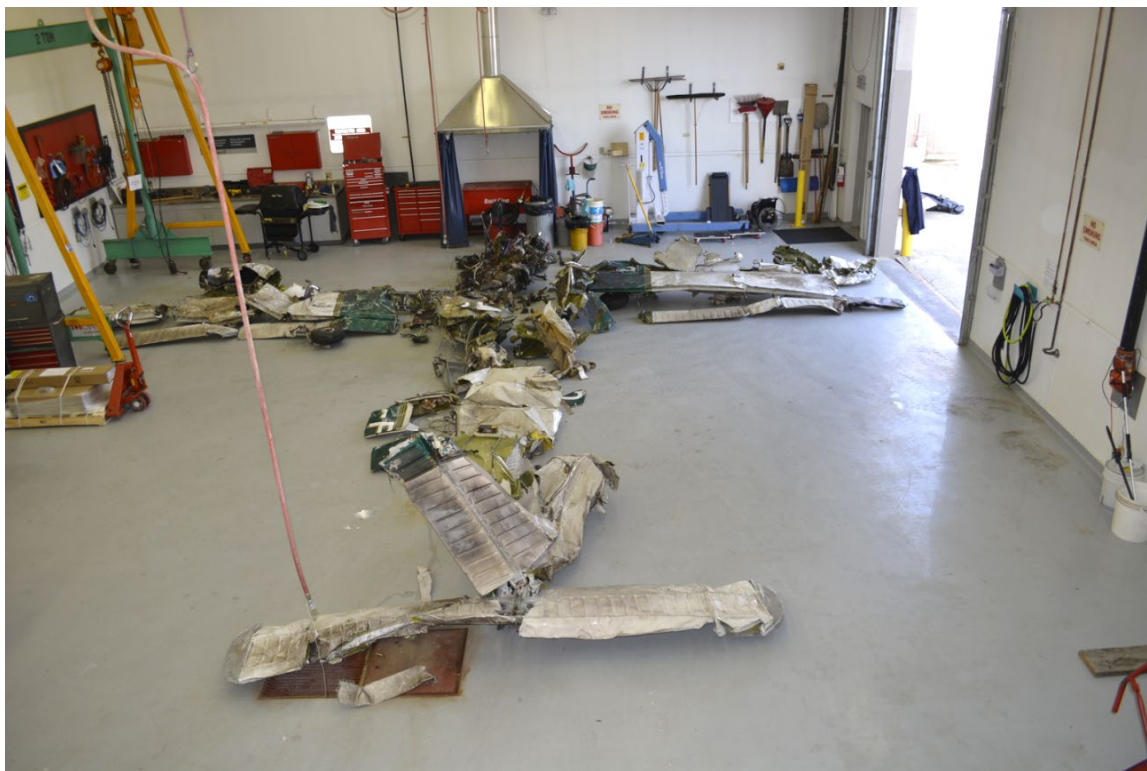
The wreckage was recovered and transported to the TSB's regional office located in Edmonton, Alberta. A detailed examination of the wreckage was performed to the extent possible, given the damage. No abnormalities were observed. A reconstruction of the wreckage was performed, and all major components of the aircraft were accounted for. The flaps and landing gear were in the retracted position, which is consistent with the aircraft being in the cruise configuration.

Figure 4. Layout of aircraft wreckage at the TSB regional office in Edmonton, Alberta (Source: TSB)

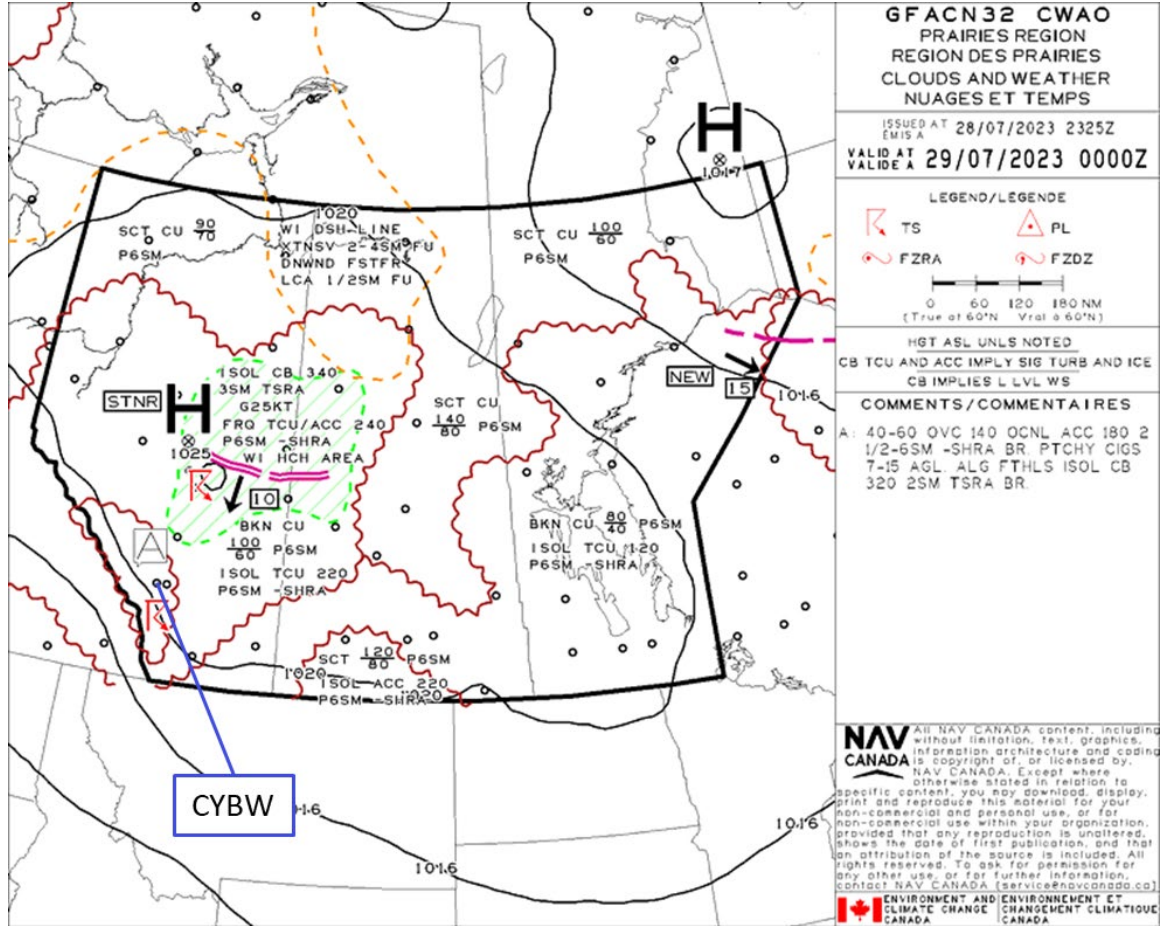
The graphic area forecast (GFA) valid at the time of the occurrence for the portion of the planned flight route from CYBW, located west of Calgary, all the way to the BC border (Appendix A, Figure A1), noted the following weather conditions:

Figure A1. Clouds and Weather Chart for the Prairies Region, valid at 1800 Mountain Daylight Time

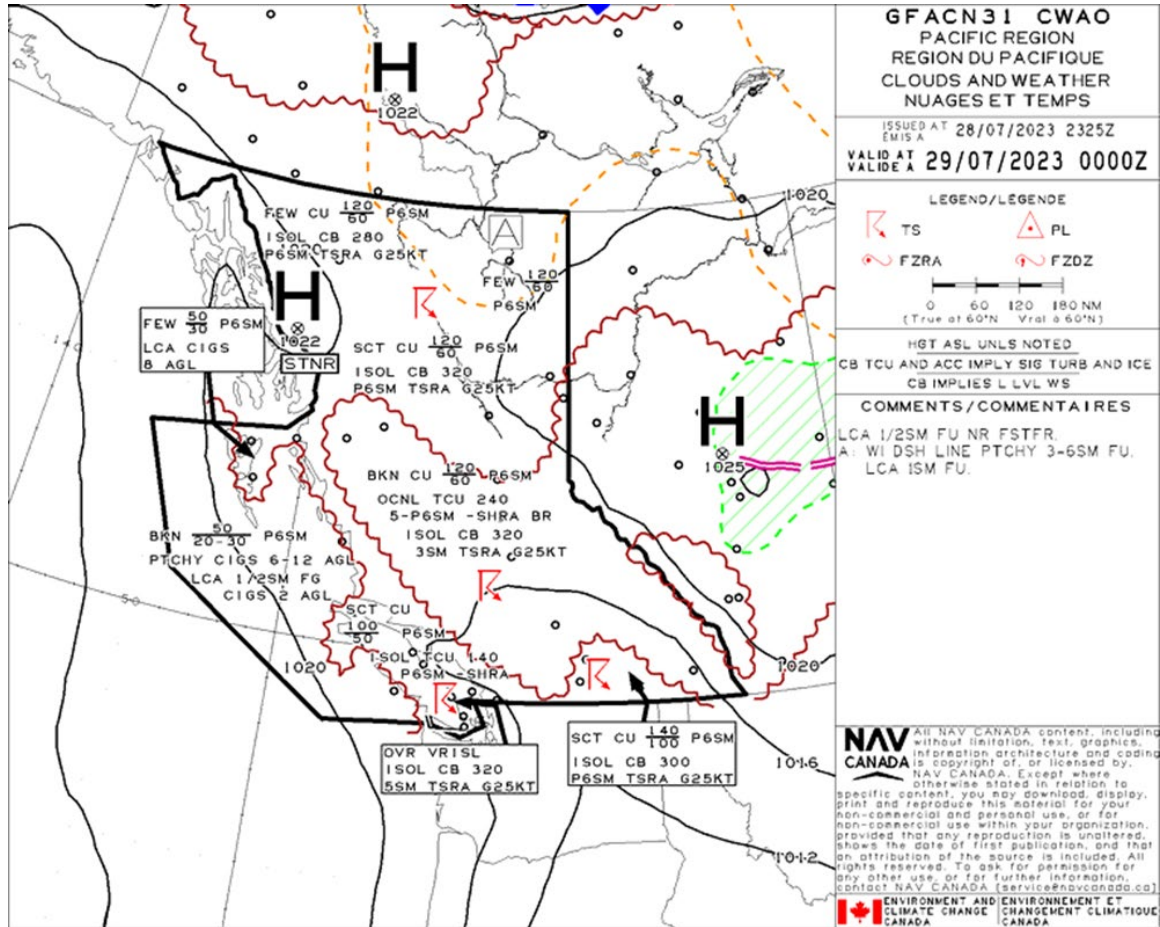
The GFA for the interior of BC along the intended flight route and valid at the time of the occurrence (Appendix A, Figure A3) noted the following forecast weather conditions for that area:

- Broken ceiling of cumulus (CU) clouds from 6000 feet to 12 000 feet ASL, with visibility greater than 6 SM

Figure A3. Clouds and Weather Chart for the Pacific Region, valid at 1700 Pacific Daylight Time (1800 Mountain Daylight Time)
