# RAIL TRANSPORTATION SAFETY INVESTIGATION REPORT R22V0238

## **COLLISION BETWEEN A TRAIN AND A TRACK UNIT**

Canadian Pacific Railway Company  
Freight train 302-25 and hi-rail vehicle L15034  
Mile 116.7, Shuswap Subdivision  
Near Campbell Creek, British Columbia  
29 December 2022

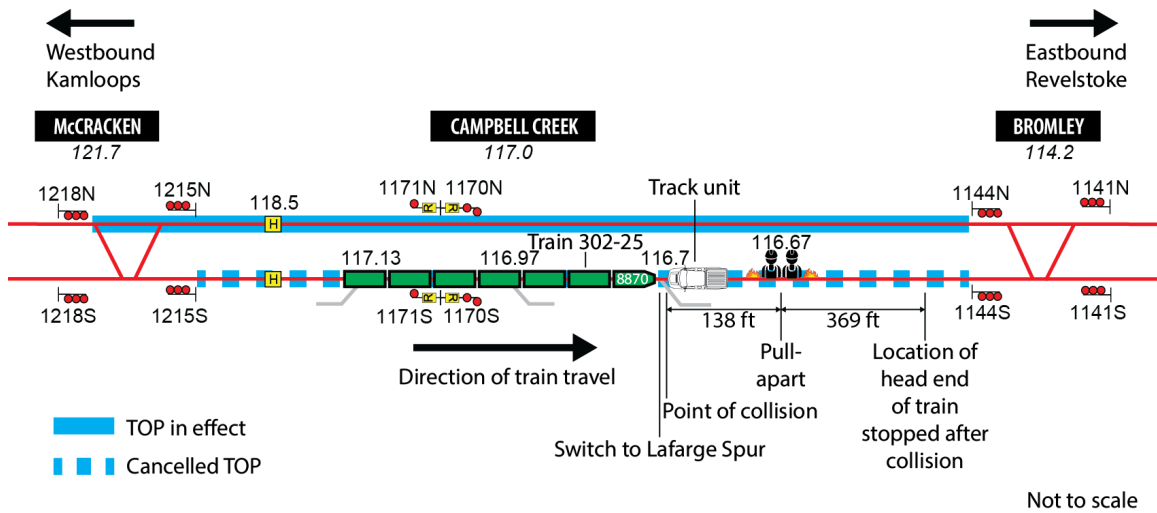
Figure 2. Site diagram (Source: TSB)

The locomotive pushed the hi-rail vehicle approximately 507 feet further east before the train stopped (Figure 2).

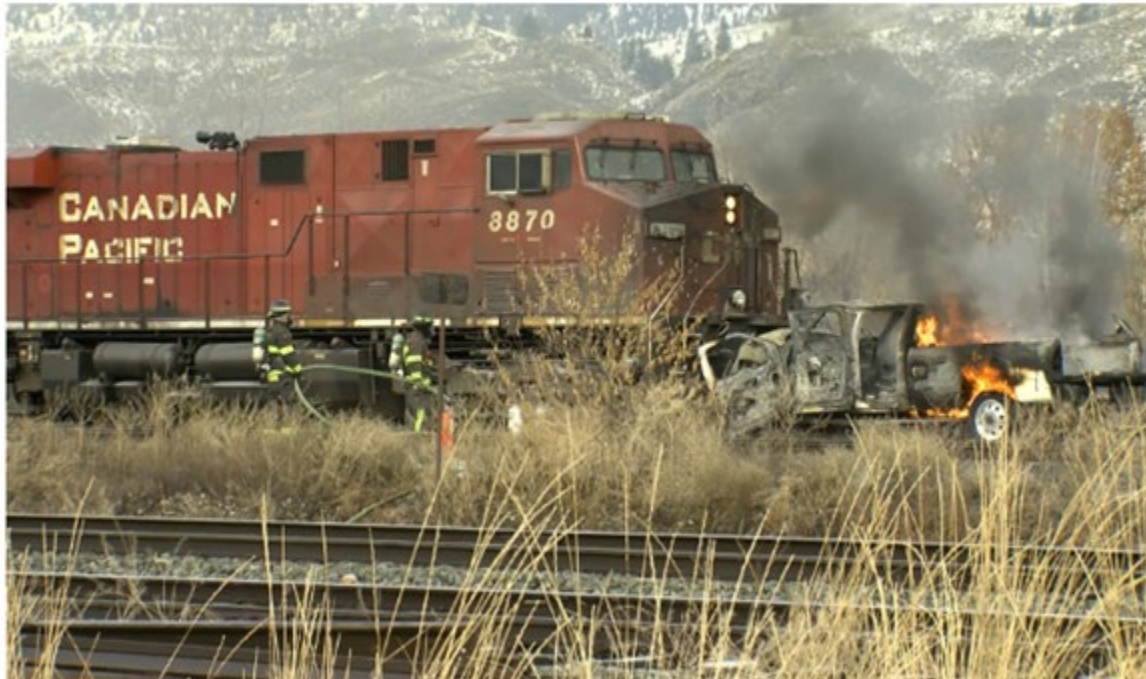
The train did not derail; the lead locomotive sustained minor damage. The hi-rail vehicle caught fire and was destroyed (Figure 3). No one was injured.

Figure 3. Destroyed hi-rail vehicle after the collision (Source: CFJC Today)
