# AIR TRANSPORTATION SAFETY INVESTIGATION REPORT A21F0210

## **RUNWAY EXCURSION ON TAKEOFF AND IN-FLIGHT FUEL IMBALANCE RESULTING IN DIVERSION**

Mitsubishi Heavy Industries, Ltd. CL-600-2D24 (Regional Jet  
Series 900), C-GJZV

San Diego International Airport, California, United States

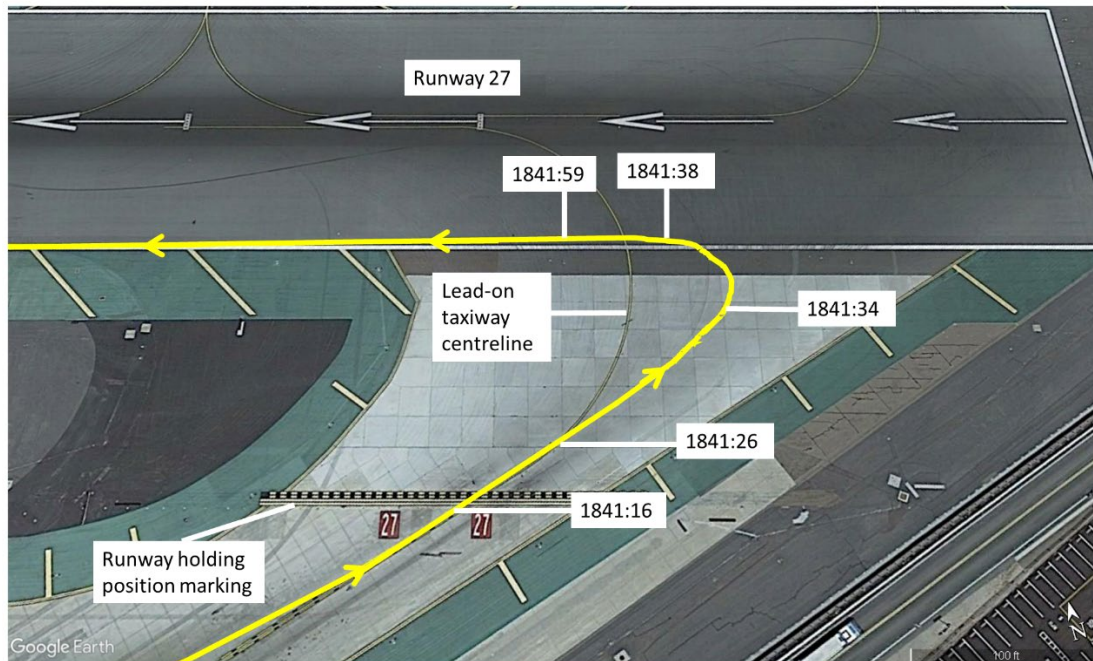
aircraft had turned onto the runway but was aligned with the left runway edge, unbeknownst to the flight crew. At 1841:53, the first officer read back the ATC take-off clearance and was then given control of the aircraft from the captain. The first officer assumed the role of pilot flying (PF), and the captain took on the role of pilot monitoring (PM). At 1841:59, the PF advanced the aircraft power levers and began the take-off roll approximately 1500 feet before the displaced threshold of Runway 27.

Figure 1. The occurrence aircraft's taxi route onto Runway 27, based on data from the flight data recorder (Source: Google Earth, with TSB annotations)

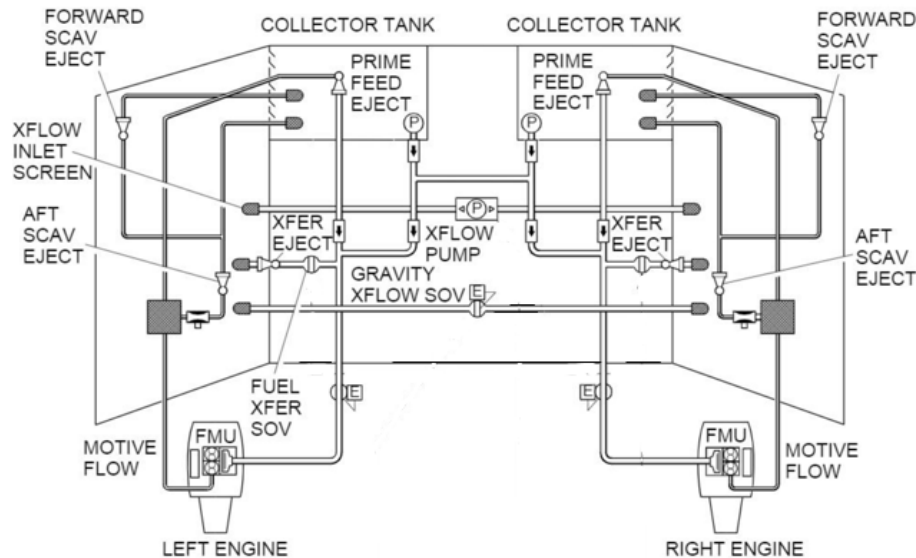
Figure 2. Regional Jet Series 900 fuel transfer and crossflow system (Source: Mitsubishi Heavy Industries, Ltd., Mitsubishi Heavy Industries Regional Jet Aviation Group, CSP C-013, *Flight Crew Operating Manual*, Revision 4 [16 February 2010], Chapter 28: Fuel System, p. 28-13-2.)

Fuel transfer from the centre tank to the wing tanks is provided by transfer ejectors (labelled as XFER EJECT in Figure 2). The ejectors are not electrically operated pumps, but rather are powered only by fuel pressure tapped from the engine supply lines. The FQGC commands the transfer ejector shut-off valves to open when the associated wing tank fuel quantity falls to 93%, or approximately 7000 pounds, and commands them to close when the fuel quantity reaches 97%, or approximately 7200 pounds. The FQGC will continue cycling the transfer system on and off until the centre tank is empty.

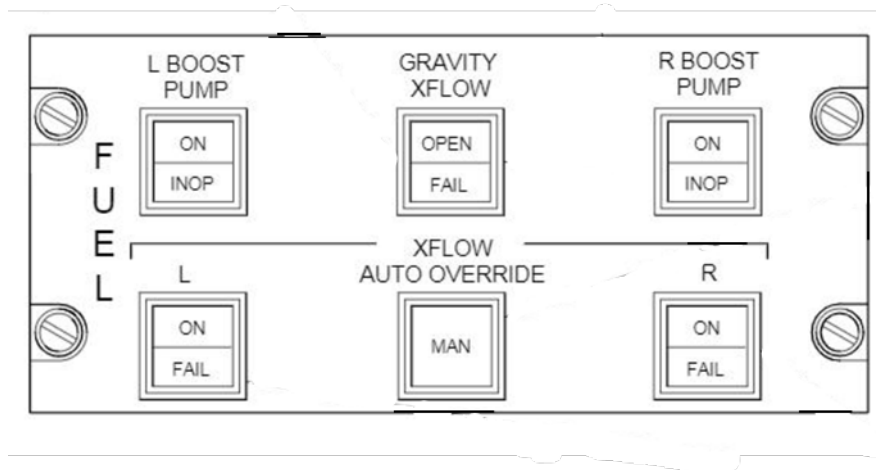
Figure 3. Series 900 overhead fuel control panel (Source: Mitsubishi Heavy Industries, Ltd., Mitsubishi Heavy Industries Regional Jet Aviation Group, CSP C-013, *Flight Crew Operating Manual*, Revision 4 [16 February 2010], Chapter 28: Fuel System, p. 28-13-2.)

The switches are single-actuation push-button switches. Both the L and R BOOST PUMPS as well as the L and R XFLOW switches are in the off position when pressed out. Similarly, the GRAVITY XFLOW is closed when the switch is in the pressed-out position. When pressed in and lit up with white light, these switches are ON or, in the case of the GRAVITY XFLOW switch, OPEN. The XFLOW AUTO OVERRIDE switch, which is labelled as “MAN” and controls the FQGC mode, is in automatic (AUTO) mode when pressed out and manual (MAN) mode when pressed in and lit up.

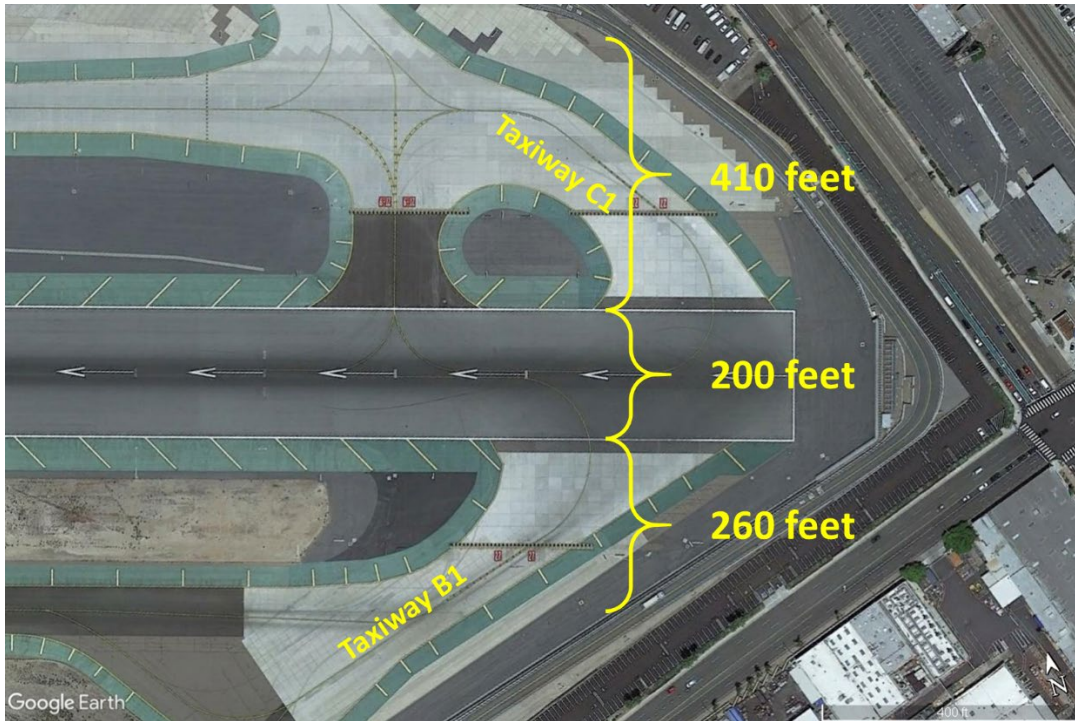
The entry point of Taxiway B1 onto Runway 27 is directly across from that of Taxiway C1, which enters the runway from the north side. The runway itself is 200 feet wide, but the width of the paved surface at this intersection, where the occurrence aircraft initiated its takeoff, is approximately 870 feet. The pavement extends approximately 260 feet to the left of the runway's southern edge and 410 feet to the right of the runway's northern edge (Figure 5).

Figure 5. Map showing the width of the paved surfaces adjacent to Runway 27 at San Diego International Airport (Source: Google Earth, with TSB annotations)

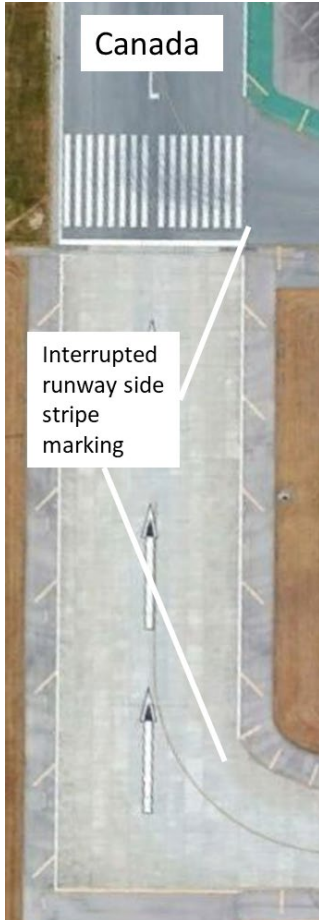
between a runway and a taxiway (Figure 8).<sup>19,20</sup> By contrast, the U.S. standard<sup>21</sup> for runway edge markings specifies that runways shall have uninterrupted edge markings (Figure 9).

Figure 8. Runway side stripe markings at Vancouver International Airport (Source: Google Earth, with TSB annotations)

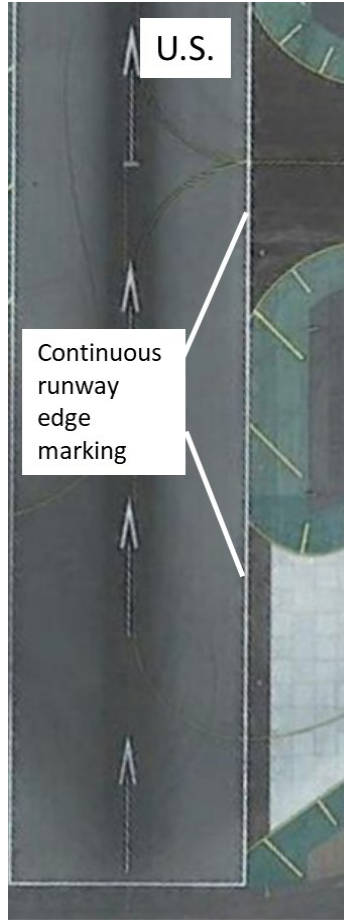
Figure 9. Runway edge markings at San Diego International Airport (Source: Google Earth, with TSB annotations)

The runway edge markings at KSAN had been most recently painted in May 2020—18 months before the current occurrence. Furthermore, in June 2021, the FAA had conducted its annual safety inspection at KSAN, in which an element was the inspection of runway markings for compliance with existing standards.

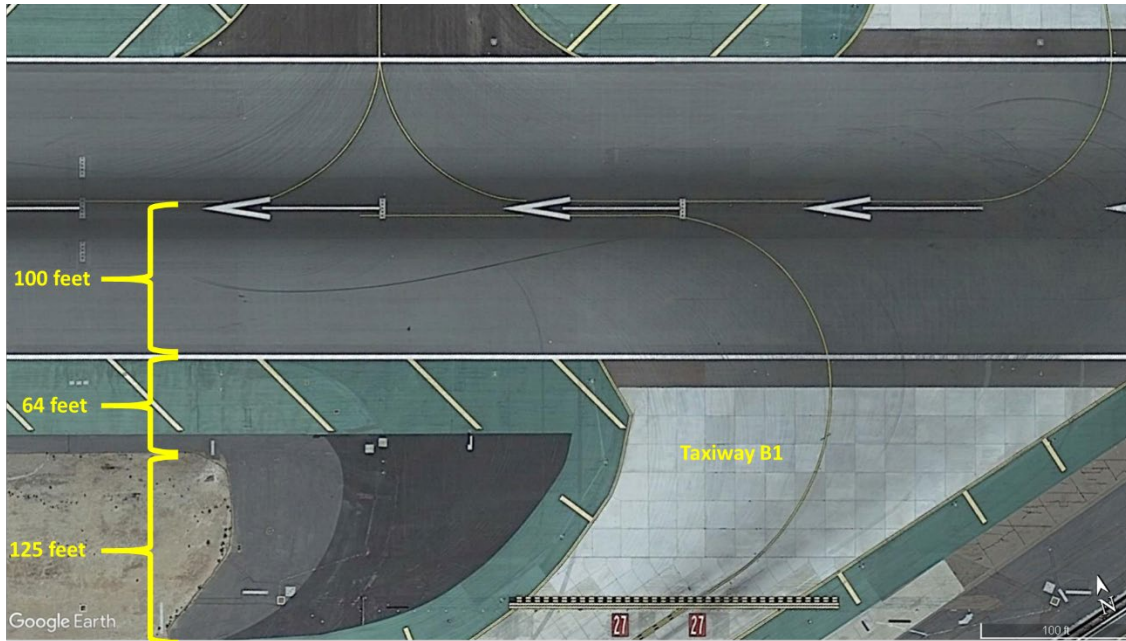
Figure 10. Runway 27 shoulder configuration at Taxiway B1 (Source: Google Earth, with TSB annotations)

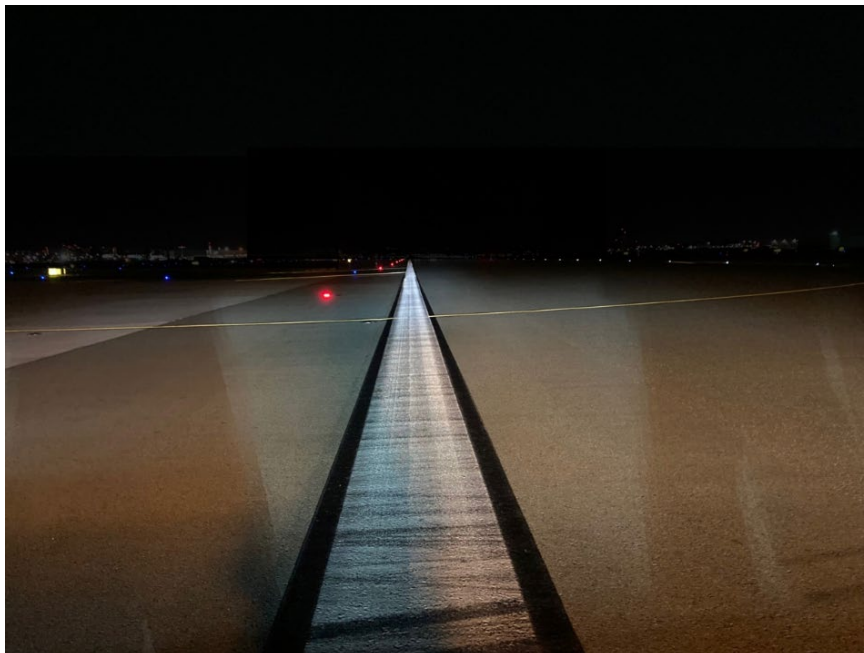
Figure 12. Approximate visual representation of the runway environment, as visible to the occurrence flight crew, while the aircraft was aligned with the left runway edge marking (Source: San Diego County Regional Airport Authority, with transparency adjustments made to the image by the TSB to recreate the visibility during the occurrence)

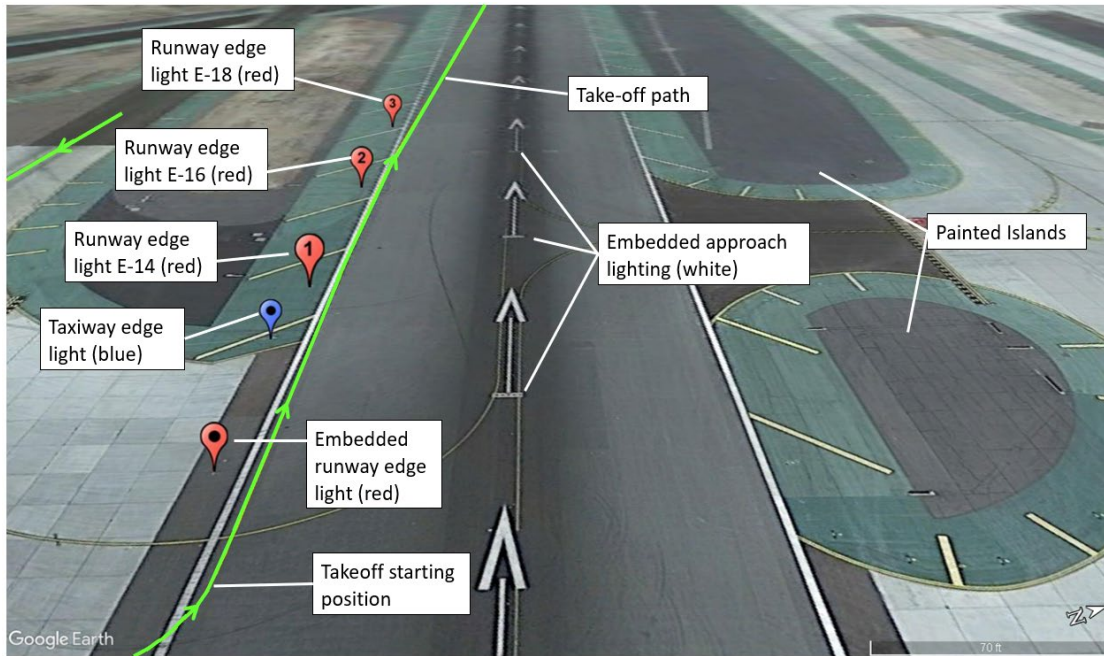
During the take-off roll, the occurrence aircraft struck and severed 3 consecutive raised runway edge lights (labelled E-14, E-16, and E-18 in Figure 13).

Figure 13. Occurrence aircraft's take-off path based on data from the flight data recorder in relation to Runway 27 edge lighting (Source: Google Earth, with TSB annotations)

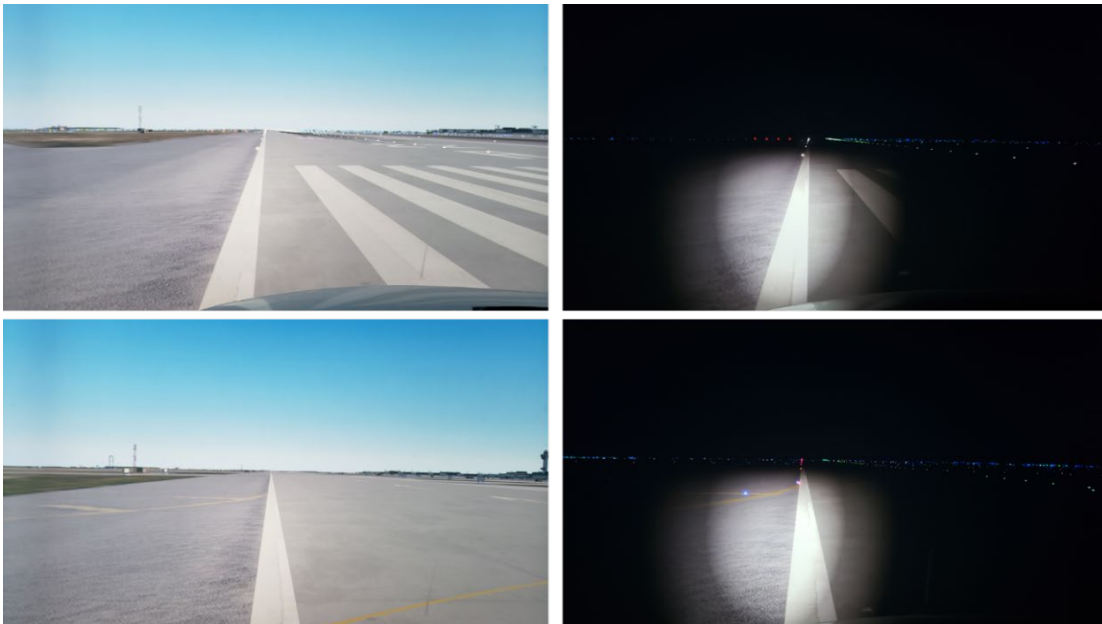
simulated a representative runway model that approximated the runway shoulder, markings, and lighting at KSAN. The environmental conditions were varied between ½ SM visibility<sup>33</sup> and unlimited visibility; conditions were also varied between daytime and nighttime. Images captured from the displaced threshold area (Figure 14) demonstrated to the investigation the level of saliency of runway markings when a flight crew judges an aircraft's lateral alignment with the runway. They also showed how the paved runway shoulder contributes to the overall visual environment.

Figure 14. Simulated runway environments at the runway's left edge. Clockwise, from top left: daytime, at runway threshold; nighttime with reduced visibility, at runway threshold; nighttime, in displaced threshold area; daytime, in displaced threshold area. (Source: TSB)

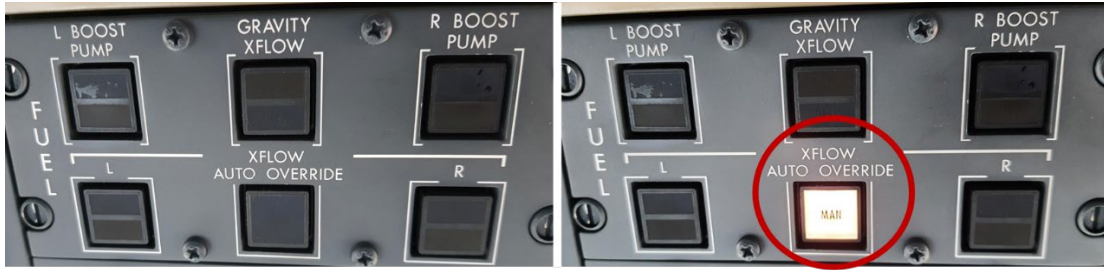
After a first officer performs the checks, he or she confirms them with the checklist, reading for this item “fuel crossflow manual off.” Per the AOM, the first officer is stating that the fuel crossflow is in manual mode and that there are no gravity crossflow or left or right crossflow messages displayed on the flight deck’s EICAS. When the XFLOW AUTO OVERRIDE push-button switch is pressed in, it becomes illuminated (Figure 15).

Figure 15. Fuel control panel before the XFLOW AUTO OVERRIDE switch is selected (left) and after the XFLOW AUTO OVERRIDE switch is selected (right) (Source: Third party with permission and TSB annotations)
