AIR TRANSPORTATION SAFETY INVESTIGATION REPORT A24W0038

AFT FUSELAGE STRIKE AND HARD LANDING

WestJet Encore Ltd.
Bombardier Inc. DHC-8-402, C-GJWE
Calgary International Airport (CYXC), Alberta
13 April 2024

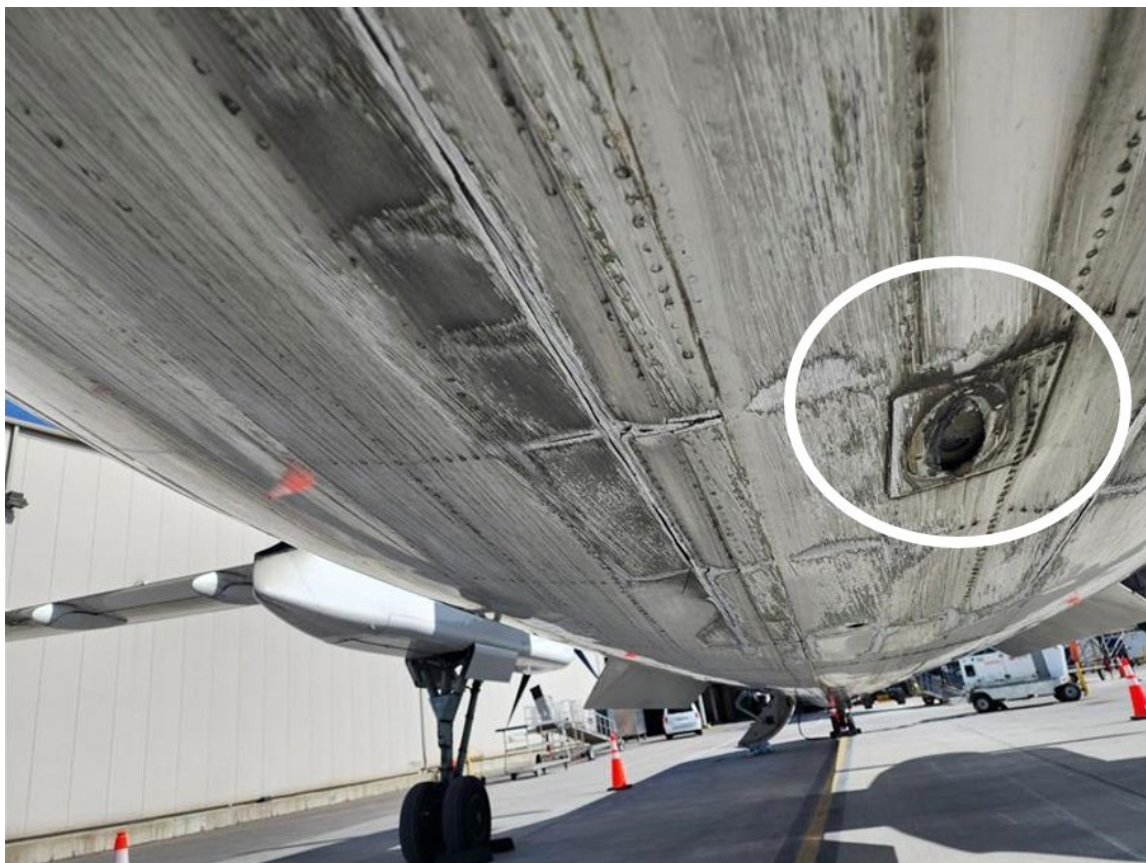
At 1452:26, the aft fuselage of the aircraft contacted the runway approximately 1070 feet beyond the threshold, illuminating the "TOUCHED RUNWAY"⁴ warning light in the caution and warning light panel. The captain taxied to the gate. While the passengers deplaned normally, the flight crew discussed the landing and called company maintenance. There were no injuries. The emergency locator transmitter did not activate.

The aircraft sustained substantial damage to the lower aft fuselage structure that consisted of deformed frames and stringers and perforated belly skins. The tail strike switch also broke off at impact (Figure 1).

Figure 1. Lower aft fuselage damage and broken off tail strike switch on the occurrence aircraft (Source: Third party [with permission], with TSB annotations)

In this occurrence, the pitch increase took less than 2 seconds to go from 5° to 8.3° at touchdown. During this time, there were no standard pitch call outs for 5° and 6° pitch attitudes.

Following the occurrence, the captain and FO completed additional simulator training reinforcing pitch awareness, among other elements, before they were assigned any further flying duties.

- communicated awareness of pitch attitudes, tail strikes, and hard landings to its flight crews in a number of its internal communication products.
- amended its pilot training curriculum and guidance material to include more emphasis on pitch awareness, landing technique, pilot monitoring call outs, and power management in the flare.
- increased the use of flap 35 landing configuration during initial line indoctrination training, and initial and recurrent simulator training.

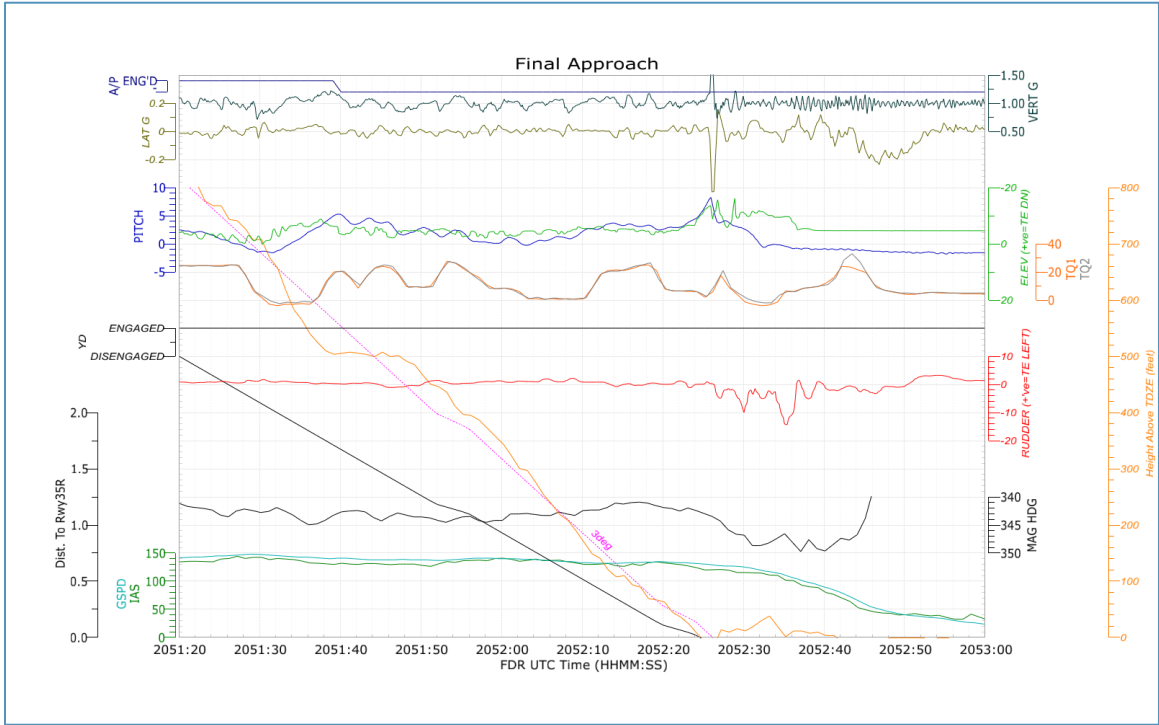
Appendix A – Parameters extracted from the occurrence aircraft’s digital flight data recorder

The autopilot was turned off at 500 feet above ground level (AGL) and the remainder of the approach was hand flown by the FO. From 500 feet AGL to touchdown, the power levers were adjusted up and down 12 times between 22% torque and 4% torque (Appendix A). Once below 350 feet AGL on approach, the aircraft's descent path varied above and below the 3° approach descent path. During this time, the captain made 3 calls to the FO to increase power. The FO responded by increasing power each time; however, the last increase in power was quickly followed by a reduction in power to 4% torque.

The aircraft crossed the Runway 35R threshold at 65 feet AGL. Over the next 6 seconds, the aircraft experienced a performance-degrading wind gust with an approximate speed of 8 knots. The FO began to increase the nose-up attitude to start the flare, slowing the aircraft to 120 knots calibrated airspeed. Two seconds before touchdown, the pitch attitude increased from 5° to 8.3° and the power levers were advanced. At touchdown, the power increased to 8% torque, and then up to 18% torque after touchdown.
