# MARINE TRANSPORTATION SAFETY INVESTIGATION REPORT M22A0052

## RESCUE OPERATION AND SUBSEQUENT LOSS OF LIFE

Fishing vessel *Mucktown Girl* and  
Canadian Coast Guard ship *Jean Goodwill*  
87.5 nautical miles southeast of Canso, Nova Scotia  
12 March 2022

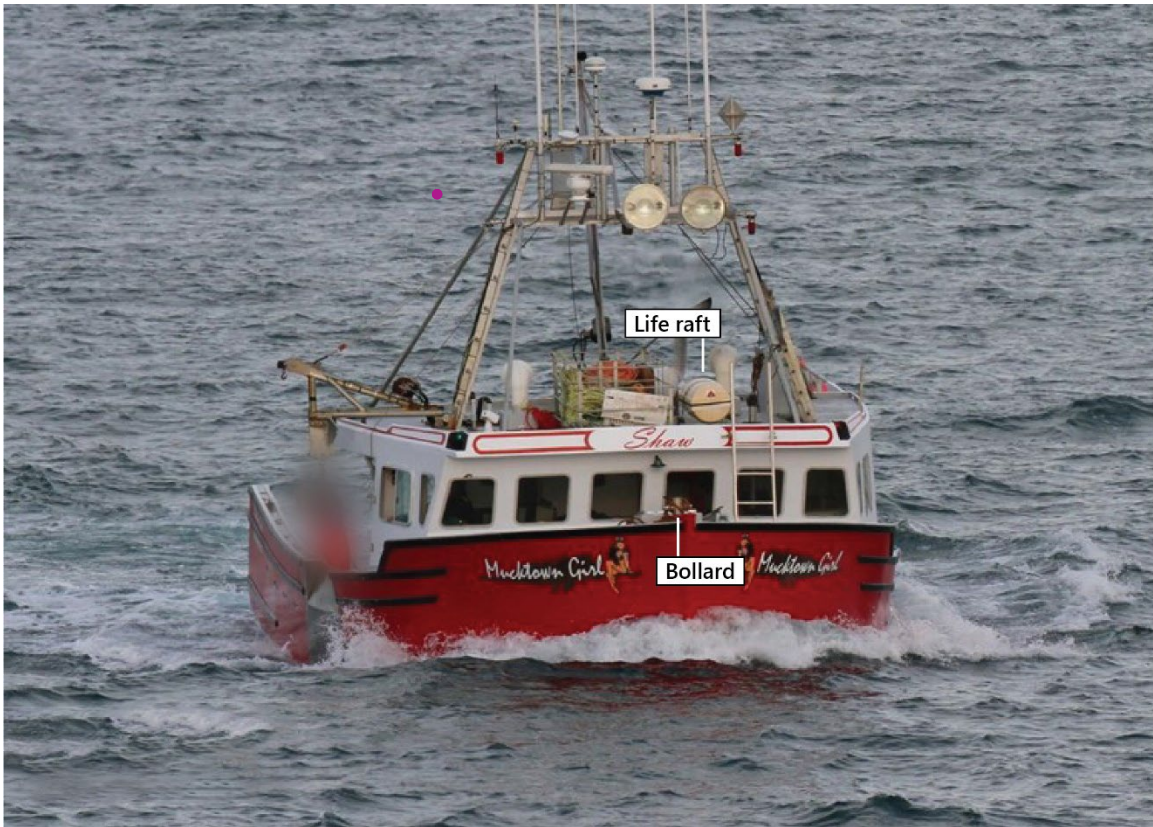
Figure 1. The fishing vessel *Mucktown Girl*, showing the bollard that the towline was attached to and the location of the life raft (Source: Steven Kennedy)

At 1555, the bollard on the *Mucktown Girl* broke and the towing arrangement failed. The break in the bollard occurred at the aluminum weld where the bollard met the base plate. At this time, the winds had increased to 30 to 35 knots with 2.5 m seas. The master of the *Mucktown Girl* reported to the master of the *Jean Goodwill* that the vessel was managing in the sea conditions.

Six hours into the towing operation, the forces from the weather and the towing arrangement caused the bollard that was being used as the towing point on the *Mucktown Girl* to break.

Before engaging in a towing operation, an assessment of the vessels and the conditions is required. A plan for towing should define the weakest point in the towing arrangement to ensure that shock forces do not overcome the towing equipment or damage the towed vessel. A plan for towing also includes contingency plans for anticipated hazards such as heavy weather in open water or ice, and events such as a vessel taking on water or the towing arrangement breaking. Finally, a plan for towing should include contingency plans for reestablishing the tow with a new towing arrangement or for actions if a new towing arrangement is not feasible, such as how to remove some or all of the crew from the towed vessel.

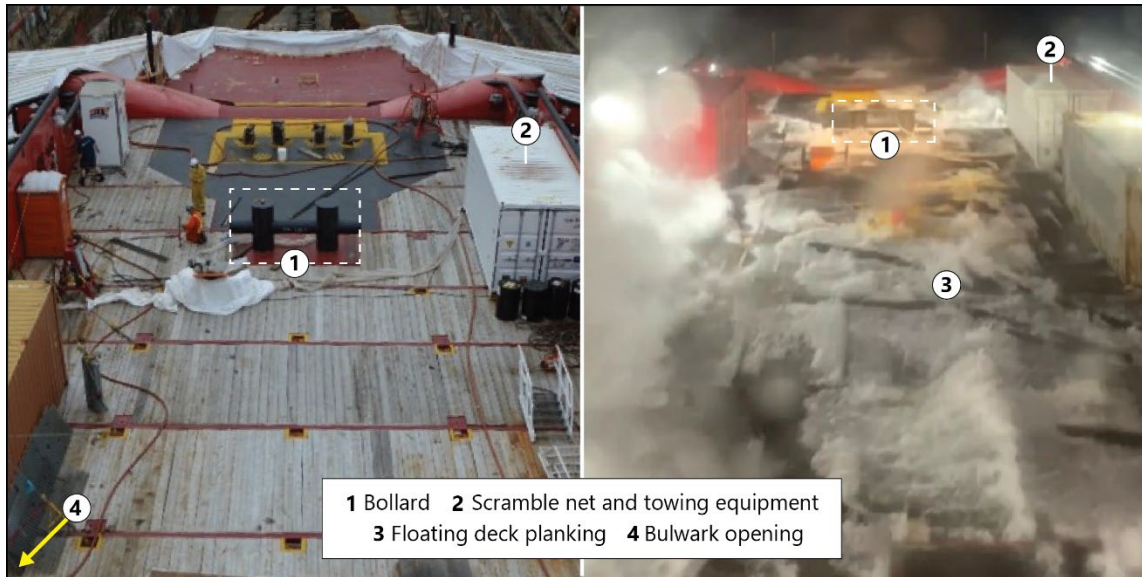
Figure 3. Photos of the aft deck of the *Jean Goodwill* while in dry dock (left) and during the occurrence (right), showing the bollard in the centre and the containers for the SAR equipment and the towing equipment (Source of left image: TSB. Source of right image: Canadian Coast Guard crew member)

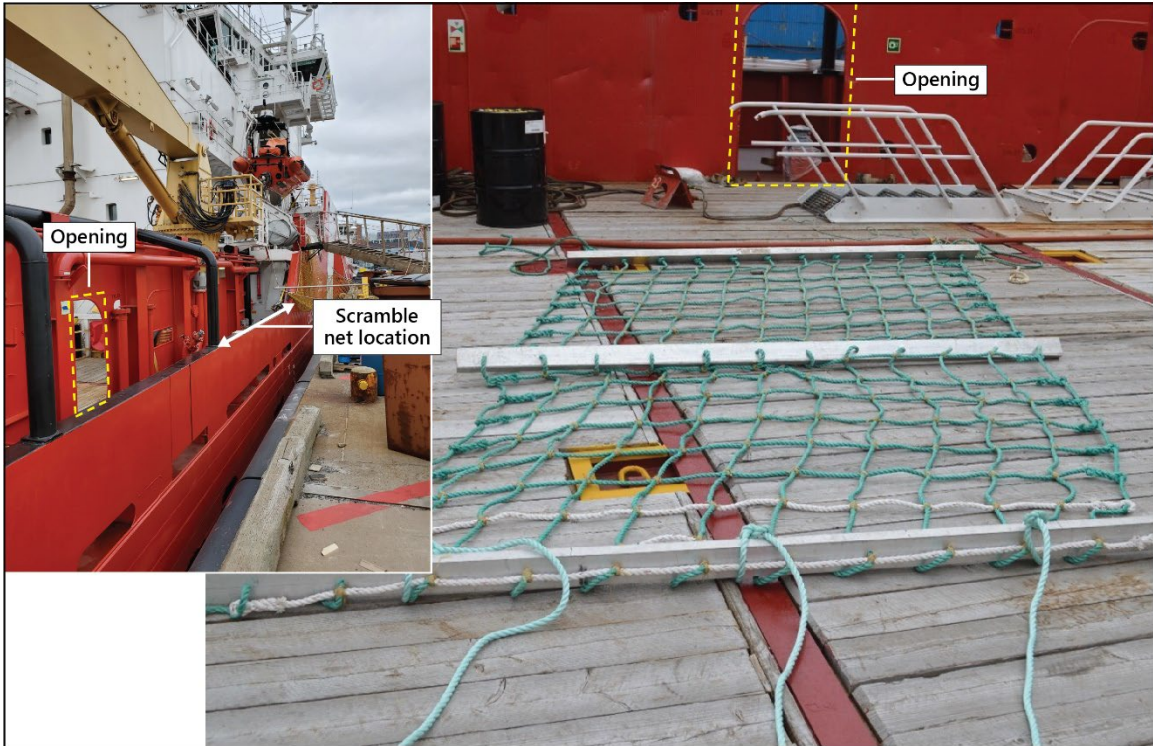
Figure 4. The *Jean Goodwill* scramble net, showing the scramble net spread on deck and the small opening in the inner bulwark from the main deck (main image) and the hull (inset image) (Source of main image and inset image: TSB)

As part of the CCG SMS,<sup>40</sup> the CCG has requirements for the vessels it operates, and the *Jean Goodwill* was required to have 2 scramble nets. At the time of the occurrence, the requirements for the type of scramble nets had just been changed to conform to International Convention for the Safety of Life at Sea (SOLAS) standards but the scramble net on board the *Jean Goodwill* had not yet been replaced.
