AIR TRANSPORTATION SAFETY INVESTIGATION REPORT A24Q0053

LOSS OF ENGINE POWER AND COLLISION WITH TERRAIN

Privately registered
Piper PA-32-260 Cherokee Six, C-GEEV
Sherbrooke Aerodrome (CYSC), Quebec
10 May 2024

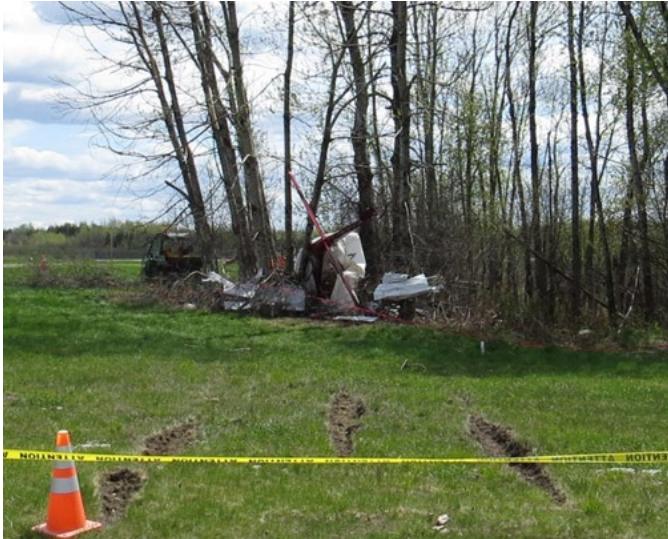
The aircraft's wheels touched down on the grassy surface approximately 70 feet from the edge of a wooded area, and the aircraft came to rest in the trees (Figure 1).

Figure 1. Occurrence wreckage (Source: TSB)

When TSB investigators arrived at the accident site, the aircraft was lying on its right side. The wings had been torn off by the impact with the trees.

The left engine cowlings were damaged, exposing the engine, which had seized. A hole caused by the connecting rod was visible in the crankcase (or engine block) at the base of the No. 6 cylinder. A tear from the nose to the tail could be seen on the belly of the fuselage on the pilot's side. The propeller blades were bent backwards, and the damage was consistent with a propeller that was not turning at the time of impact.

Although aircraft built before 18 July 1978 are not required to be equipped with shoulder harnesses, it is advised that they be equipped with harnesses to reduce injuries in the event of an accident.

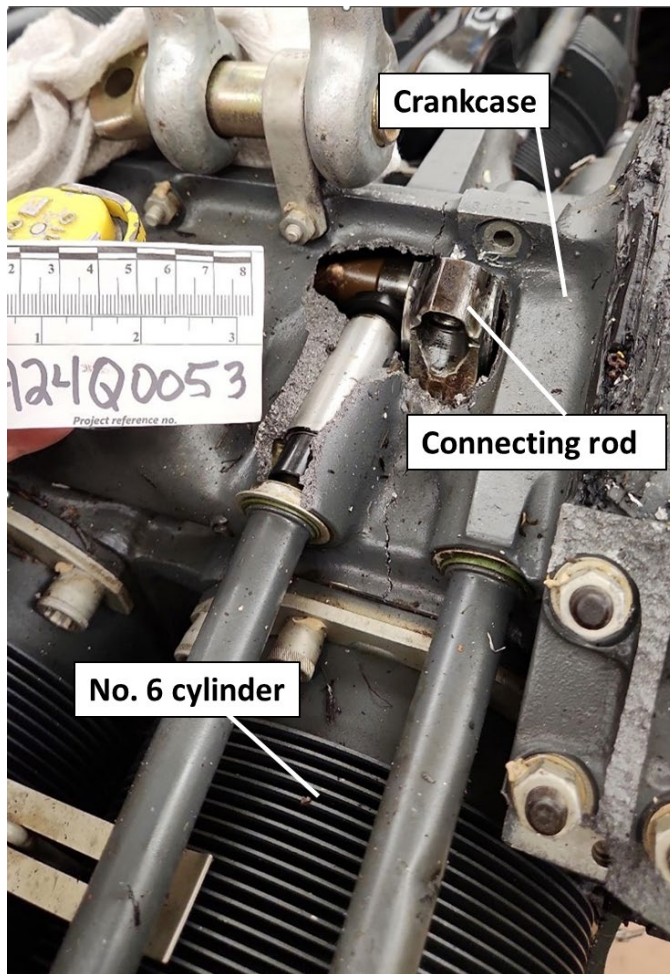
The No. 6 cylinder was removed and inspected. The connecting rod was bent downward and had punched through the casing of the upper portion of the crankcase at the base of the No. 6 cylinder (Figure 2).

Figure 2. Crankcase at the base of the No. 6 cylinder, with the hole created by the connecting rod (Source: TSB)

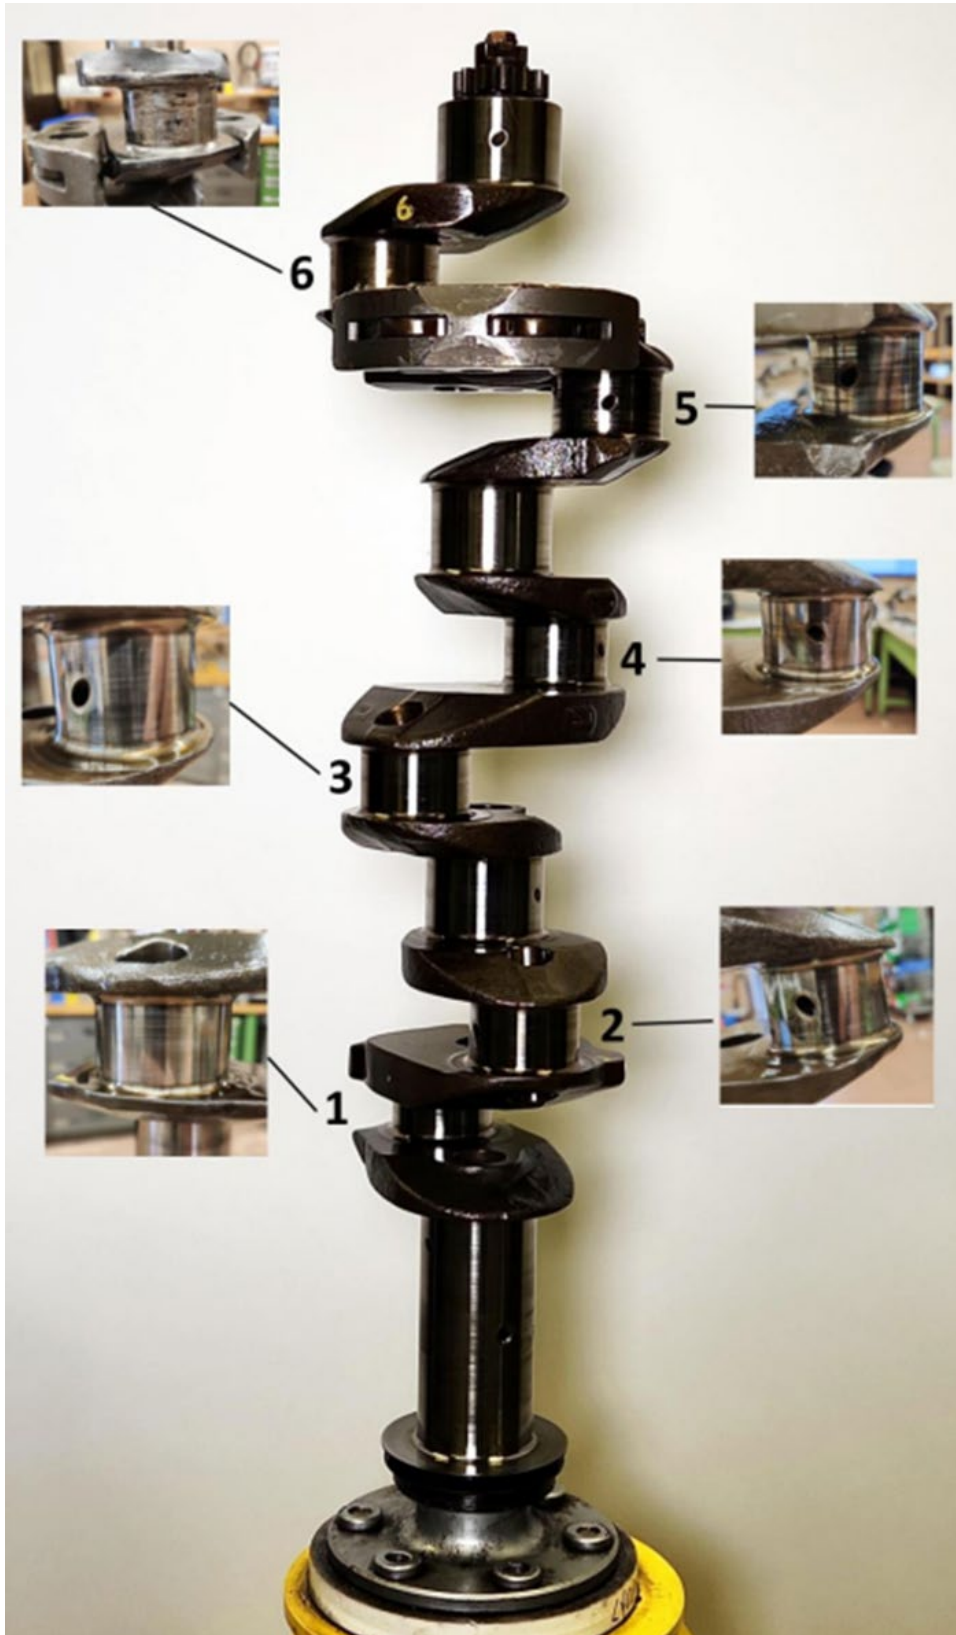
- The crankshaft rod bearings showed increasing heat signatures and scoring from the No. 1 cylinder up to the No. 6 cylinder (Figure 3).
- The crankshaft main bearings showed varying degrees of overheating.
- The camshaft had impact damage near the Nos. 5 and 6 cylinders.
- The crankcase showed varying degrees of damage from being struck by pieces of the No. 6 cylinder assembly as they broke off.
- The engine starter ring gear was sheared and split in 2 separate parts.

Figure 3. Scoring marks on the crankshaft rod bearings (Source: TSB)

The progression of the heat signatures, the increasing scoring marks, and the damage to cylinders Nos. 1 through 6 are consistent with oil starvation.

Maintenance staff and aircraft owners should be familiar with, review, and apply, as necessary, all relevant maintenance instructions published by aeronautical product manufacturers even if their implementation is not always required by Transport Canada.
