MARINE TRANSPORTATION SAFETY INVESTIGATION REPORT M23C0104

ENGINE ROOM FIRE

Bulk carrier *Cuyahoga*
Lake Erie
Kingsville, Ontario
23 May 2023

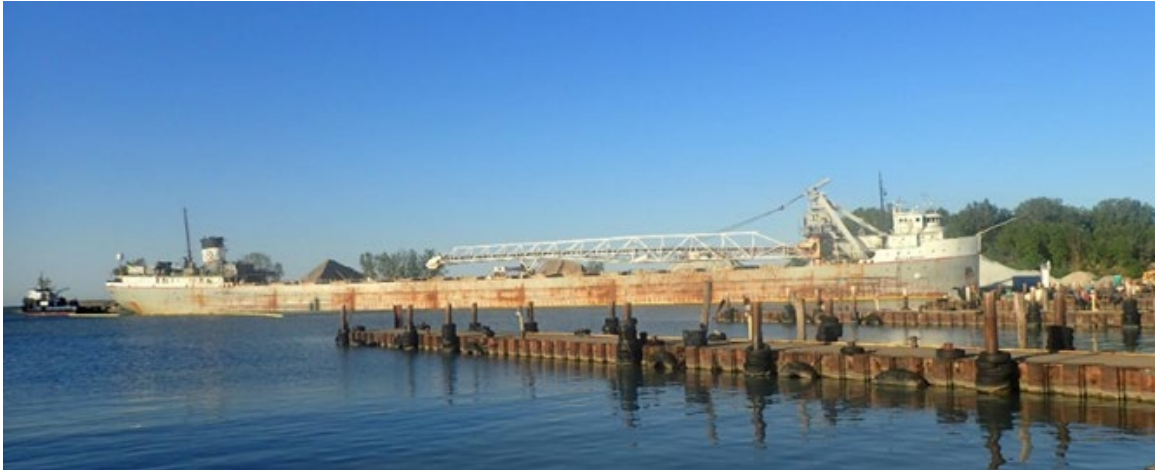
Figure 1. The *Cuyahoga*, shortly after the fire (Source: TSB)

The *Cuyahoga's* engine room and associated machinery sustained heat and smoke damage from the fire. The main engine and various electrical cables and equipment sustained moderate to severe fire damage.

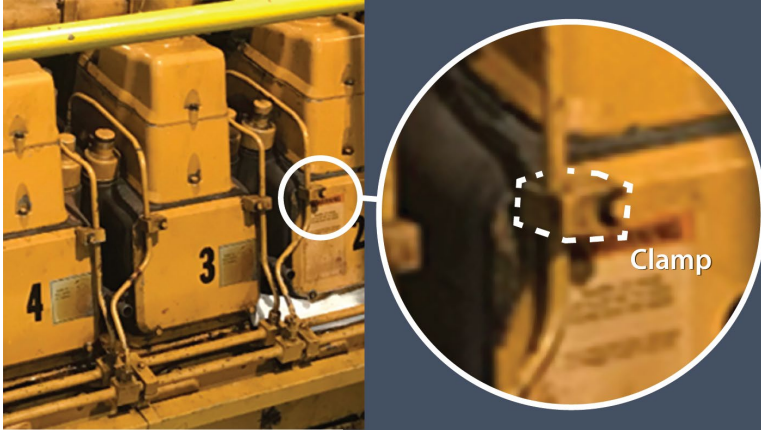
Figure 6. Cylinders 2, 3, and 4 on the main engine before the occurrence, with retaining clamps (enlarged) securing the fuel injection lines (Source: Lower Lakes Towing Ltd.)

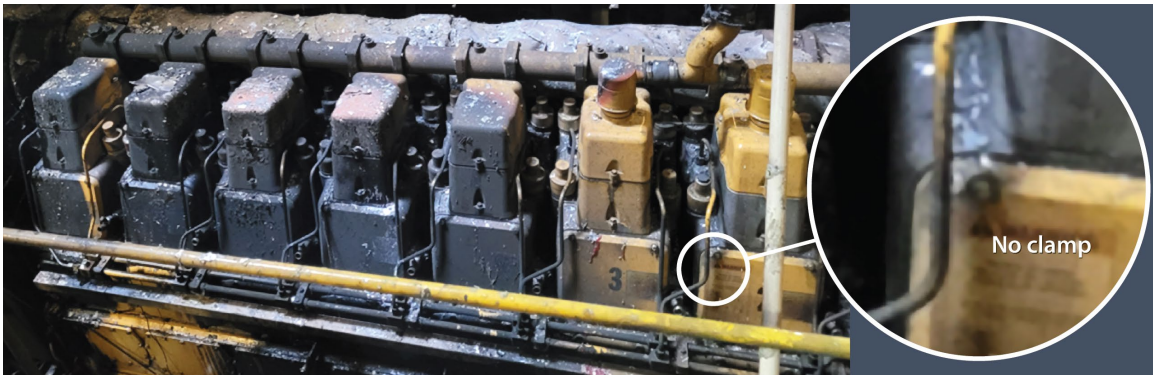
The TSB found that the fuel injection return line for cylinder 7 was disconnected, which resulted in a spray of marine diesel oil. At the time of the occurrence, all the retaining clamps on the fuel injection lines were missing (figures 6 and 7). The investigation found that the retaining clamps were most likely removed in 2021, when the crew replaced the fuel supply and return manifolds.

Figure 7. Main engine after the occurrence showing fuel injection lines with only bolts at the location for the retaining clamps (1 enlarged) (Source: TSB)

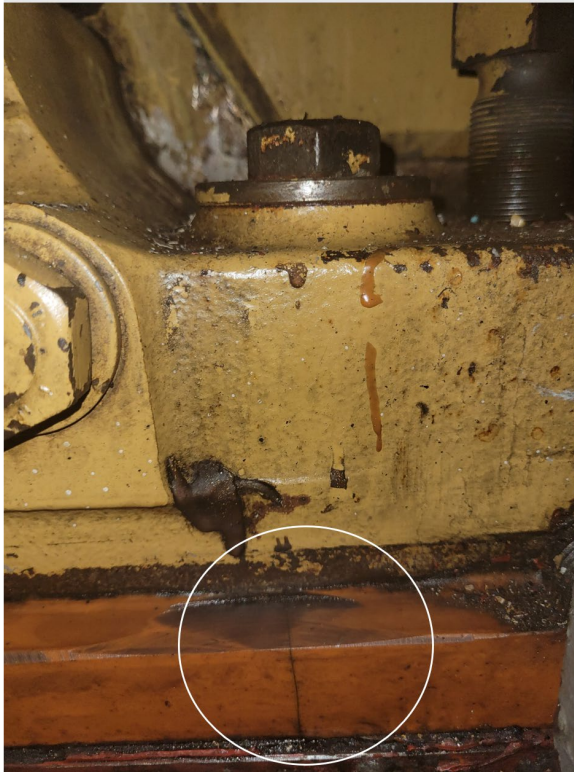
In 2020, the reduction gearbox was removed from the *Cuyahoga's* engine room for repairs and reinstalled during the winter layup. The alignment between the engine and gearbox was outside of the maximum tolerance for vertical and angular misalignment specified by the manufacturer of the coupling. During the 2021 layup period, the engine was realigned to the gearbox to correct the misalignment. The engine's epoxy chocks were repoured during the realignment. During the TSB examination of the mounting arrangement, cracks in 2 chocks were noted (figures 9, 10, and 11). The presence of oil and debris in the cracks indicated they predated the occurrence.

Figure 9. Close-up photo of engine mounting, showing a crack on the forward port engine mount near the bolts (Source: TSB)

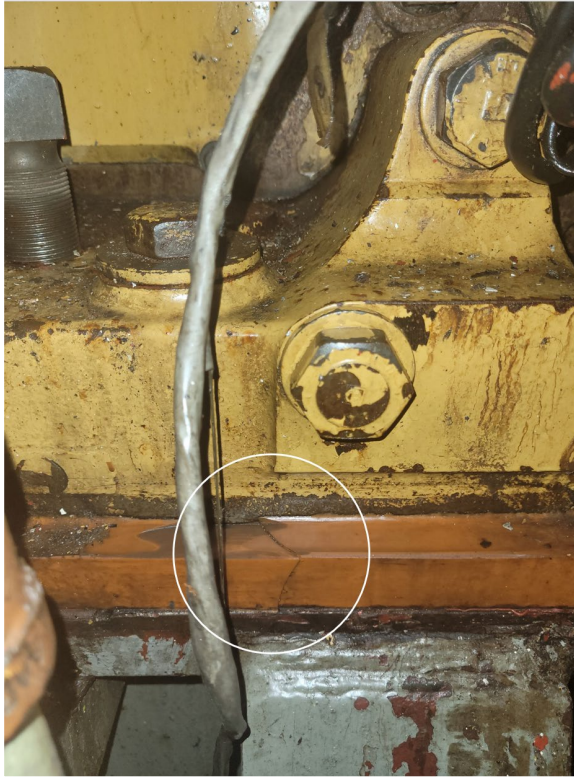
Figure 10. Close-up photo of engine mounting, showing a second crack on the forward port engine mount near the bolts (Source: TSB)

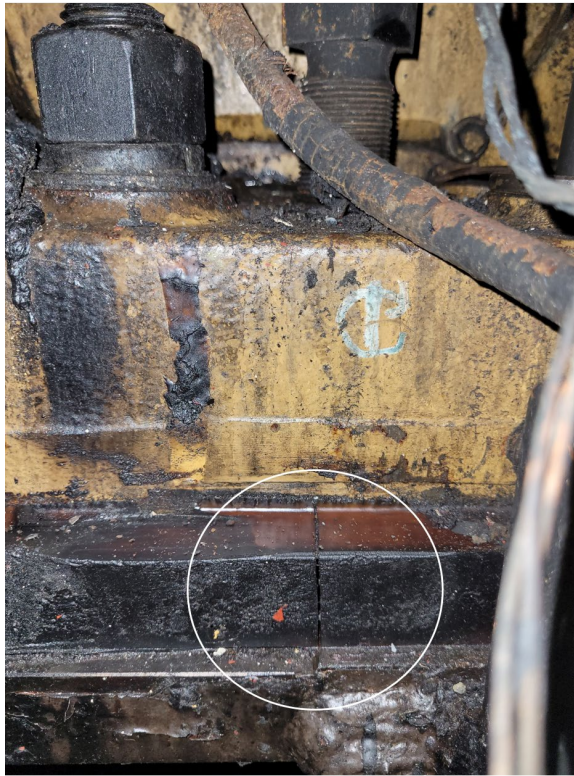
Figure 11. Close-up photo of engine mounting, showing a crack on the aft port engine mount near the bolts (Source: TSB)

The *Cuyahoga's* planned maintenance system generated a maintenance task after every 900 hours of engine operation that included a check of foundation bolt tightness. The task did not include any instructions for inspecting the engine mounts or epoxy chocks for damage, nor did it provide the torque for the bolts. When the task was last completed, on the day of the occurrence, the cracks in the epoxy chocks were not recorded.

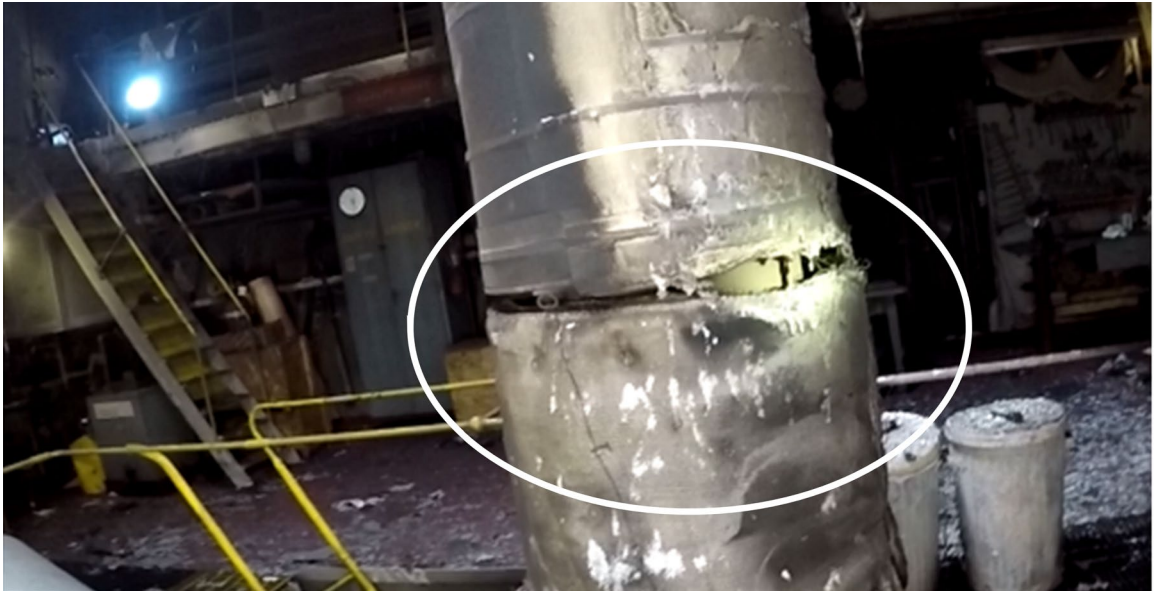
- Notches were worn into the lower edge of the lagging covering the bellows where previously there had been support brackets. These notches formed openings that exposed the exhaust gas piping.
- Gaps between sections of lagging and the insulation encased in sheet metal left piping exposed.
- Flanges in the exhaust gas piping between the reducer, expansion bellows, and main piping section were uncovered.
- Gaps were left for exhaust gas turbocharger temperature sensors.
- The lagging over the opening in the turbocharger casing for the engine manifold piping was loose fitting.

The sections of insulation covering the turbocharger outlet had been in use for several years, were occasionally removed and replaced during engine maintenance, and had deteriorated over time.

Figure 12. Insulation on turbocharger showing gaps in the way the insulation had been installed on the turbocharger outlet from the side (Source: TSB)

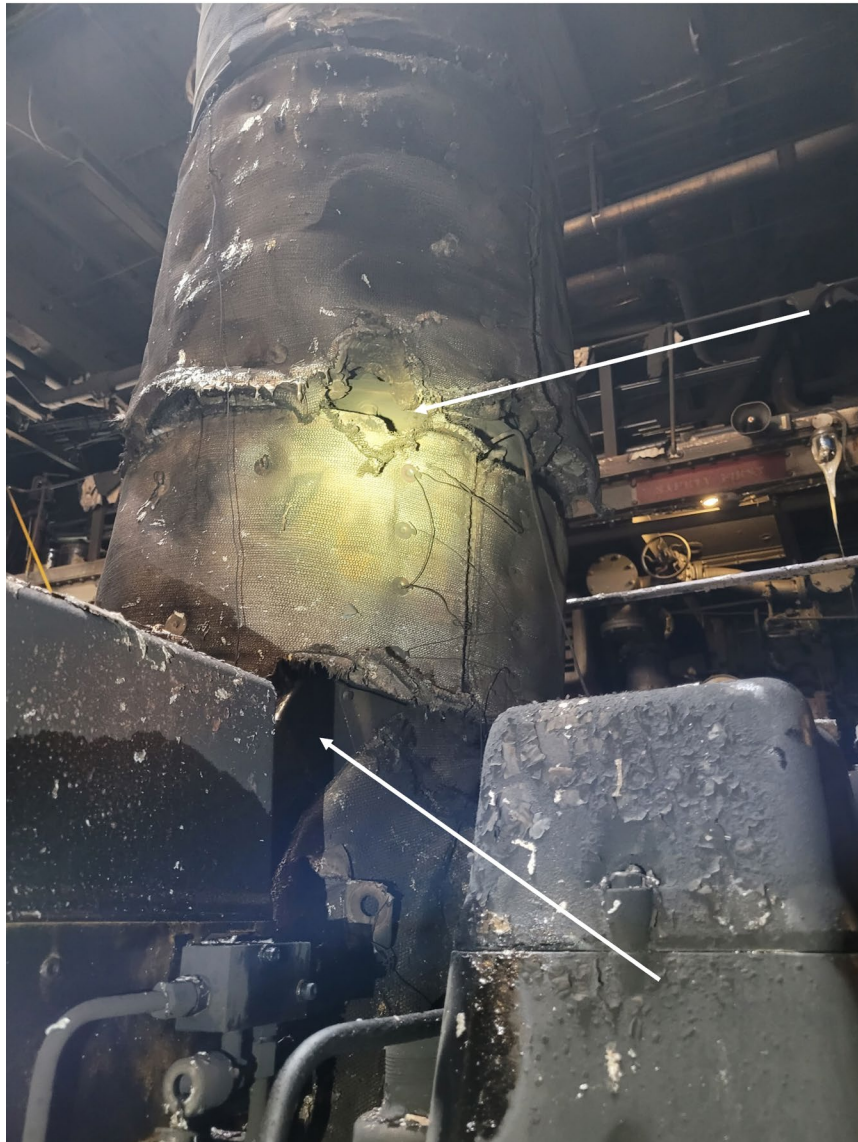
Figure 13. Insulation on turbocharger showing a notch in the way the insulation had been installed on the turbocharger outlet (Source: TSB)

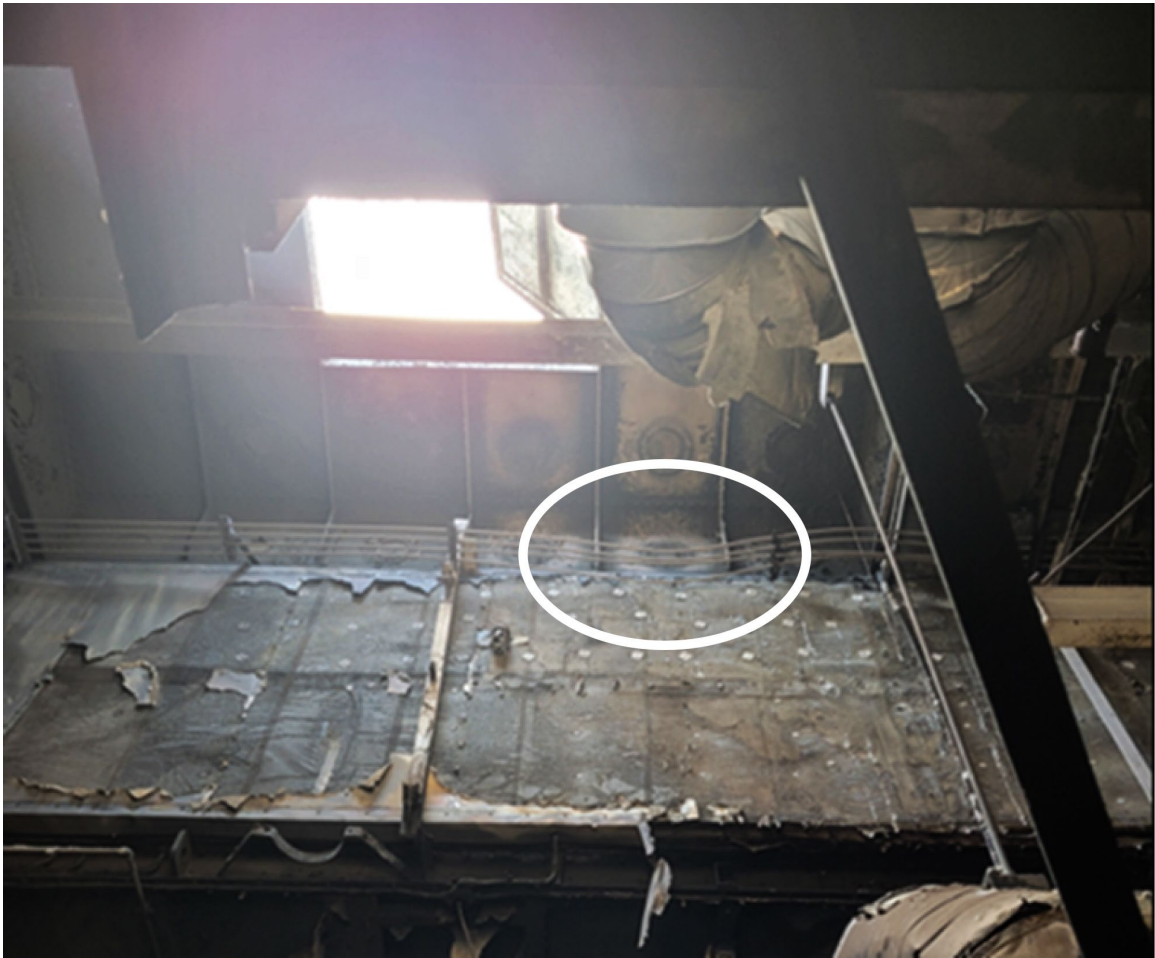
Figure 17. The conduits for the remote release cables passed close to the skylight and the cables were damaged in the fire (circled location). The insulation on the boundary between the engine room and accommodation spaces was partially destroyed. (Source: TSB)

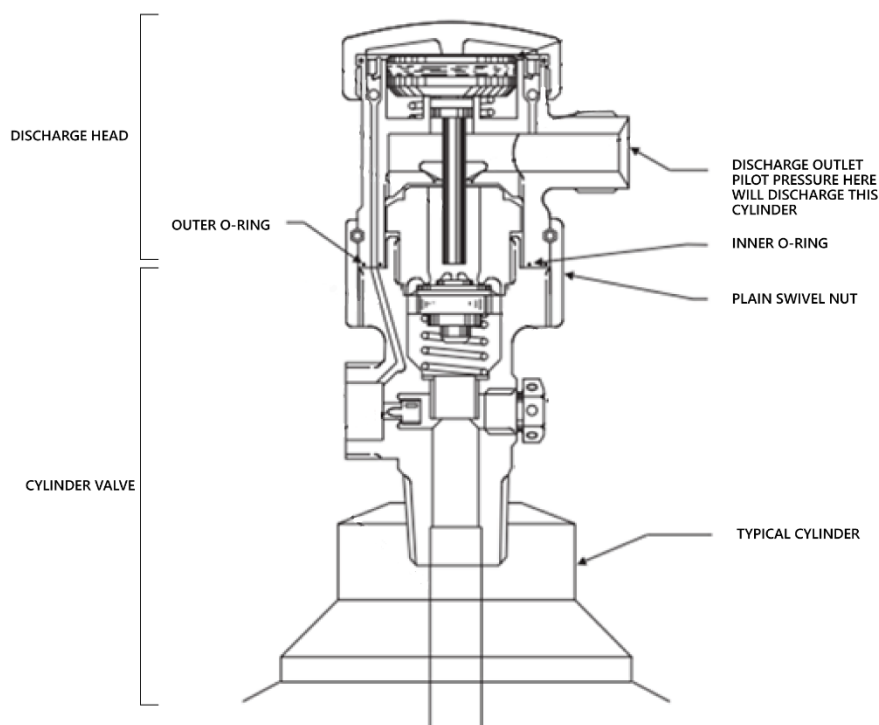
Figure 18. Diagram of the head of a CO₂ cylinder showing the valves and the O-rings that were missing or damaged at the time of use (Source: Manufacturer's manual, with TSB modifications)

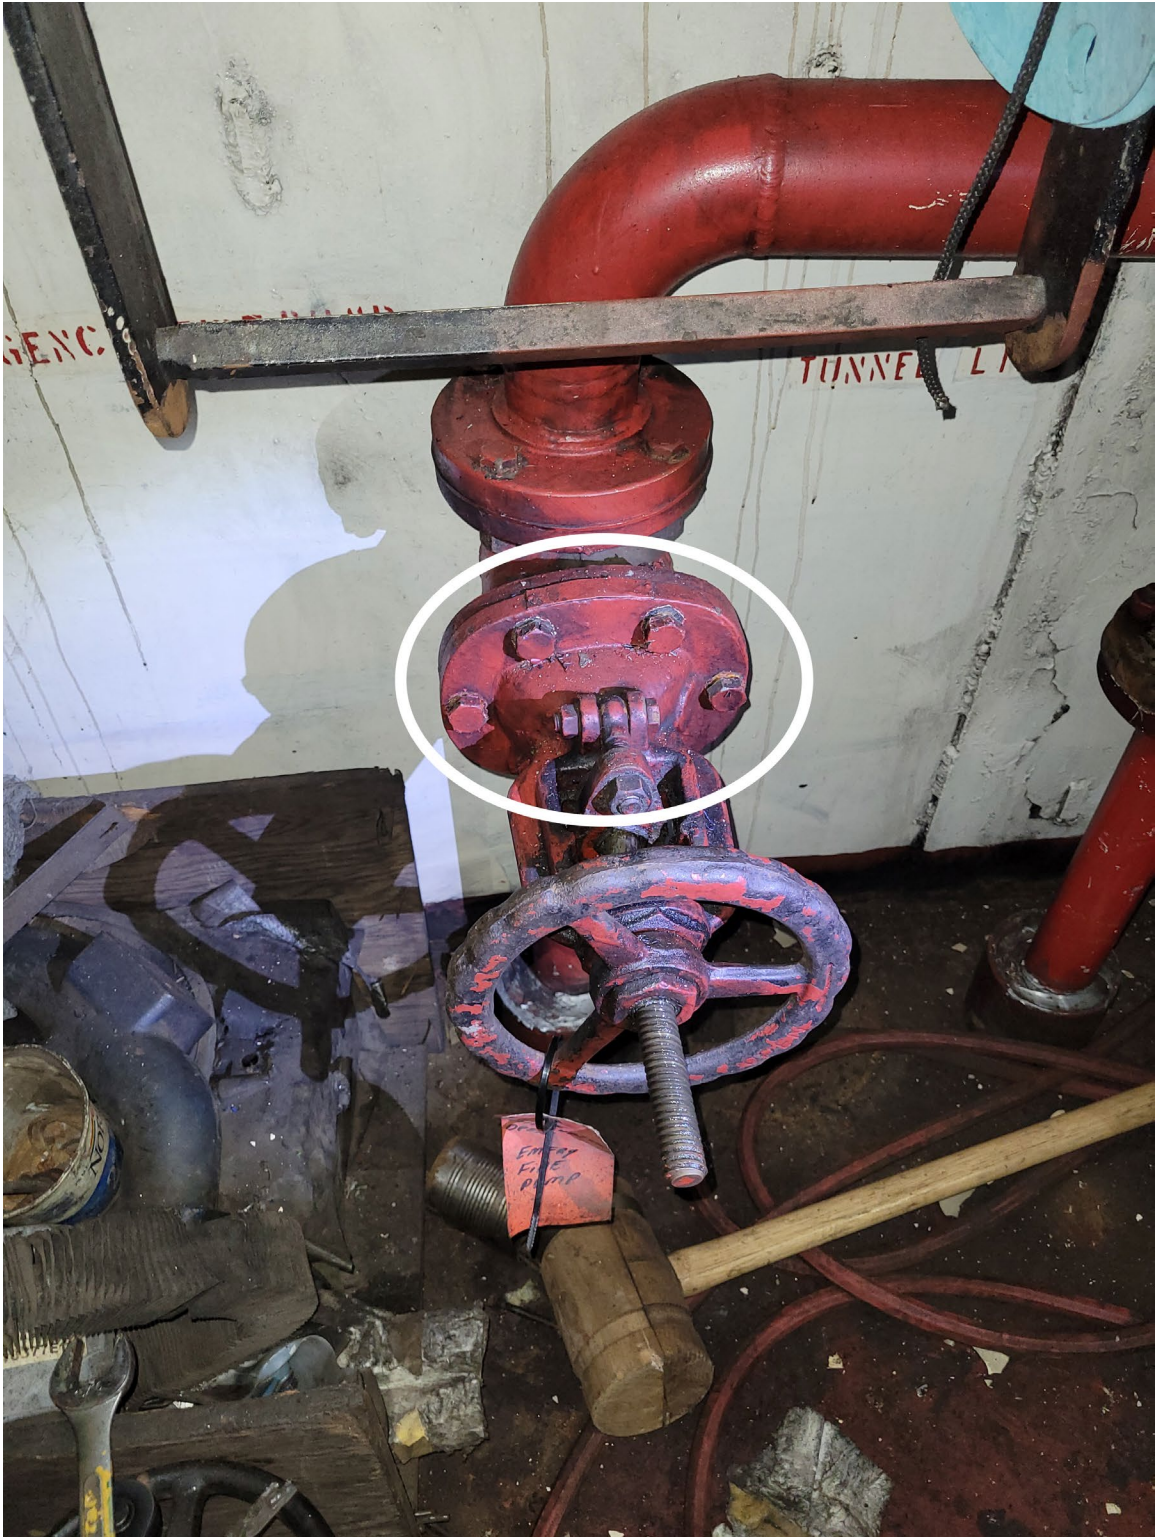
the closed position (figures 19, 20, 21). However, the valve spindle was in the open position and the crew was not aware that the gate had disconnected. When operated, the spindle had some resistance, which could give the appearance that the valve was operating normally.

Figure 19. The isolation valve, in position (Source: TSB)

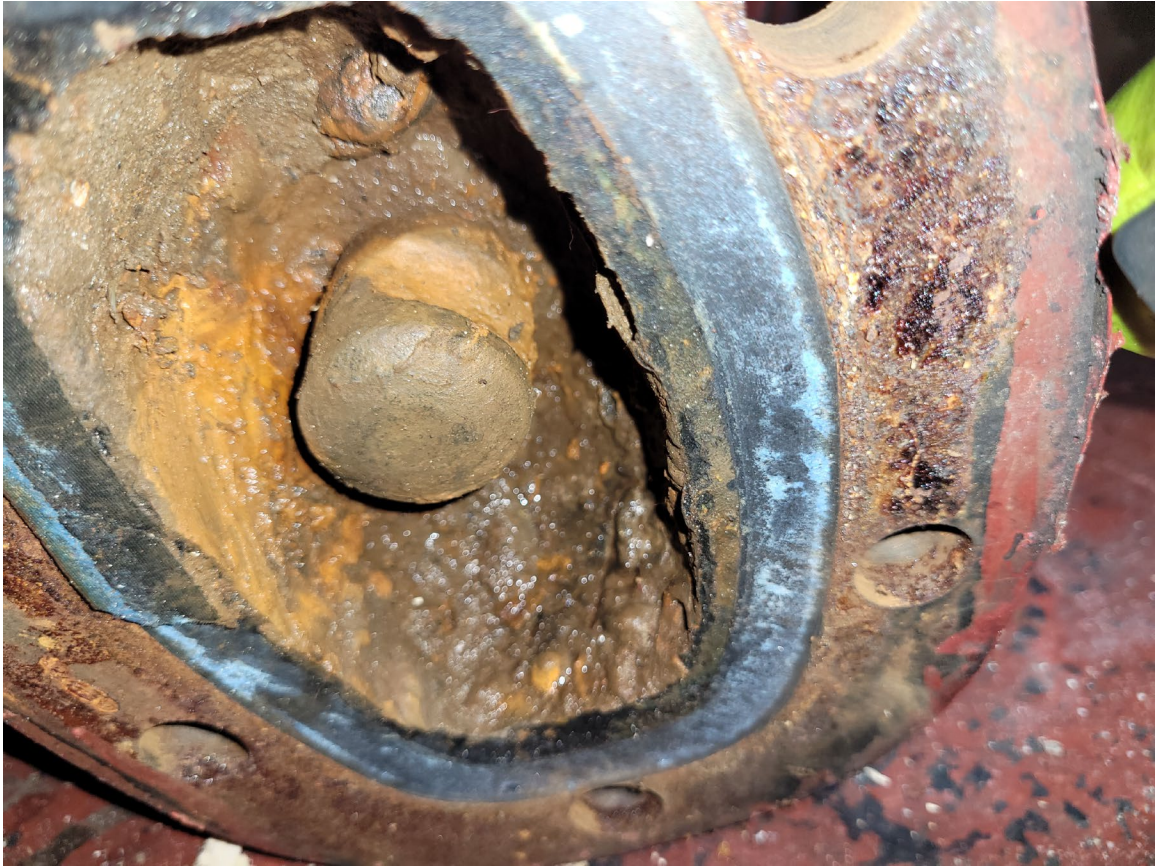
Figure 20. The isolation valve disassembled, showing the disconnected spindle (Source: TSB)

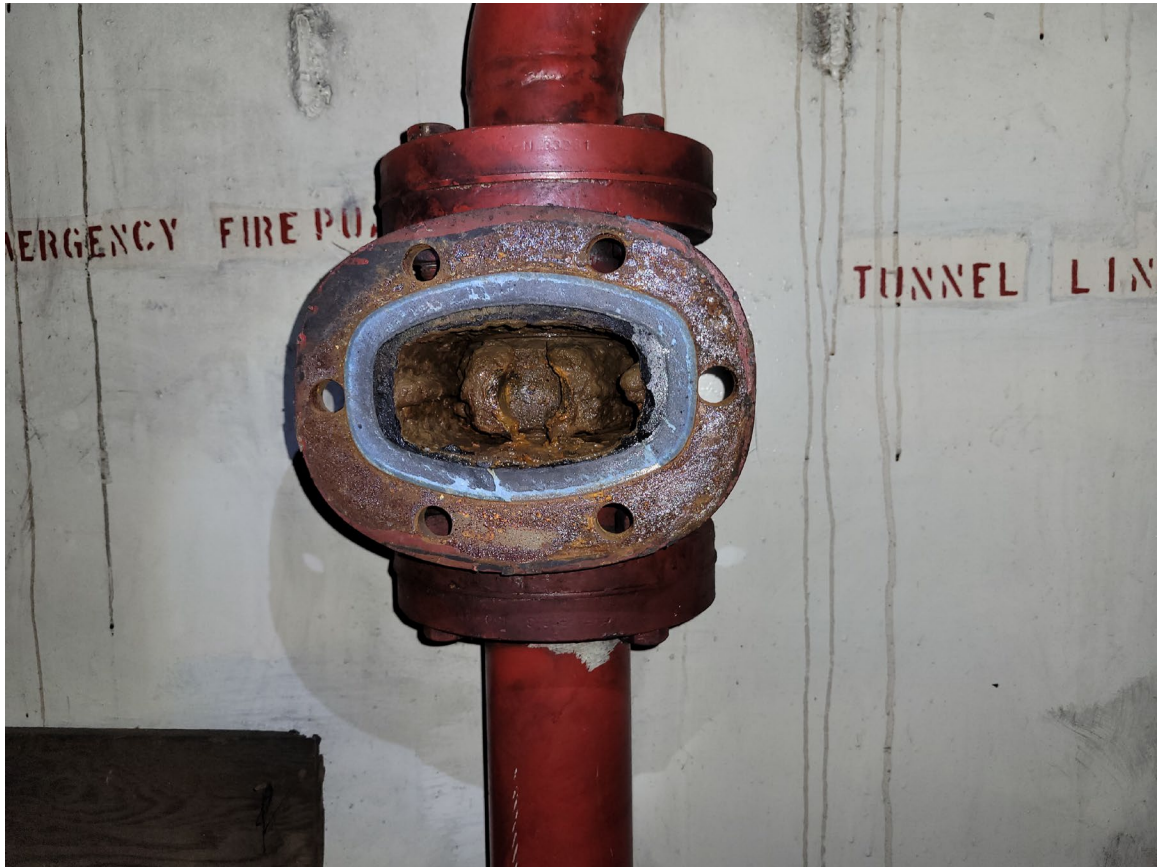
Figure 21. The isolation valve, showing the disconnected gate (Source: TSB)
