RAIL TRANSPORTATION SAFETY INVESTIGATION REPORT R25T0038

EMPLOYEE INJURY

Essex Terminal Railway Company
Mile 8.5, Essex Terminal Railway Subdivision
Windsor, Ontario
16 February 2025

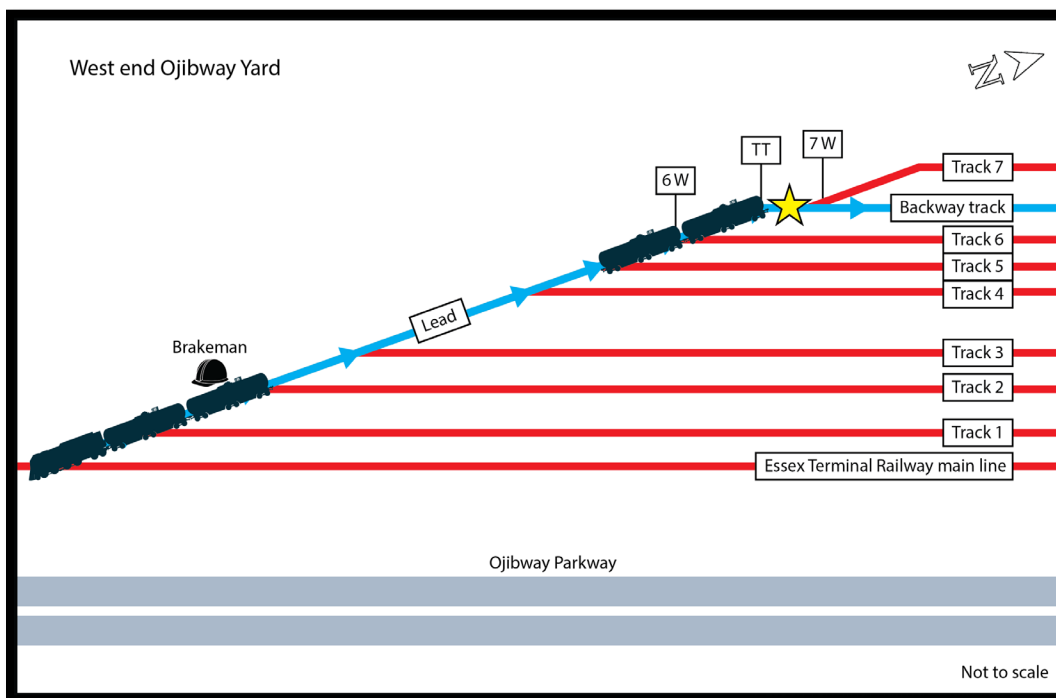
Figure 2. Tracks and switches at the west end of Ojibway Yard and occurrence location (Source: Google Earth, with TSB annotations)

At approximately 0940, the crew were at the west end of the yard, preparing for their next switching move, which would involve kicking 2 coupled tank cars eastward on the lead track toward the Backway track, located between tracks 6 and 7 (Figure 2).

Unaware of the cars rolling eastward, the MOW employee changed location and placed himself between the rails of the lead track, between switches TT and 7W; at this location, he was directly in the path of the cars, which were travelling at about 5 mph. The MOW employee was facing in the direction of the approaching cars but was looking down. The conductor shouted to warn him, but the MOW employee did not hear him due to the noise of the leaf blower.

The MOW employee was struck by the leading car, causing him to spin and fall face down between the rails. The leaf blower caught on the underside of the leading car, pulling the MOW employee's arms and coat over his head as the cars passed over him. The rail cars continued to travel toward the Backway track. The MOW employee sustained serious injuries and was transported to hospital.
