# MARINE TRANSPORTATION SAFETY INVESTIGATION REPORT M23C0305

## PERSON OVERBOARD AND LOSS OF CARGO

Cargo vessel *Sivumut*  
Frobisher Bay, Nunavut  
27 October 2023

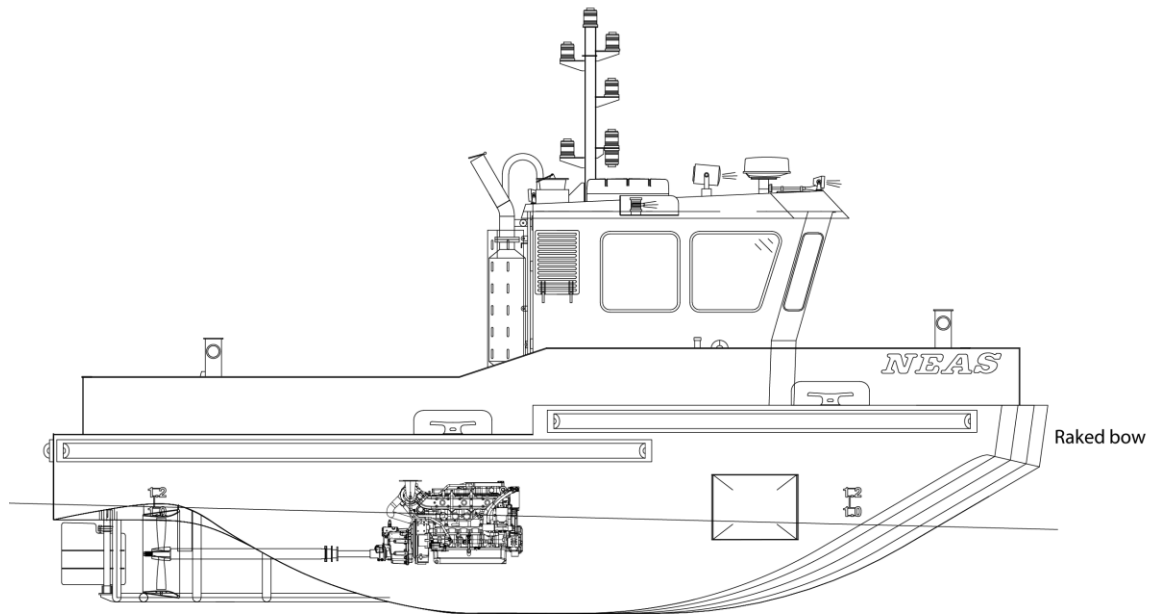
Figure 2. Diagram showing a profile view of the *Qimmiq* tug and the raked bow (Source: NEAS Inc., with TSB annotations)

The *Qimmiq* sustained damage to the starboard side of the wheelhouse and starboard fenders. The tug's radar antenna, search light, and navigation lights were also broken.

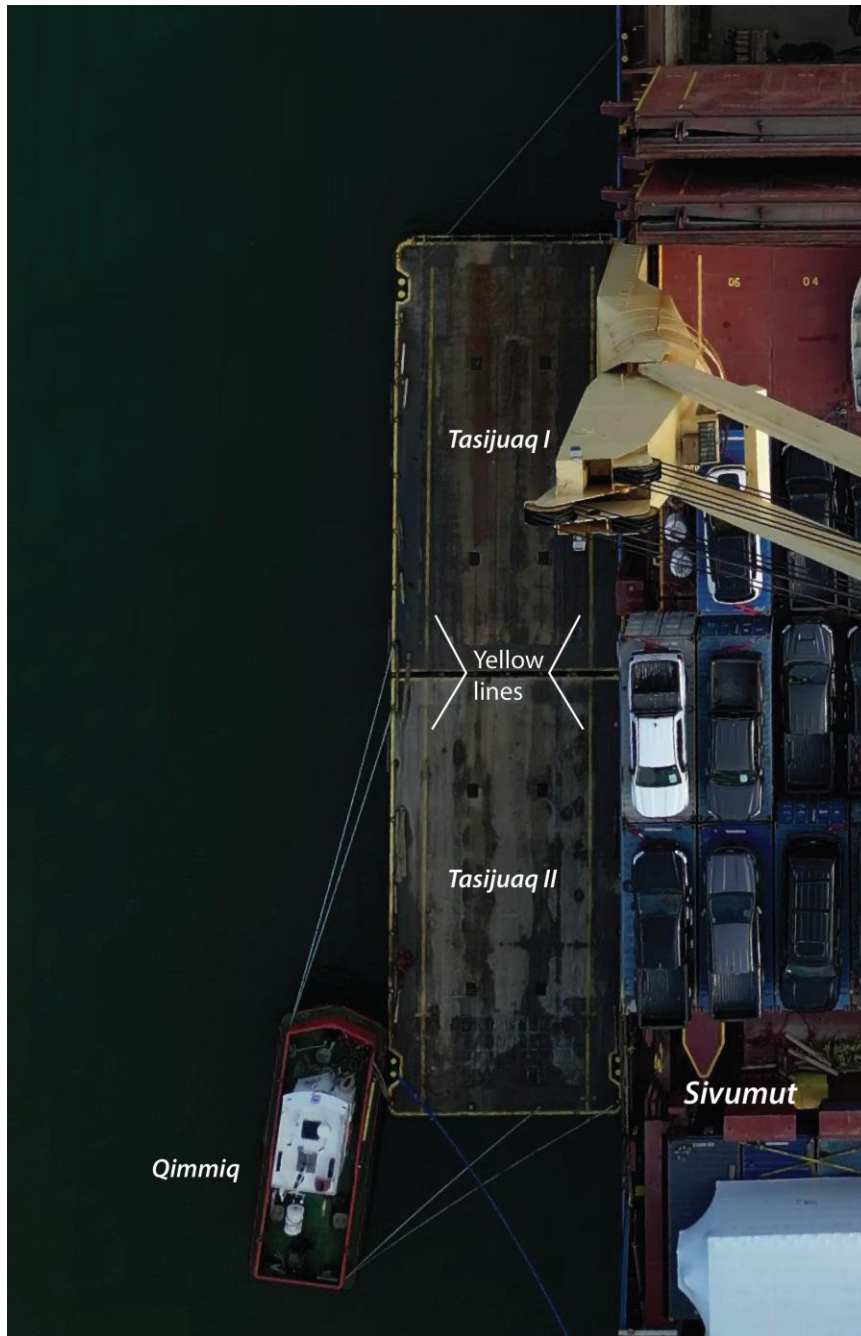
Every spring, in preparation for the Arctic sealift season, *Tasijuaq I* and *Tasijuaq II* are painted with 2 yellow lines that run the length of the deck from aft to forward. Each line is 1.22 m inboard from the port and starboard sides, and is used to indicate the limits of where containers should be placed (Figure 3).

Figure 3. The *Tasijuaq I* and *Tasijuaq II*, connected and operating as a single barge (*Tasijuaq*), painted with yellow lines along the length of its deck. The *Tasijuaq* is moored along the *Sivumut*'s port side, with the *Qimmiq* attached to the barge in an alongside towing arrangement.  
(Source: Mathieu Durocher, with TSB annotations)

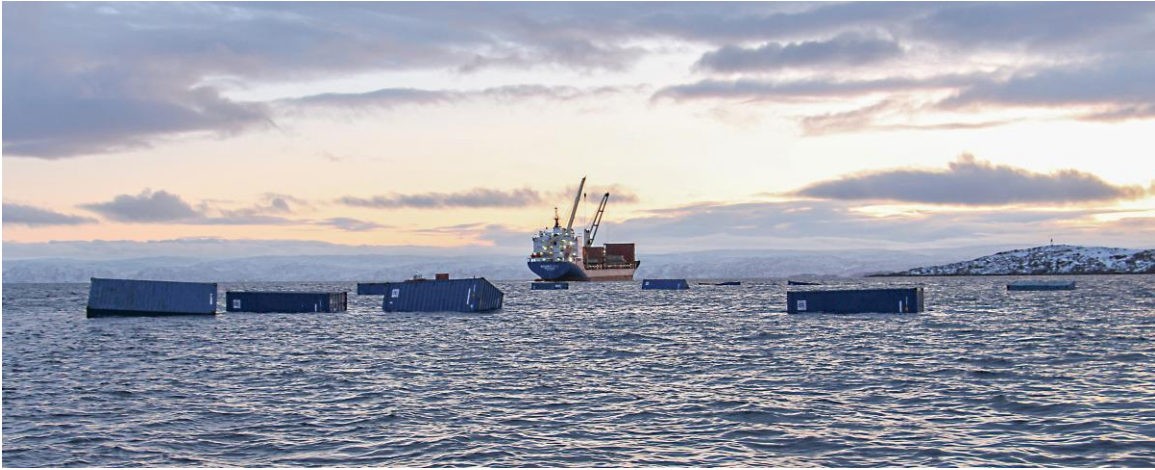
Figure 5. Image of several shipping containers floating on the water, with the *Sivumut* in the background (Source: CCGS *Henry Larsen*)

Because it was the *Sivumut*'s last trip of the 2023 sealift season, and due to the incoming winter conditions, including the formation of sea ice in Frobisher Bay, 7 of the containers could not be recovered during the 2023 sealift season.
