RAIL TRANSPORTATION SAFETY INVESTIGATION REPORT R25W0047

MAIN-TRACK TRAIN DERAILMENT

Canadian National Railway Company
Freight train G89641-28
Mile 101.1 Fort Frances Subdivision
Near Devlin, Ontario
28 June 2025

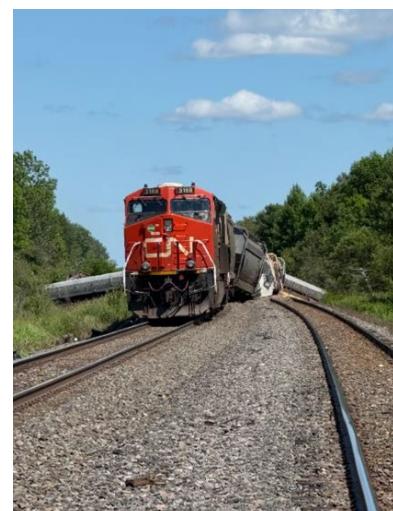
At about 1340 Central Daylight Time, while the train was travelling at 41 mph in a 0.9° right-hand curve, a train-initiated emergency air brake application occurred at Mile 101.1 near Devlin (Figure 1). After the train came to a stop, the crew conducted an inspection and found that 13 hopper cars near the tail end (positions 119 to 131) had derailed (Figure 2). Most of the derailed cars were extensively damaged and released their product. There were no injuries.

Figure 2. View of tail-end locomotive and derailed cars
(Source: Canadian National Railway Company)

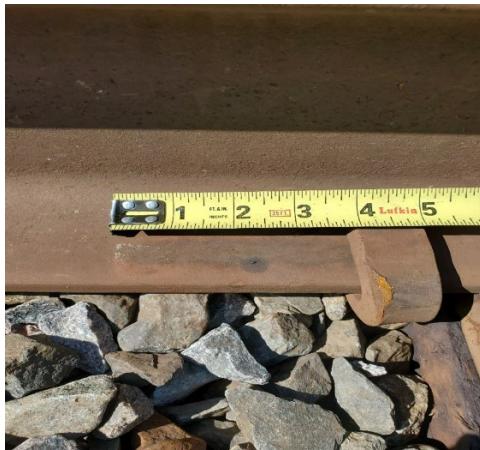
In July 2025, the TSB examined the track in the area of the derailment. Signs of previous rail creep² were observed in several locations. At Mile 101.8, the anchors had been repositioned by up to 4 inches (Figure 3) during repairs conducted after the derailment. The track in the adjacent siding showed signs of rail creep; in some cases, the anchors were displaced by up to 6 inches (Figure 4). All the anchor displacements on the main track were in the eastward direction, indicating that the rail creep was in the direction of the heavy tonnage traffic.

Figure 3. Rail anchor repositioned by 4 inches at Mile 101.8 on the Fort Frances Subdivision main line (Source: TSB)

The investigation determined that this practice was not consistently followed during post-derailment repairs at Mile 101.8, as some anchors were manually slid along the rail base by up to 4 inches with a sledge hammer.

CN's ETS specify that rail anchors should be applied uniformly along the rail and firmly against the side of the tie. The ETS also state that anchors can be slid along the rail base only with a mechanical anchor squeeze or spreader, and that anchors that need to be manually adjusted must be removed and reapplied.⁸

So as not to compromise the structural integrity of tracks, it is important that track maintenance employees adhere to the appropriate operational procedures for the work they are carrying out, such as when adjusting rail anchors.

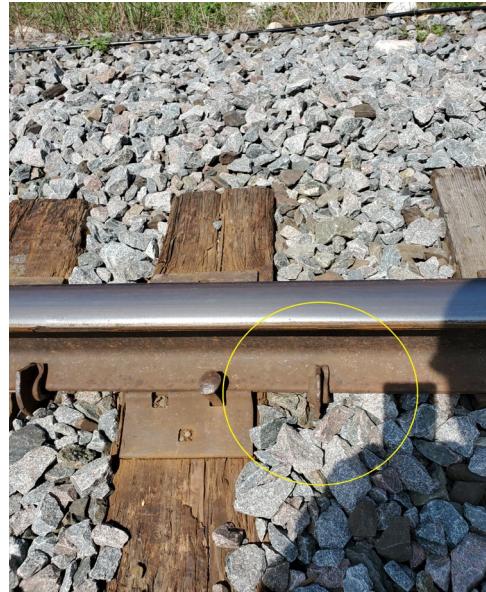
Figure 4. Track in the siding adjacent to the point of derailment, showing an anchor displaced several inches away from the tie (Source: TSB)

The rail creep observed in this area indicates that the track had been under compressive stress for some time. The high ambient temperature on the day of the occurrence and the sharp variations in temperature in the preceding days would have increased this stress. The passage of the heavy train created friction heat from the wheel contact with the rail; these forces added to the compressive stress that was already present. The location of the derailed cars (near the end of the train) indicates that track buckling likely occurred as the end section of the train travelled over the track.

reinforcing track securement (for instance by adjusting the position of the anchors closer to the ties or by replacing the anchors) or by destressing the rails.³
