RAIL TRANSPORTATION SAFETY INVESTIGATION REPORT R25T0189

MAIN-TRACK DERAILMENT

Canadian National Railway Company
Mile 30.66, Dundas Subdivision
Paris, Ontario
25 July 2025

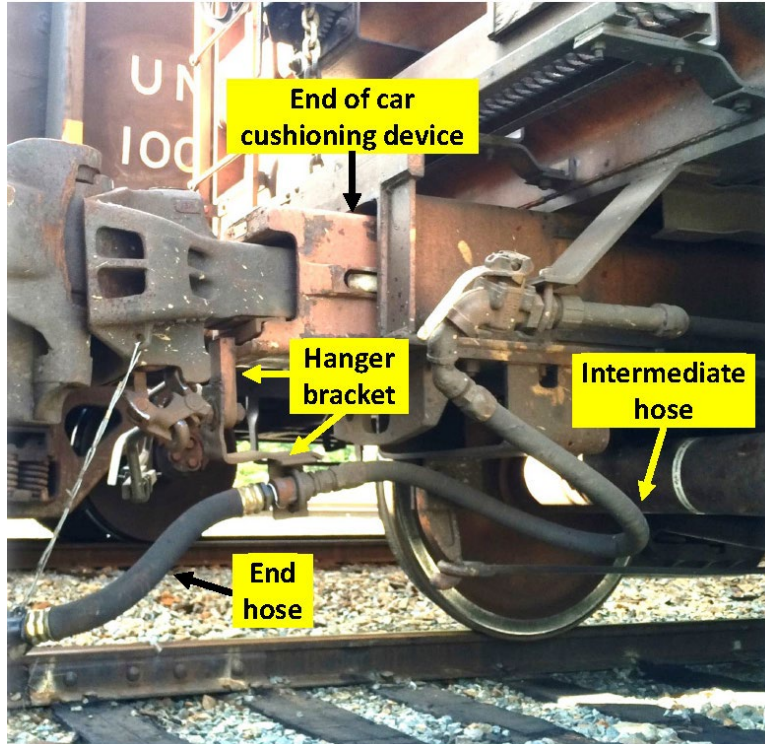
On the occurrence train, there were 81 rail cars equipped with end-of-car cushioning devices (EOCCDs). Cars equipped with EOCCDs use long underslung intermediate air hoses to accommodate the EOCCD's increased longitudinal travel (Figure 1). Due to the hoses' length and routing, they are more prone to kinking under in-train slack action than the shorter hoses used on cars equipped with standard draft gear.

Figure 1. End arrangements on a rail car equipped with an end-of-car cushioning device, showing the long underslung intermediate hose (Source: Y. Wang, "Brake System End Arrangement Tests," presented at the Expo & Technical Conference of the Railway Supply Institute, Fort Worth, Texas, 11 to 13 October 2022, with TSB annotations)

If the movement of the intermediate hose becomes impeded when the EOCCD is compressed under buff forces, the hose can bend further where it is looped beneath the rail car. If this bending becomes excessive, the hose may fold over on itself, creating a kink that can partially restrict or completely block the normal flow of air through the brake pipe. Such restrictions can result in intermittent air flow in the brake pipe and impede brake signal propagation.

On some older cars manufactured to meet earlier Association of American Railroads (AAR) specifications for end arrangements, the intermediate hoses on EOCCD-equipped rail cars are particularly susceptible to kinking. Current AAR standards for end arrangements, updated in 1999, do not permit the use of end arrangements that pre-date the current standards in new or modified installations, as these arrangements were prone to damage, malfunction, and poor performance, which could impede the proper movement of the intermediate hose. There is no AAR requirement to upgrade end arrangements to comply with newer standards unless the end arrangements are found to be damaged and require repair.

The railway industry is reminded that the long intermediate hoses used on rail cars equipped with EOCCDs present an increased risk of kinking under elevated buff forces, particularly on cars with legacy end arrangements, which can result in intermittent air flow restrictions in the brake pipe.
