OPERATIONAL SERVICES BRANCH
ENGINEERING LABORATORY REPORT

LP149/2013

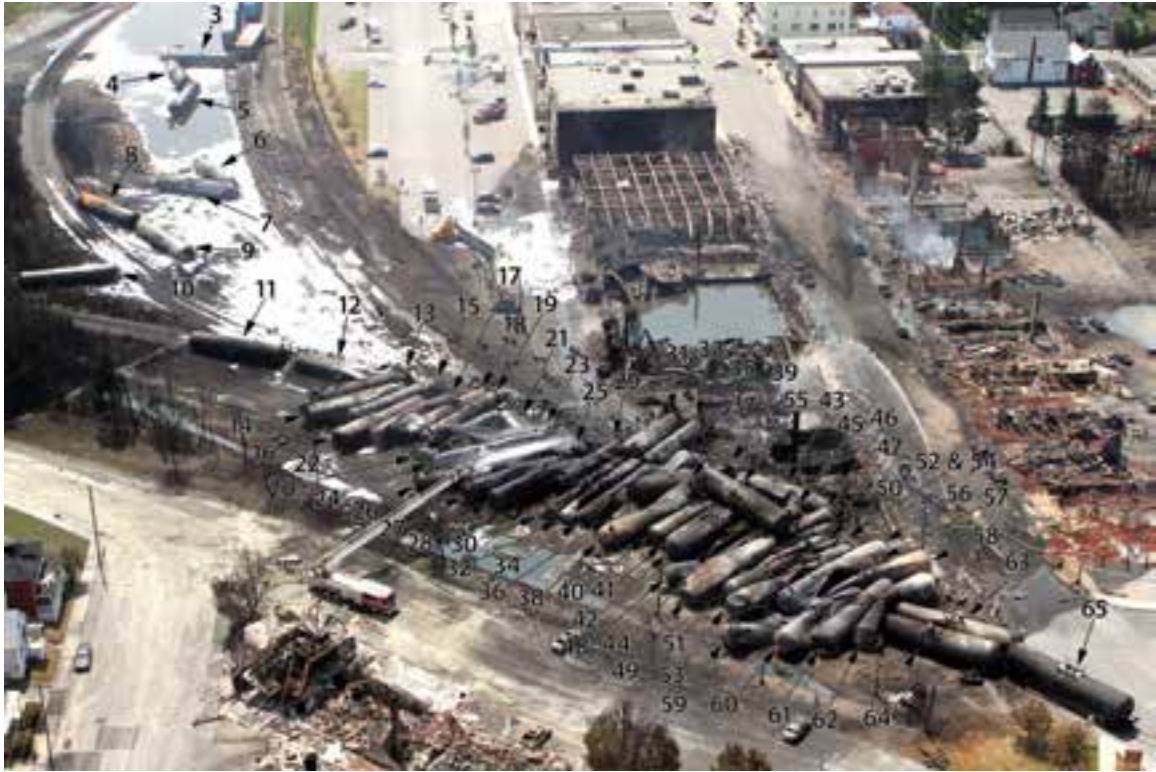
Figure 1: Aerial photograph of the derailment zone

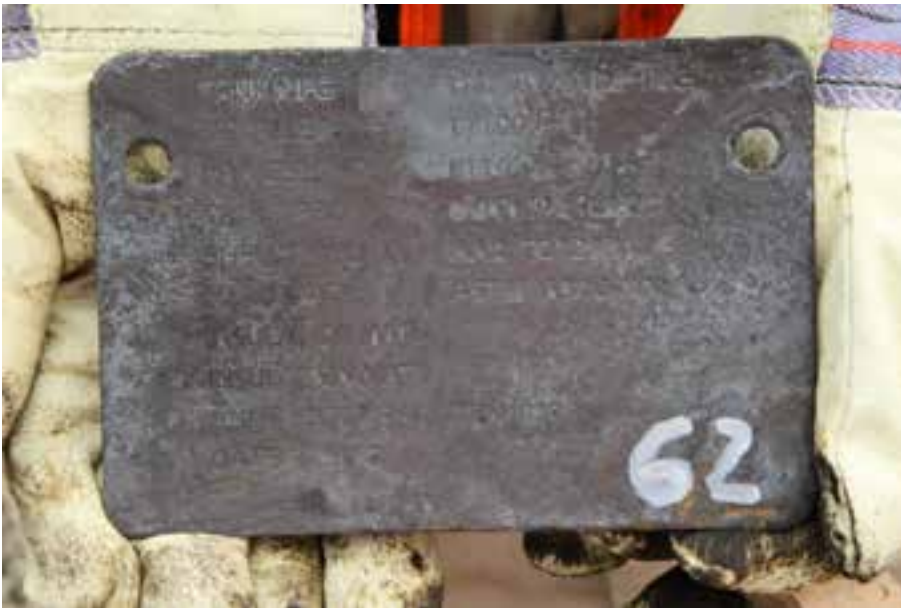
(c) Separated tank identification plate found adjacent to car TILX316622

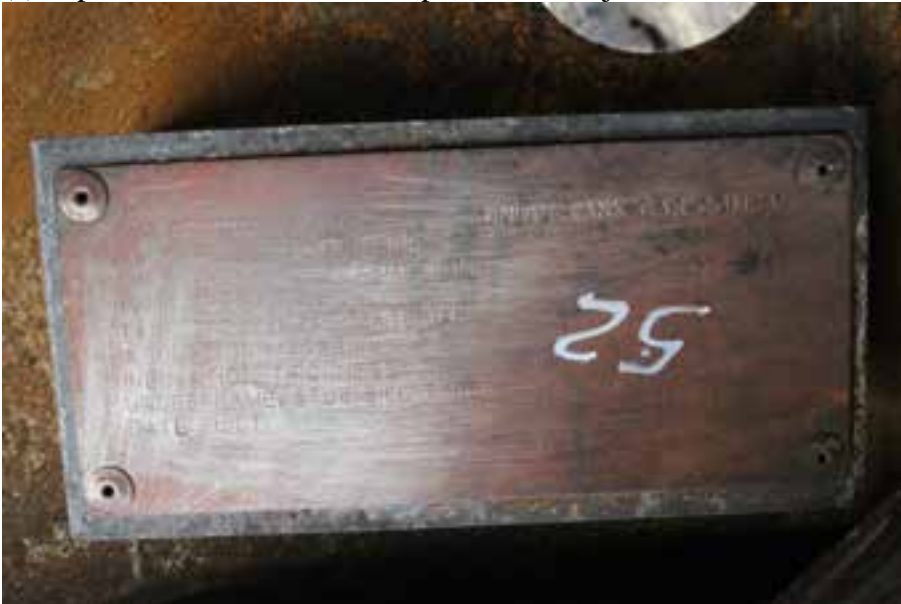
(d) Tank identification plate with missing text attached to car PROX 44428

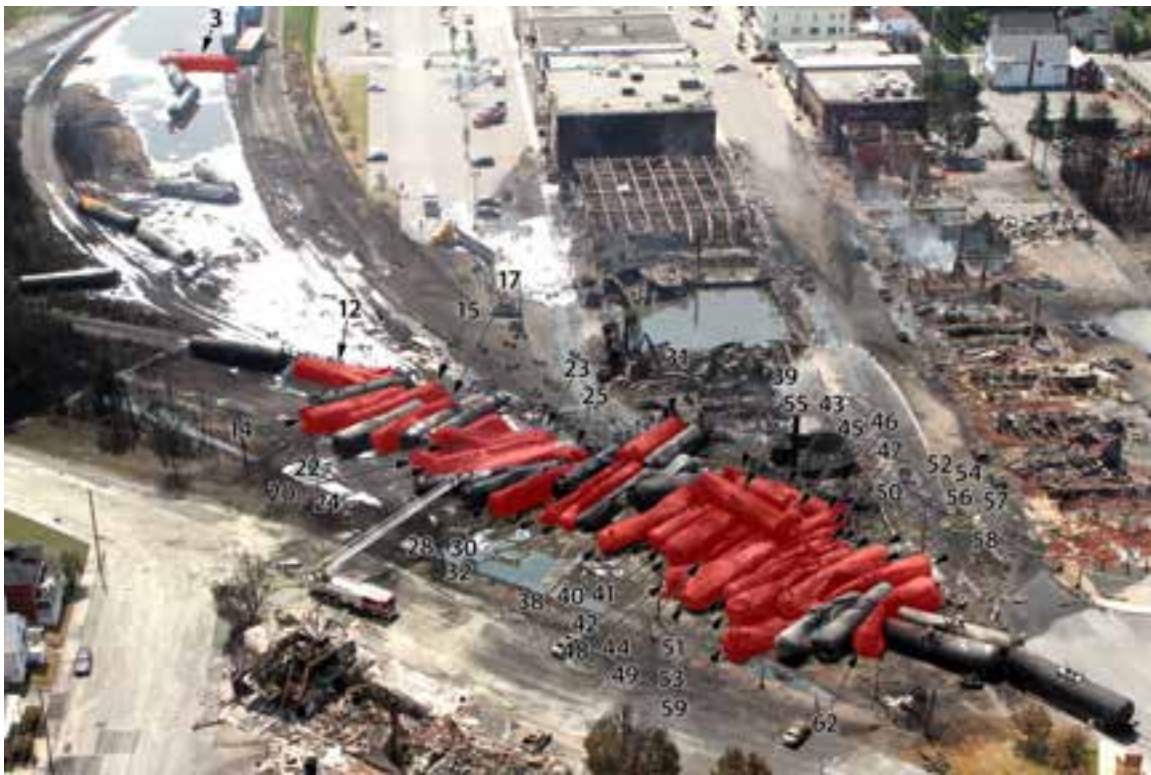
Figure 4: Aerial photograph showing cars with breaches from impact-damaged shells indicated in red

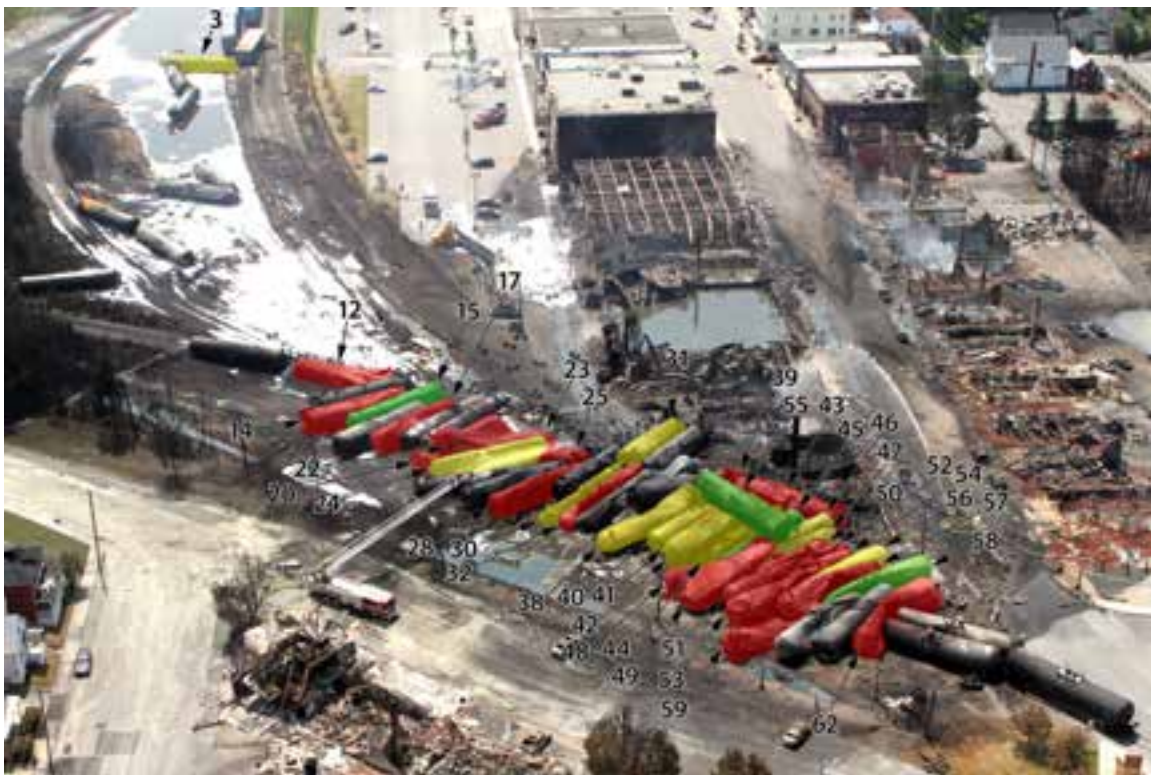
Figure 5: Aerial photograph showing cars with small (green), medium (yellow) and large (red) shell breaches

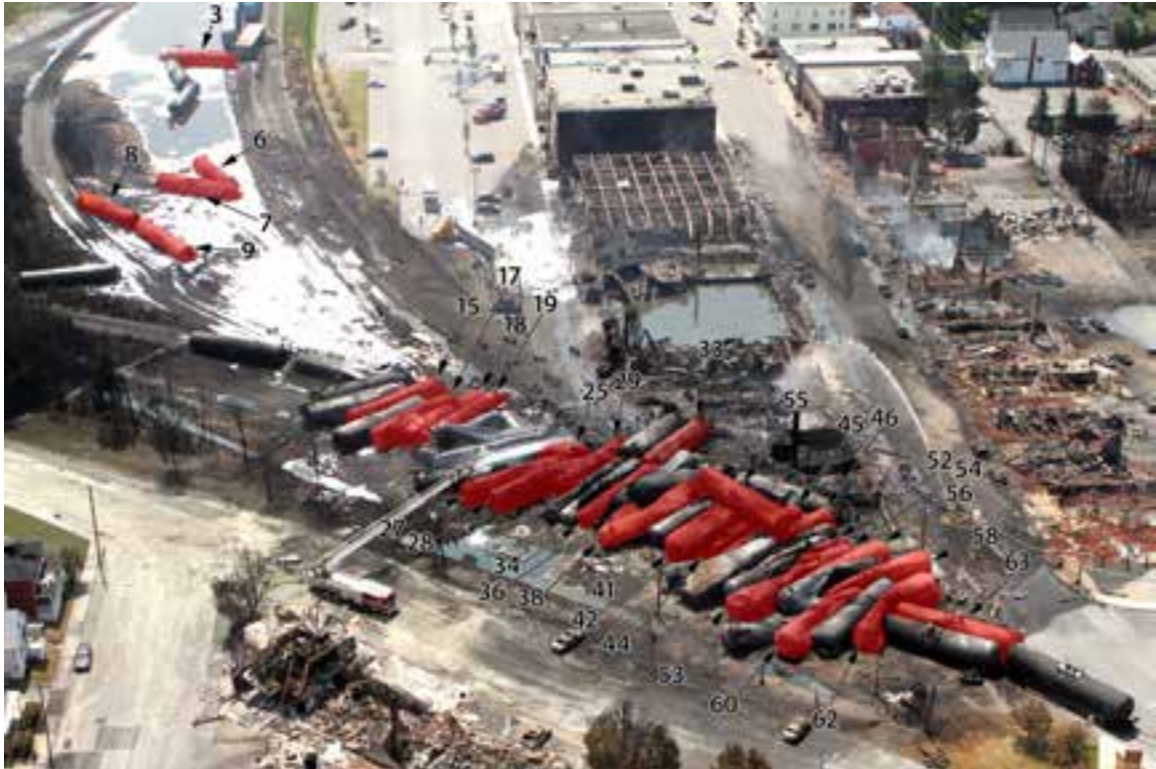
Figure 6: Aerial photograph showing cars with breaches from impact-damaged heads indicated in red

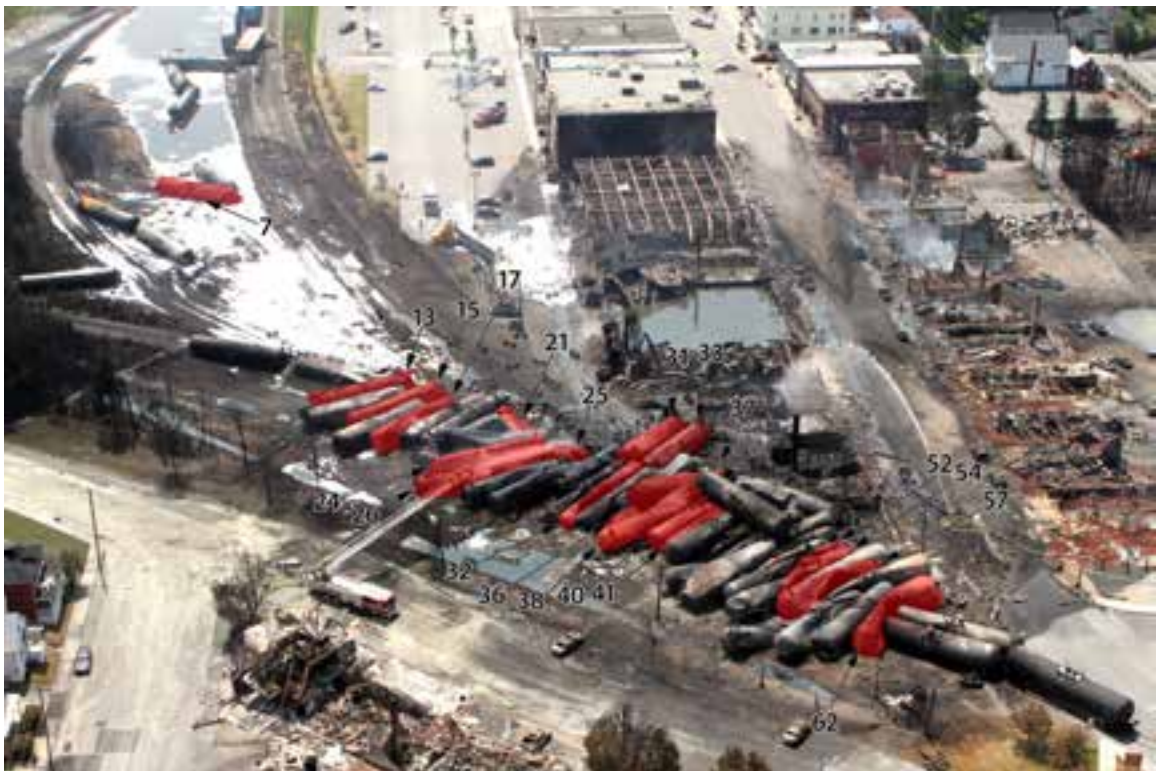
Figure 7: Aerial photograph showing cars with breaches from impact-damaged top fittings indicated in red

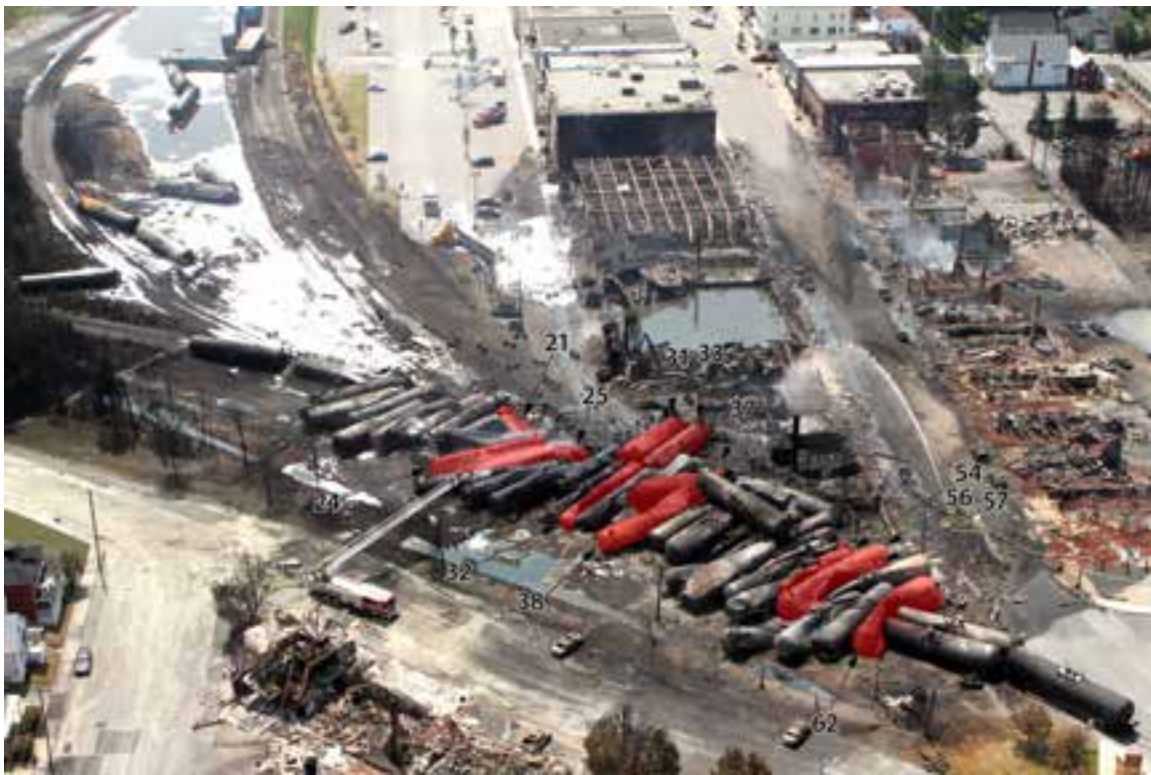
Figure 8: Aerial photograph showing cars with breaches from impact-damaged PRDs indicated in red

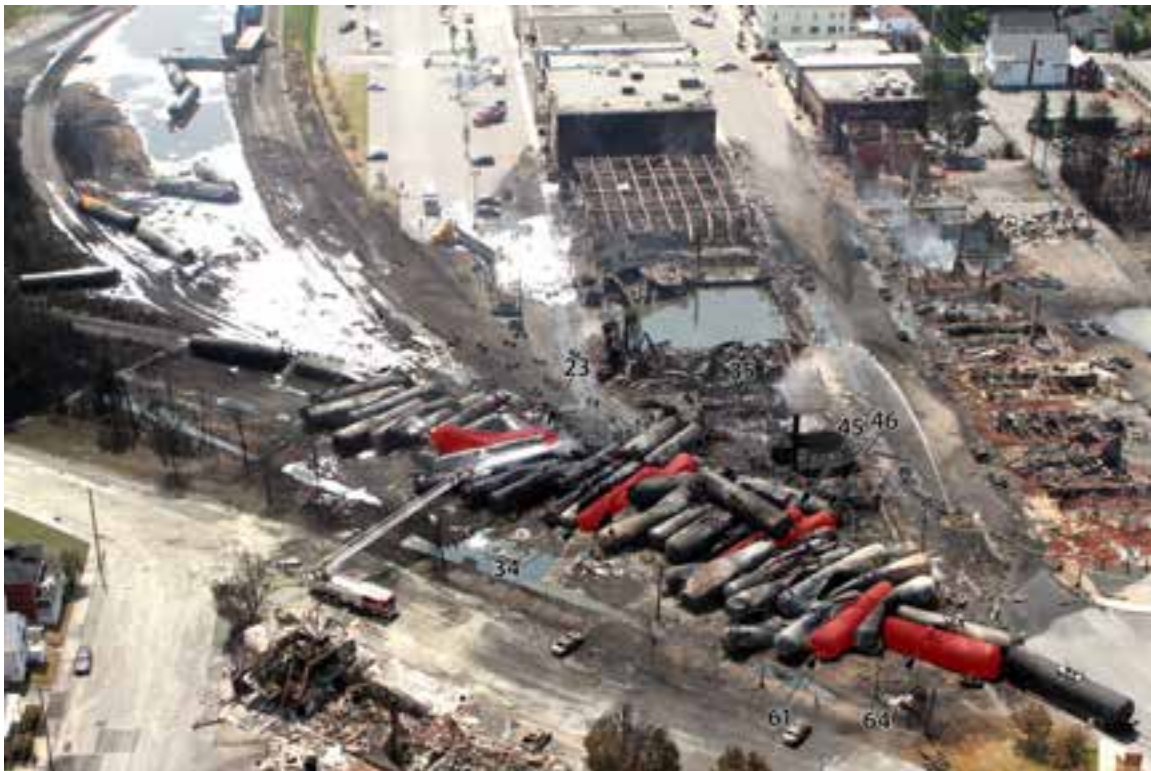
Figure 9: Aerial photograph showing cars with breaches from impact-damaged BOVs indicated in red

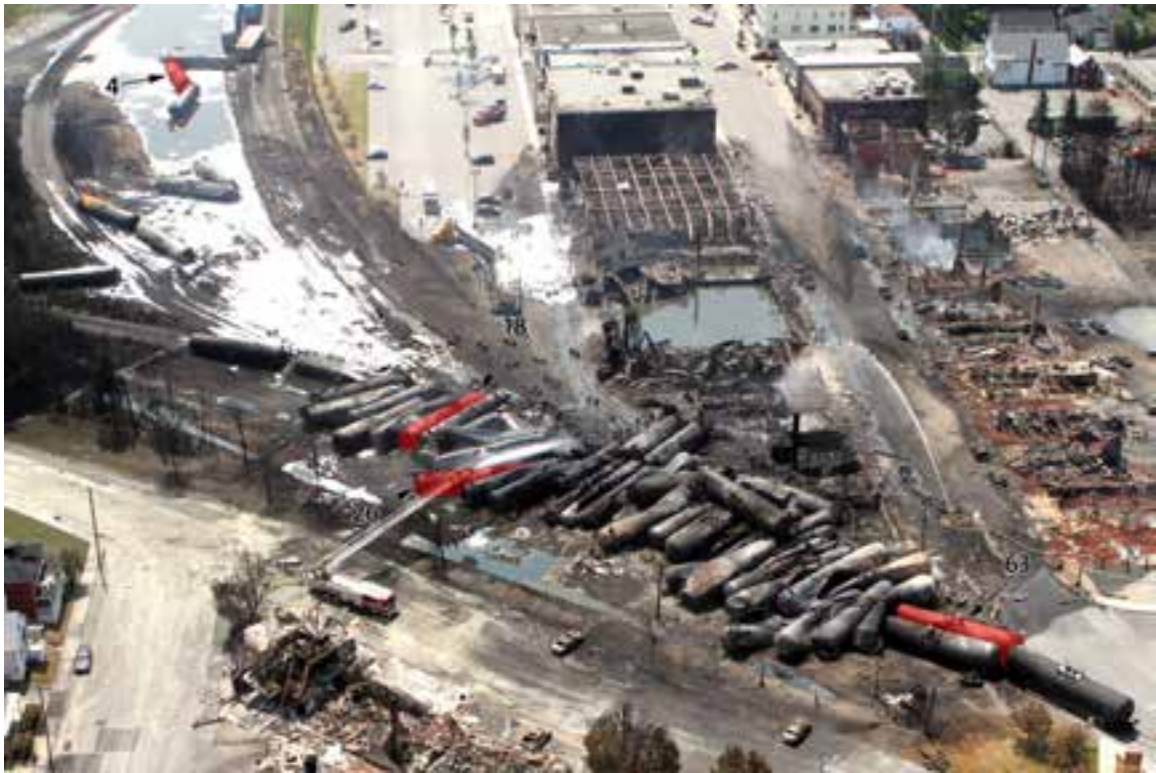
Figure 10: Aerial photograph showing cars with breaches from thermal tears indicated in red

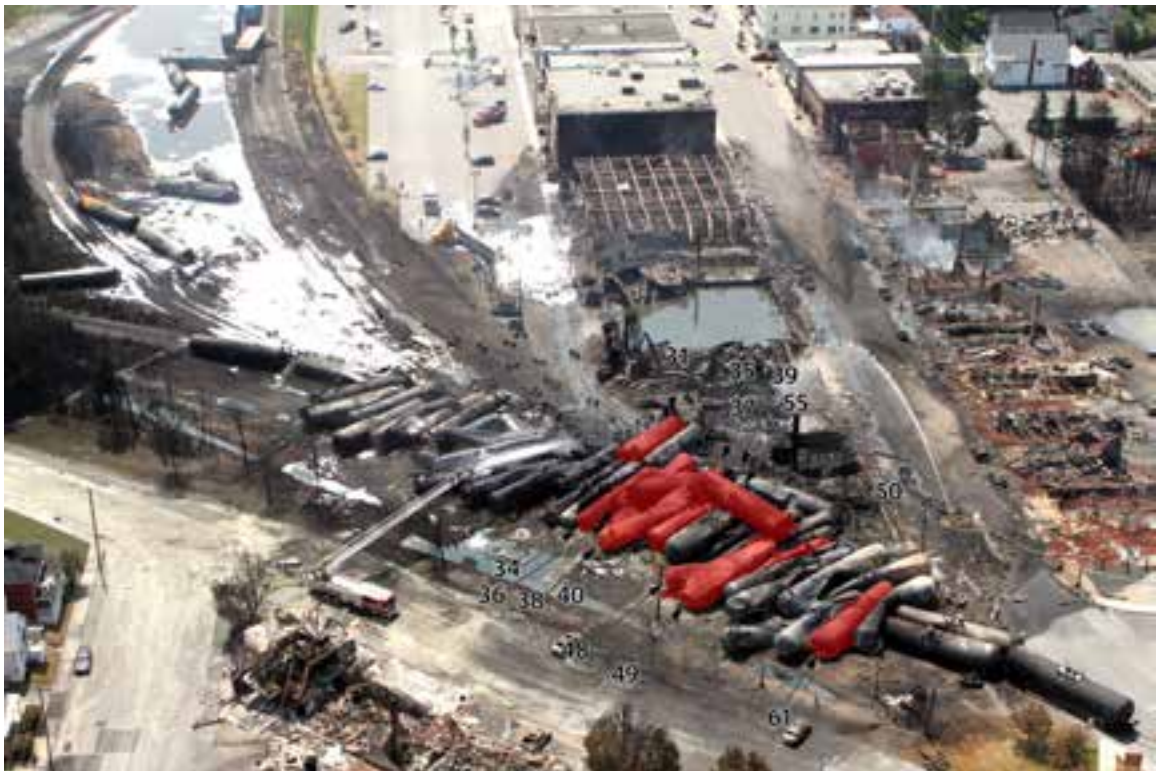
Figure 11: Aerial photograph showing cars with burn-throughs indicated in red

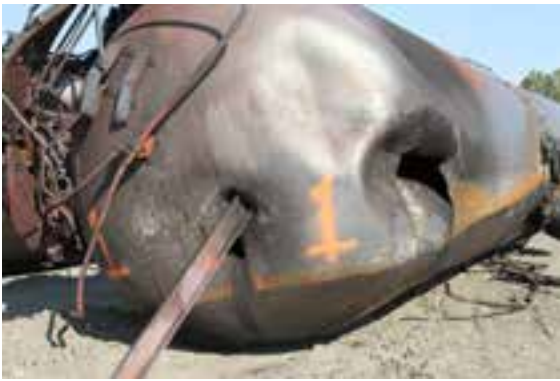
Bottom outlet valve	The skid, BOV nozzle and handle assembly had no impact damage. The BOV handle was in the closed position but not locked as the securement mechanism was damaged.
Top fittings	The housing cover was warped but still secured. There was no impact damage to the housing wall. The fittings inside the housing were not visible for inspection.
Pressure relief device	The PRD was inside the housing and not visible for inspection.
Manway	The manway cover was closed with all 6 bolts intact.
Stub sills and couplers	No visible impact damage.

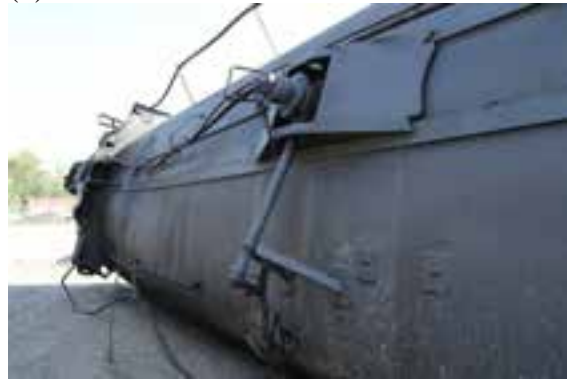
(e) Top fittings and manway

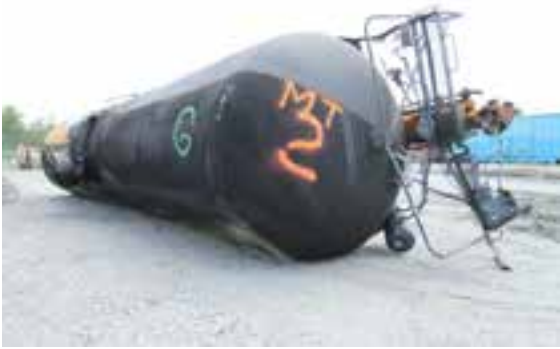
Manway	The manway cover was closed with all 6 bolts intact.
Stub sills and couplers	No visible impact damage.

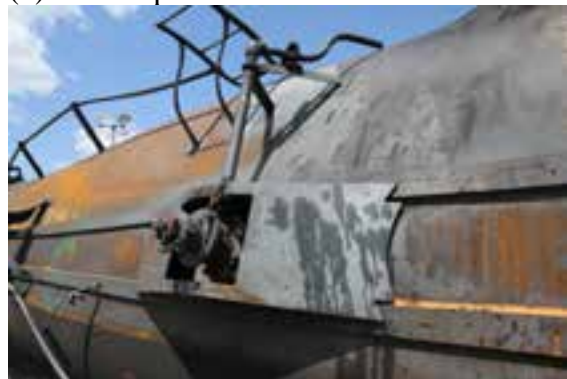
(e) Top fittings and manway

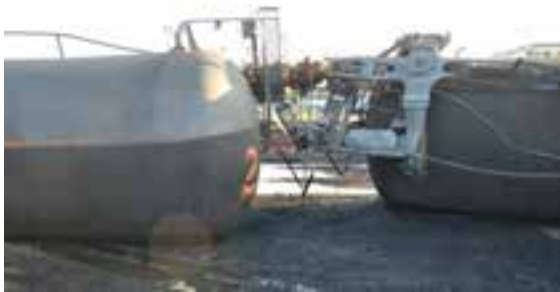
(a) In-situ photo showing car WFIX 130608 (left) coupled to car TILX 316359 (right) (RSI-AAR Safety Project photo)

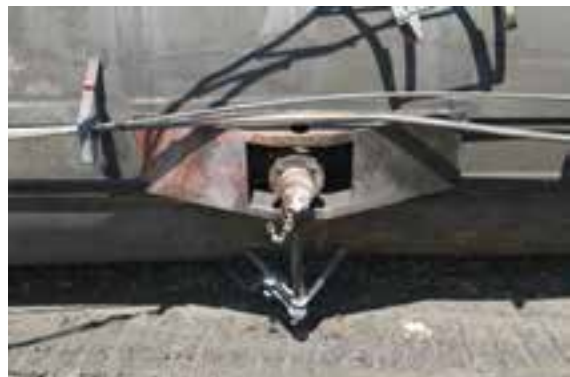
(g) Top fittings and manway

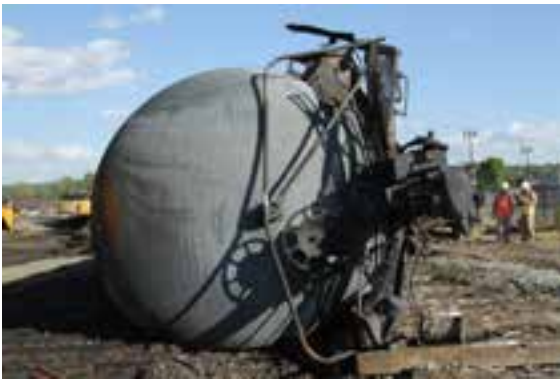
Manway	The manway cover was open with all 6 bolts intact. It was likely opened for product recovery.
Stub sills and couplers	No significant impact damage on either end. A separated coupler from car NATX 310428 was still attached to the B end coupler of car TILX 316338.

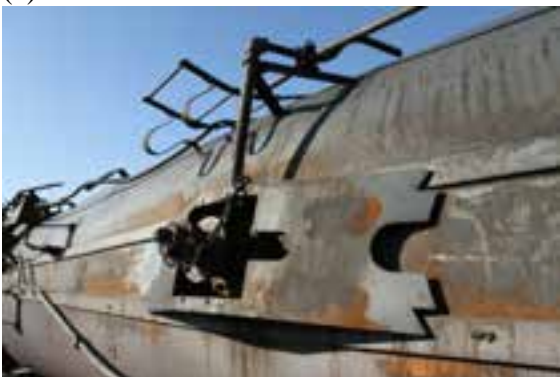
(f) Top fittings and manway

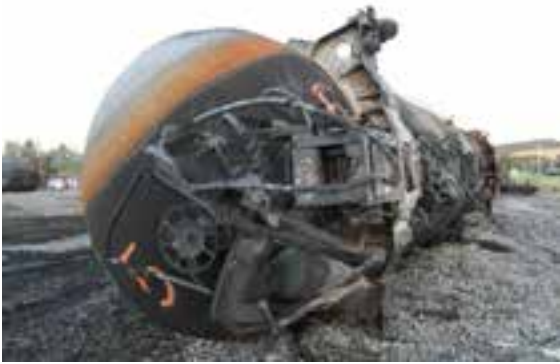
Pressure relief device	The PRD was plugged with debris but externally appeared undamaged.
Manway	The manway cover was open and all 8 bolts were released with 1 bolt slightly bent. The manway cover was closed on aerial photographs confirming it was opened during recovery operations.
Stub sills and couplers	Both stub sills were slightly deformed. The B end coupler was missing and was found still attached to car TILX 316338.

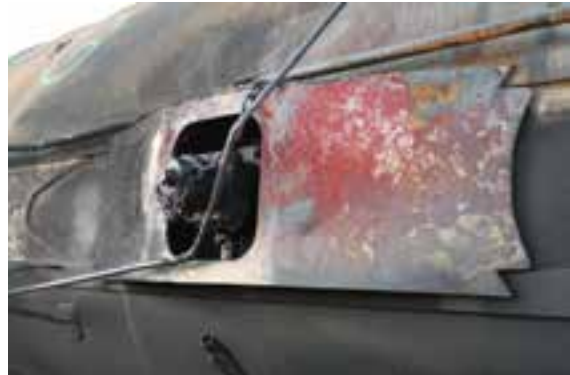
(e) Top fittings and manway. The arrow points to an angled dent in the shell

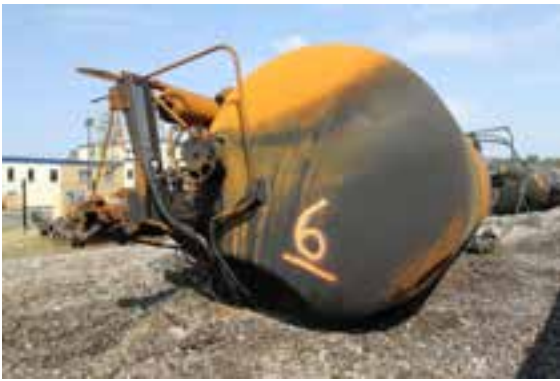
Pressure relief device	No visible impact damage.
Manway	The manway cover was open. 2 of the 6 bolts were missing and 1 bolt was bent. The cover was closed on aerial photographs of the derailment site indicating that it was opened during recovery operations.
Stub sills and couplers	No visible impact damage.

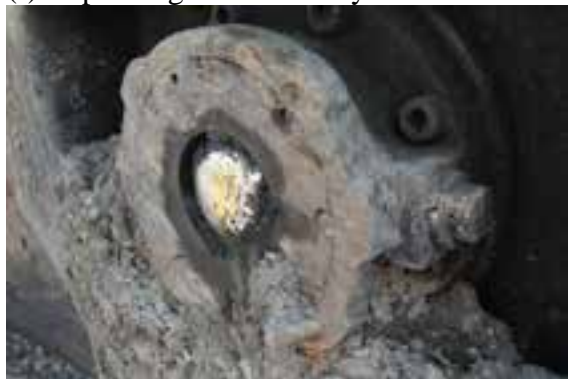
(h) Close up showing light seepage from BOV

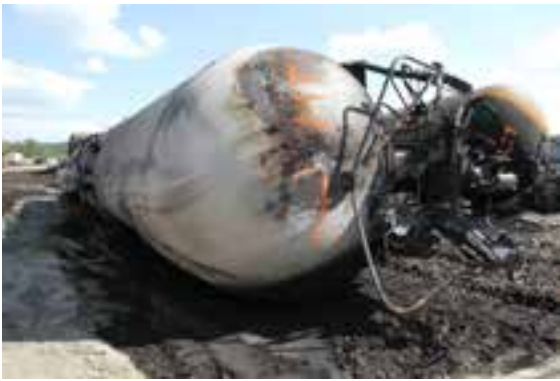
Top fittings	The housing was deformed, torn and hanging from one side of the hinge. The fittings had no visible impact. A 2-inch ball valve had been removed after the derailment and was hanging from its chain.
Pressure relief device	No visible impact damage.
Manway	The manway cover was open with 1 of the 6 bolts missing. The gasket was burnt. The cover was closed on aerial photographs of the derailment site indicating that it was opened during recovery operations.
Stub sills and couplers	No visible impact damage.

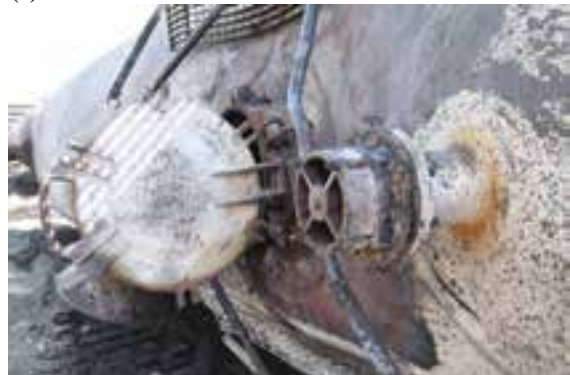
(g) Top fittings and manway

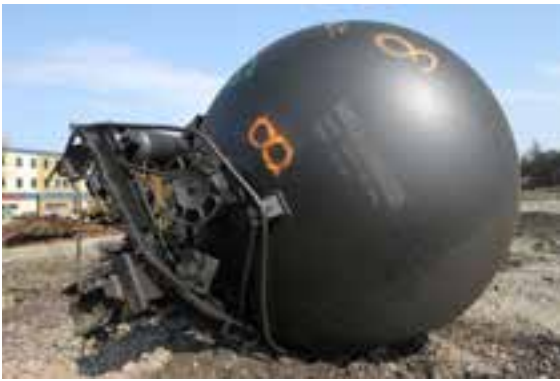
Pressure relief device	No visible impact damage.
Manway	The manway cover was open with all 6 bolts intact. It was opened during recovery operations as it had been found closed after the derailment.
Stub sills and couplers	Both stub sills were slightly deformed.

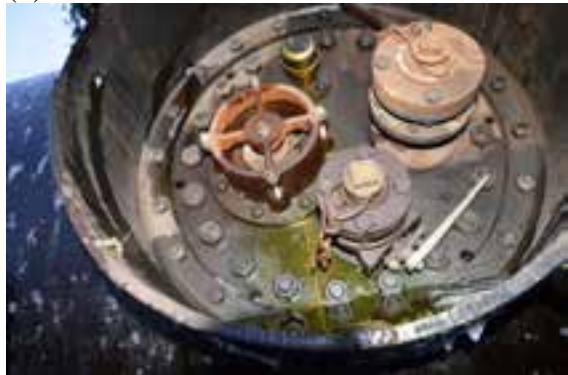
(f) Product in housing (RSI-AAR Safety Project photo)

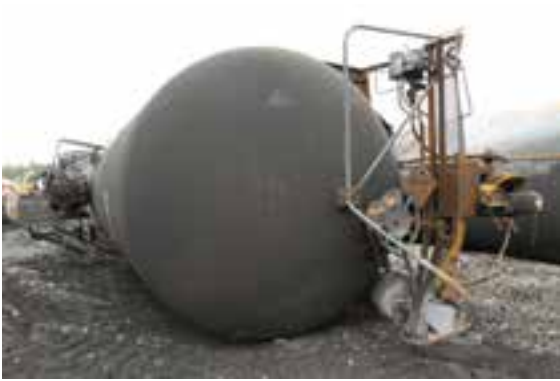
Stub sills and couplers	The A end stub sill was slightly bent to the left. The B end stub sill was unremarkable.

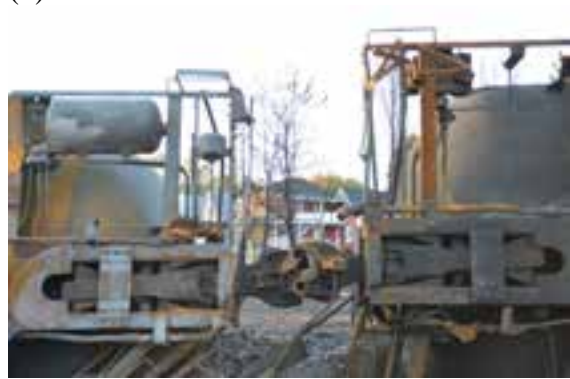
(f) In-situ photo showing car TILX 316570 (left) still coupled to car TILX 316641 (right) (RSI-AAR Safety Project photo)

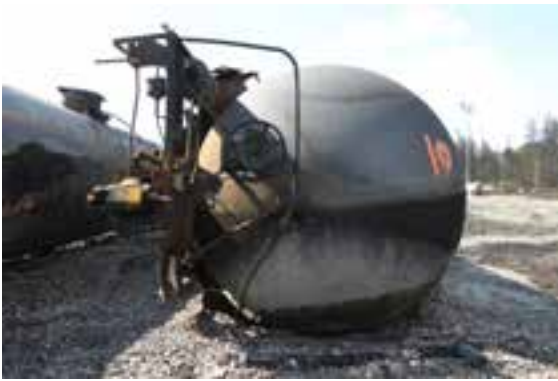
Pressure relief device	No visible impact damage.
Manway	The manway cover was closed with 1 bolt loose and the other 5 bolts intact.
Stub sills and couplers	Two rails were embedded in the AR bolster. The A end stub sill was slightly bent to the right. The B end stub sill was unremarkable.

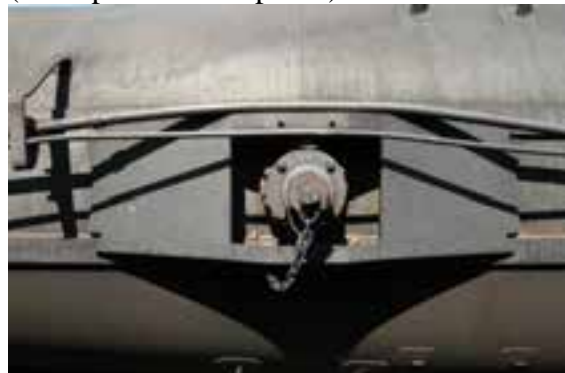
(g) Top fittings and manway

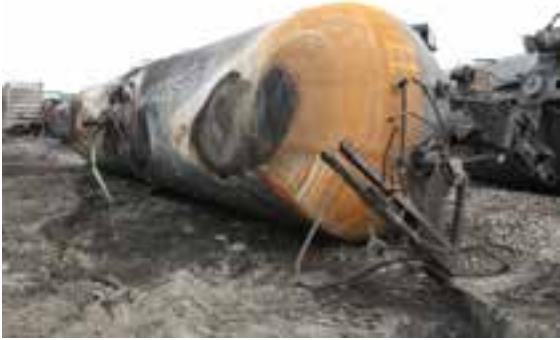
Top fittings	The housing was missing and the fittings had sheared off and the education pipe was partly pulled out of the tank.
Pressure relief device	The PRD was plugged with dirt but there was no visible impact damage.
Manway	The manway cover was closed with 1 bolt loose and the other 7 bolts intact.
Stub sills and couplers	The A end stub sill was slightly bent to the left. The B end stub sill was extensively deformed to the left.

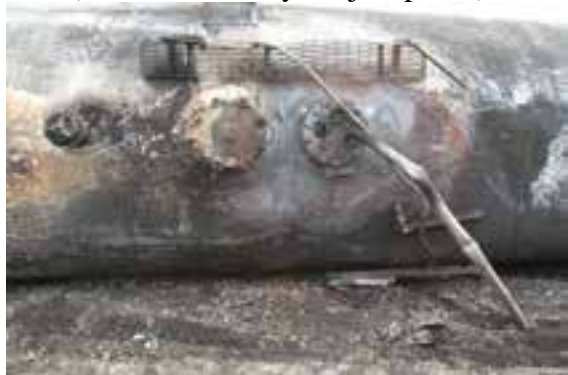
(f) PRD, top fittings and manway

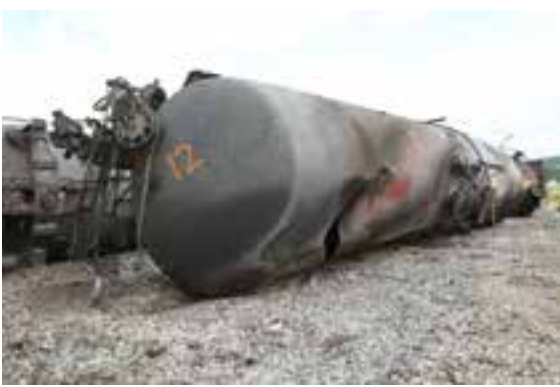
Top fittings	The housing cover was slightly deformed and askew but still secured. Some debris was observed inside the housing but the condition of the fittings could not be determined as they were not visible.
Pressure relief device	The PRD was not visible for inspection.
Manway	The manway cover was closed with 1 bolt loose and the other 5 bolts intact.
Stub sills and couplers	The A end stub sill was slightly bent to the left. The B end stub sill was bent to the left. Both stub sills had some impact damage.

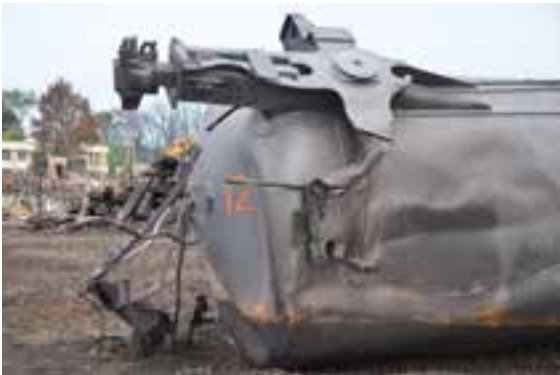
(e) Dent and damaged bolster on AR side of shell (RSI-AAR Rail Safety photo)

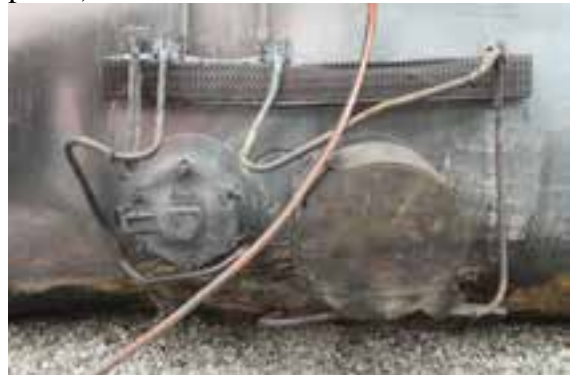
(f) Top fittings and manway

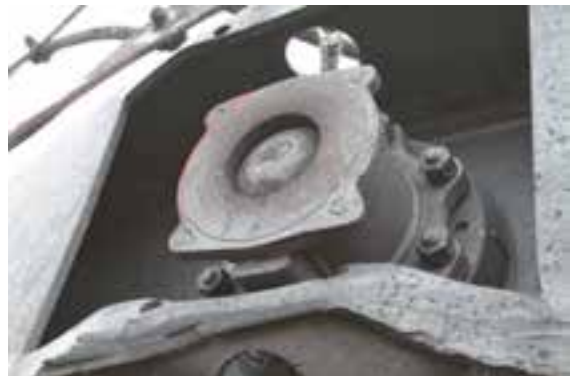
(h) Close-up of BOV ball

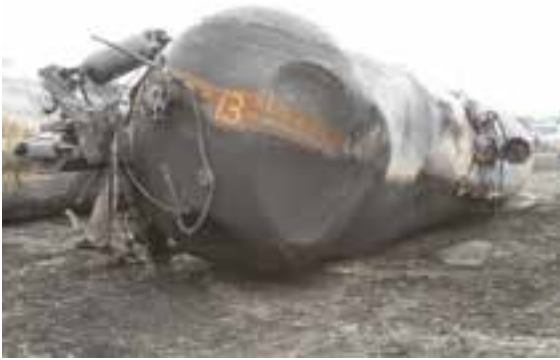
Bottom outlet valve	The fabricated skid and BOV nozzle did not exhibit any impact damage. The handle was in the closed position and secured. However, the extension and support brackets were impact damaged and some product seepage was noted inside the skid.
Top fittings	The housing was missing and both nozzles were sheared; 1 nozzle was hanging from its end cap chain.
Pressure relief device	The PRD was plugged with dirt but had no visible impact damage.
Manway	The manway cover was open with 1 of the 8 bolts and lugs broken. The cover was closed when the car came to rest and had been opened during recovery operations.
Stub sills and couplers	The A end stub sill was bent to the right. The B end stub sill was bent slightly upwards.

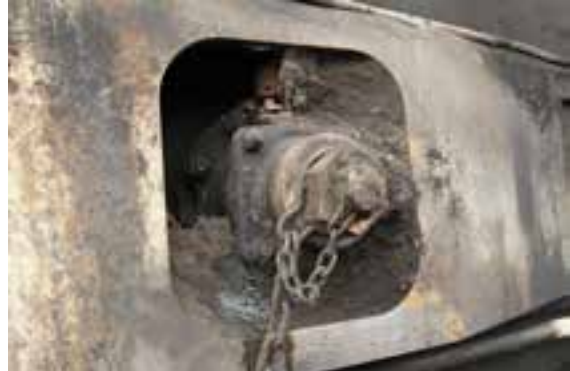
(h) Close-up showing seepage from BOV

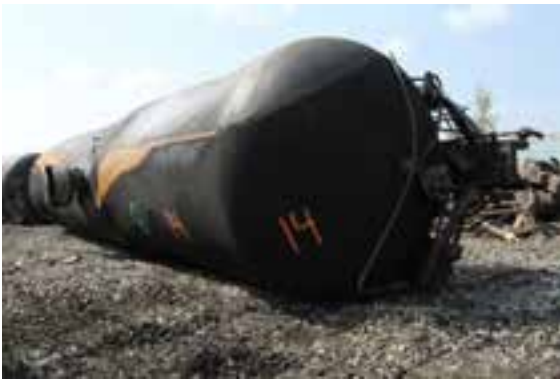
Top fittings	The housing cover was deformed and askew with the locking pin unsecured. There was no visible impact damage to the fittings inside; however, the fittings and housing a reddish colour indicative of extensive fire damage.
Pressure relief device	No visible impact damage.
Manway	The manway cover was found beside the staged car. The hinge and 2 of the 6 bolts were broken.
Stub sills and couplers	The A end stub sill was unremarkable. The B end coupler had separated and the stub sill was deformed (impact damaged).

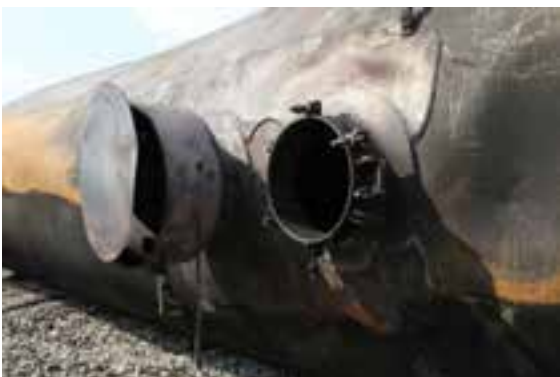
(g) Top fittings and manway

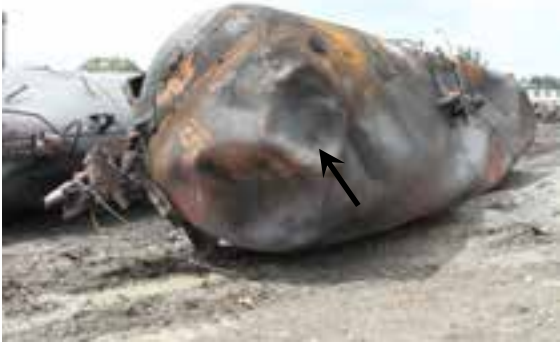
Pressure relief device	One of the 2 PRDs exhibited minor impact damage (broken bolt). The other PRD was unremarkable.
Manway	The manway cover was closed. 7 of the 8 bolts had released; the 8 th bolt was intact.
Stub sills and couplers	The top shelf of the B end double-shelf coupler was broken. The B end stub sill was unremarkable. The A end coupler had separated and the stub sill was deformed and bent to the right.

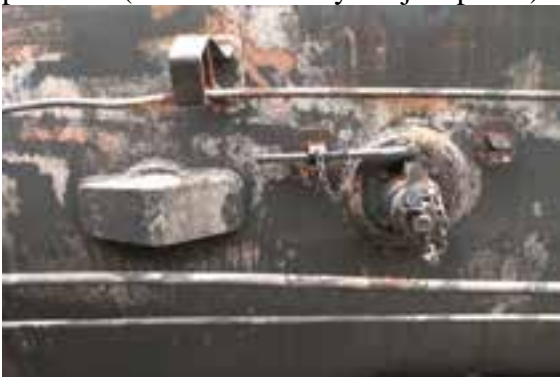
(f) Top fittings and manway

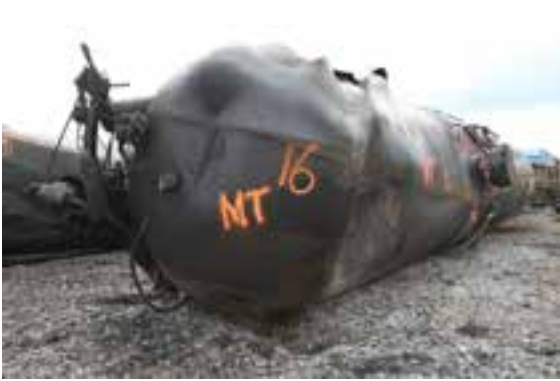
Bottom outlet valve	The fabricated skid exhibited slight impact damage and scoring on its right side. The BOV adaptor had sheared-off at the flange, exposing a closed BOV ball. The BOV handle had separated at its connection with the valve and was missing.
Top fittings	The housing cover was slightly warped but closed and secured. The fittings inside were not visible for inspection.
Pressure relief device	The PRD was inside the housing and not visible for inspection.
Manway	Manway cover was closed but 4 of the 6 bolts had released.
Stub sills and couplers	The A end stub sill was unremarkable. The B end stub sill was impact damaged and bent to the left.

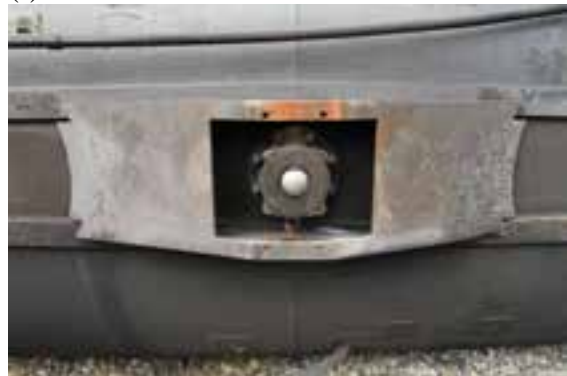
(g) Top fittings and manway

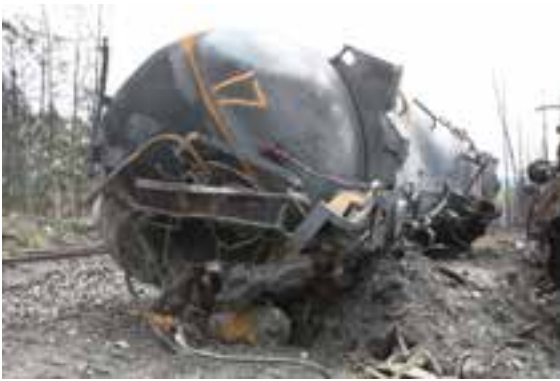
Pressure relief device	The PRD was inside the housing and not visible for inspection.
Manway	The manway cover was open with all 6 bolts intact. The cover exhibited round patterns at the bolt locations with less fire damage than the surrounding surface. This suggests the bolts had been secured when the car was exposed to the post-derailment fire and that the cover was subsequently opened during recovery operations.
Stub sills and couplers	The A end stub sill was slightly bent to the left and the knuckle was missing from the coupler. The B end stub sill was extensively damaged and bent to the left. The coupler had been pulled out of the stub sill and was partially separated from it.

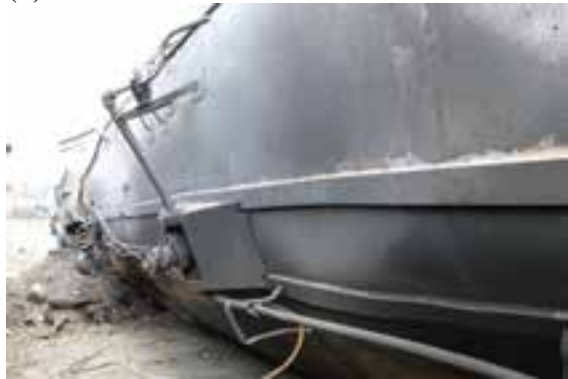
(e) Top fittings and manway

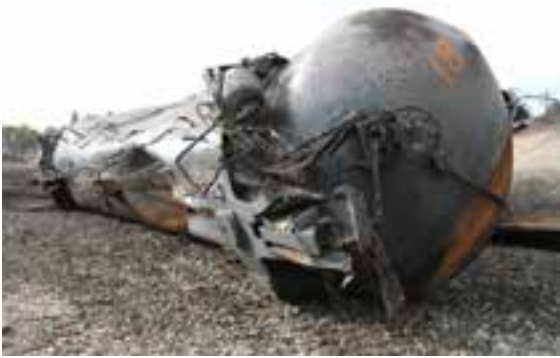
Bottom outlet valve	The cast skid was impact damaged on its right side. The BOV adaptor had sheared-off at the flange, exposing a closed and oxidized (fire damaged) BOV ball. The BOV handle had separated at its intended break-off point and was missing.
Top fittings	The housing was deformed and askew. It was closed but unsecured. The fittings inside were not visible for inspection.
Pressure relief device	No visible impact damage to PRD.
Manway	The manway cover was closed with all 6 bolts intact.
Stub sills and couplers	The A end stub sill was impact damaged and bent to the left. The B end stub sill was broken, bent to the left and the coupler assembly was missing.

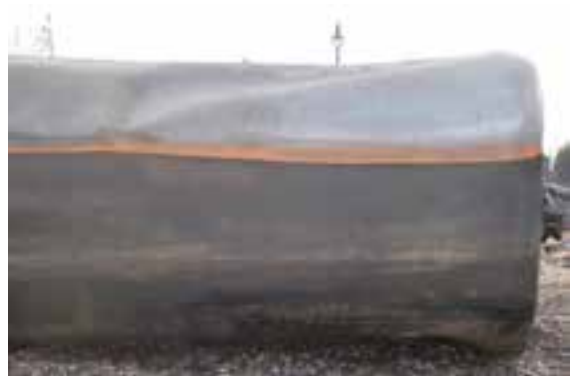
(h) Buckle in shell near A end (RSI-AAR Safety Project photo)

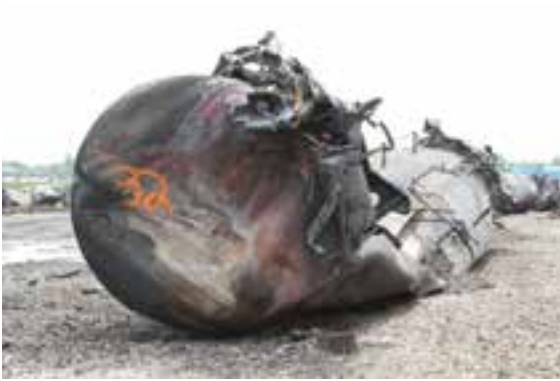
Bottom outlet valve	The fabricated skid and BOV assembly had no significant impact damage. The handle was in the closed position and secured. However, the handle extension and the support brackets were deformed due to impact damage.
Top fittings	The housing had separated and the top fittings were sheared off.
Pressure relief device	The PRD nozzle was sheared off just above the reinforcement pad on the shell.
Manway	The manway cover and several of the bolts were missing.
Stub sills and couplers	The A end stub sill was bent to the top-right and its left side was broken. The B end stub sill was bent in the top-right direction.

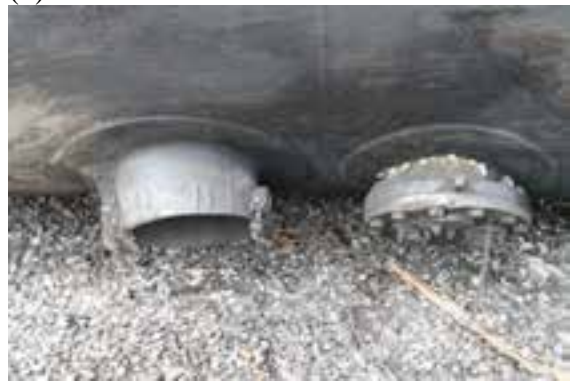
(f) Manway and top fittings

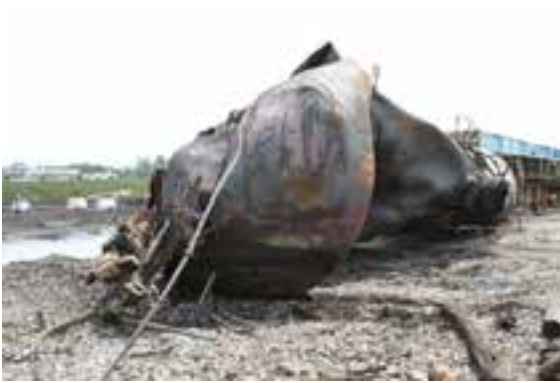
Top fittings	The housing cover was deformed and hanging from the hinge but the wall was intact. The fittings inside the housing had no visible impact damage.
Pressure relief device	The PRD inside the housing had no impact damage.
Manway	The manway cover was closed with all 6 bolts intact.
Stub sills and couplers	The A end stub sill was broken and bent to the right. Its coupler had been torn out. The B end stub sill was bent to the right and the left side was broken.

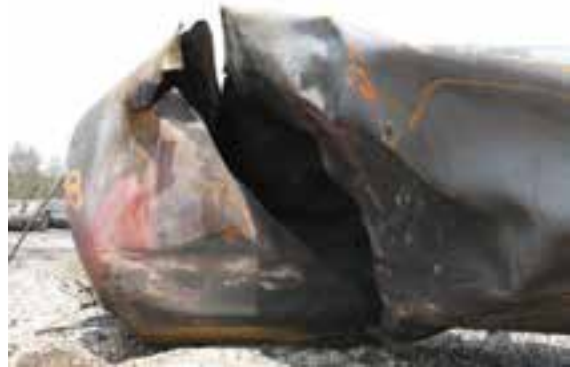
(d) Detail of shell rupture

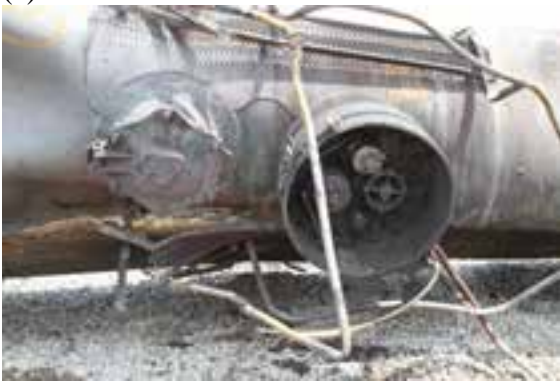
(e) Manway and top fittings

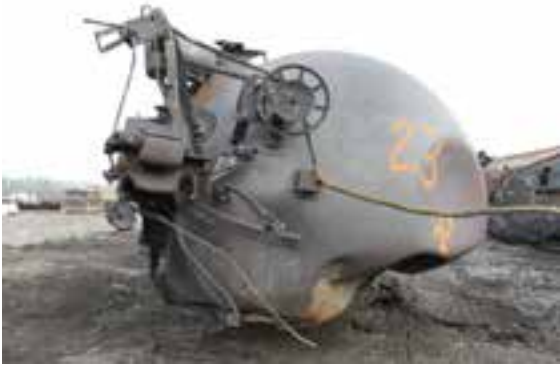
Top fittings	The cover of the housing assembly was missing and the wall was extensively deformed, having started to separate from the flange. The interior of the housing was partly filled with debris, preventing inspection of 1 fitting (vacuum relief valve). The remaining top fittings did not exhibit any visible impact damage.
Pressure relief device	The PRD inside the housing had no visible impact damage.
Manway	The manway cover was closed with 2 bolts missing and 4 bolts intact.
Stub sills and couplers	The A end stub sill was bent to the right. The knuckle was broken off the coupler. The B end stub sill was unremarkable.

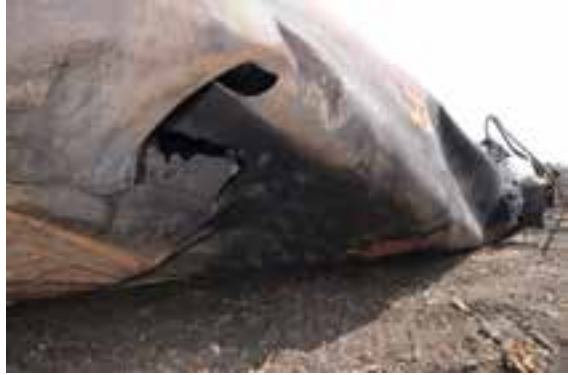
(d) Detail of shell rupture (RSI-AAR Safety Project photo)

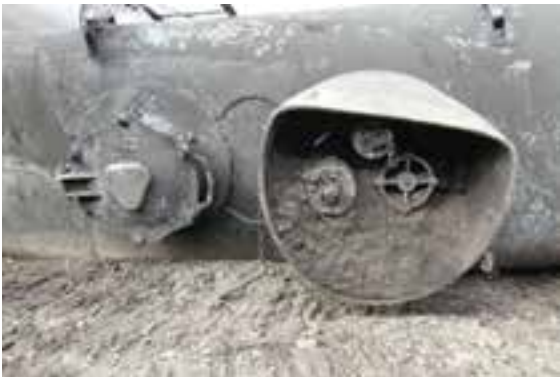
(e) Manway and top fittings

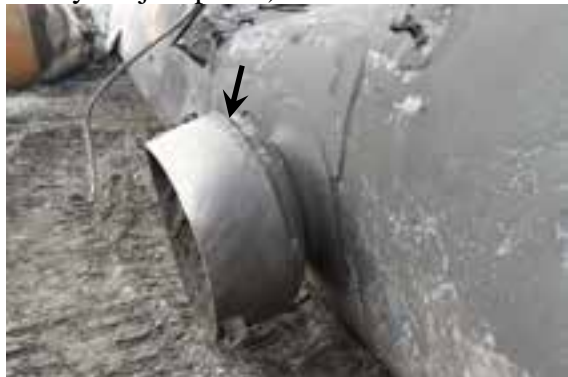
(f) Detail showing damaged housing wall (arrow)

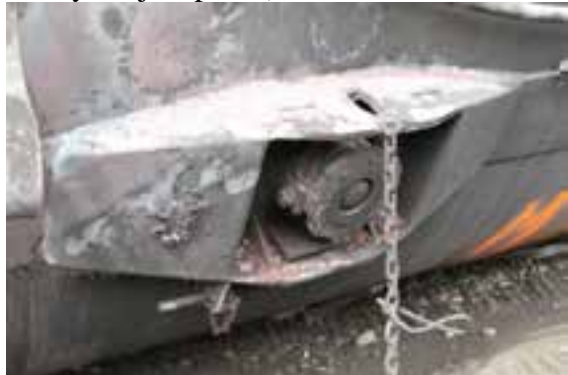
(e) PRD, manway and top fittings

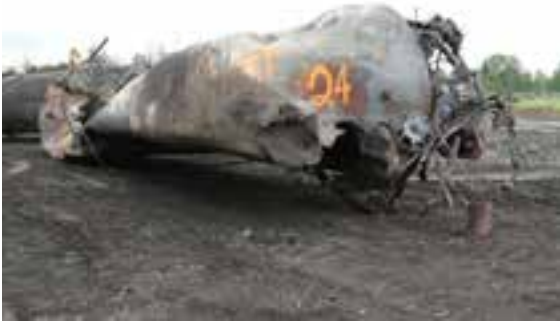
(a) B end head and shell

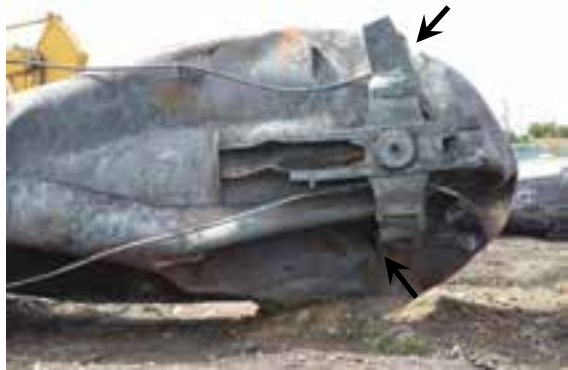
(d) Ruptures at the AL and AR ends of the A end bolster (RSI-AAR Safety Project photo)

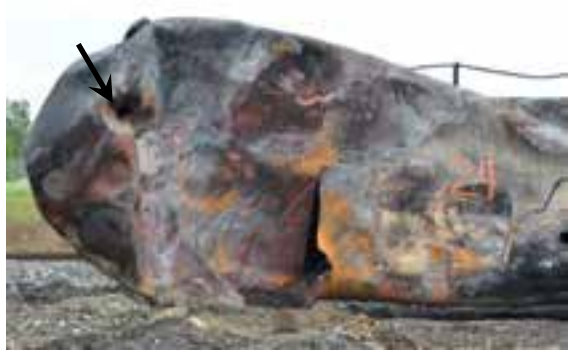
(f) Detail of large shell rupture and smaller puncture (arrow) (RSI-AAR Safety Project photo)
