OPERATIONAL SERVICES BRANCH
ENGINEERING LABORATORY REPORT

LP149/2013

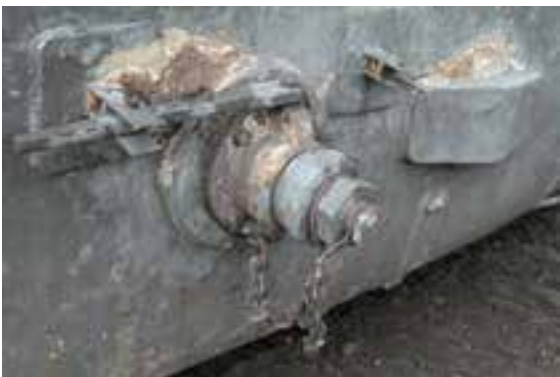
(f) Detail of large shell rupture and smaller puncture (arrow) (RSI-AAR Safety Project photo)

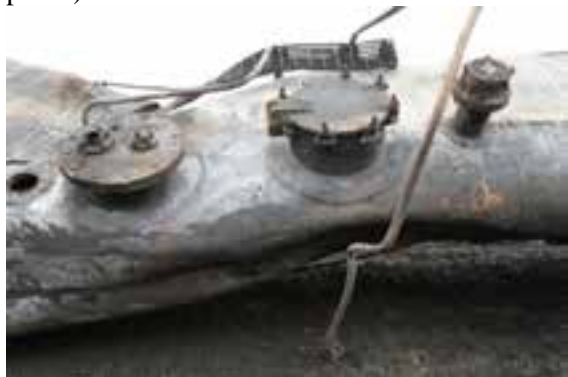
(h) PRDs, manway and top fittings

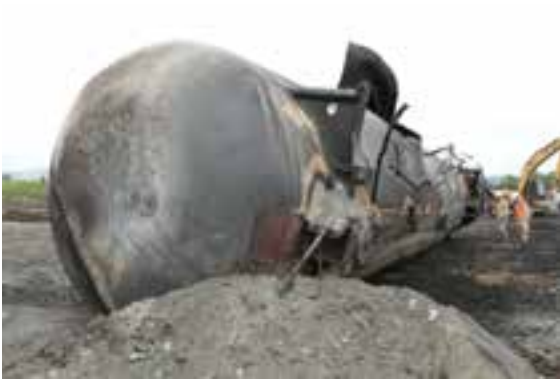
Top fittings	The housing was deformed at the hinge and unsecured, partially exposing the fittings inside. One of the fittings was impact damaged (bent at its flange).
Pressure relief device	There was no visible impact damage to the PRD.
Manway	The manway cover was closed with no impact damage.
Stub sills and couplers	The B end stub sill was broken and the coupler was missing. The front sill pad had separated from the tank at the fillet weld. None of the weld failures had propagated to the tank. The A end stub sill had no significant impact damage.

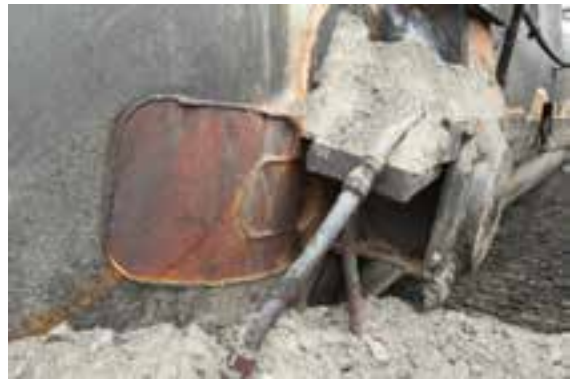
b) Close-up showing broken B end stub sill

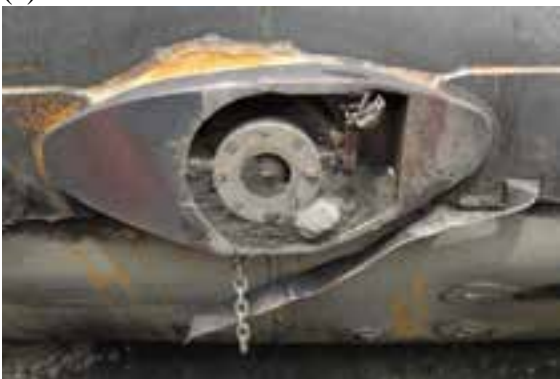
(f) Manway, top fittings and PRD

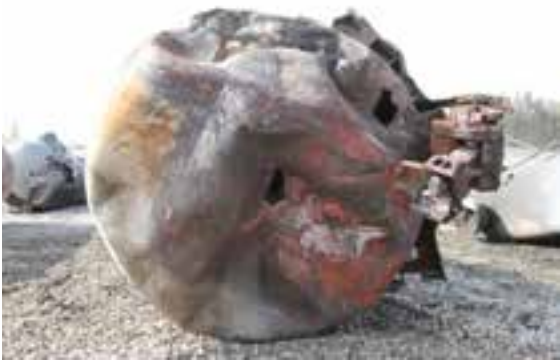
Top fittings	The housing had separated at the hinge and was missing. The exposed top fittings had no visible impact damage.
Pressure relief device	The PRD was plugged with debris but had no visible impact damage.
Manway	The manway cover was closed. 1 of the 8 bolts and its lug were broken off.
Stub sills and couplers	The B end stub sill was broken bent up and to the left. The B end coupler was impact damaged (the knuckle and bottom shelf were broken off). The A end stub sill was bent to the right and its coupler was missing.

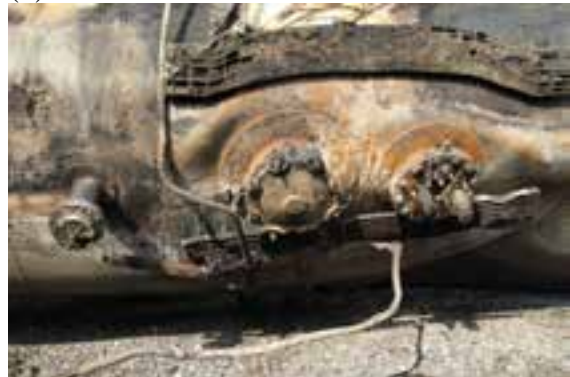
(f) PRD, manway and top fittings

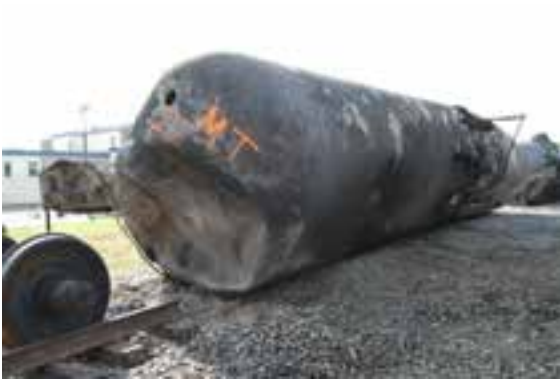
Top fittings	The housing was slightly askew but otherwise undamaged. The fittings inside were not visible for inspection.
Pressure relief device	The PRD was plugged with debris but had no visible impact damage.
Manway	The manway cover was closed with no impact damage.
Stub sills and couplers	The A end stub sill was bent to the right. The B end stub sill was bent to the left and the coupler was missing.

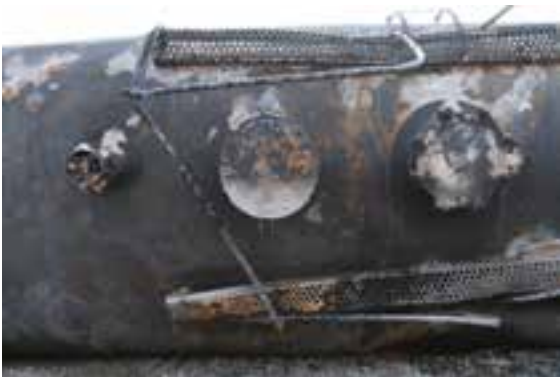
(g) PRD, top fittings and manway

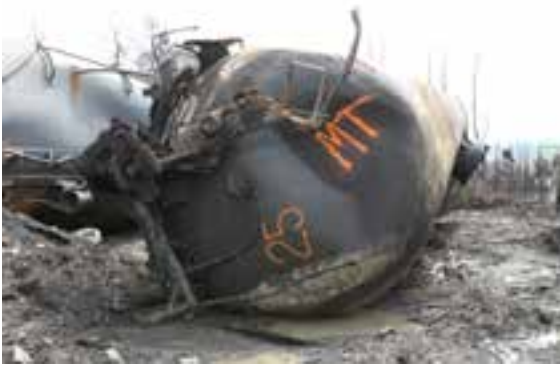
Top fittings	The housing cover was missing and the wall is deformed as a result of impact damage. The housing was partially filled with debris. The 3-inch valve handle was not in the horizontal position, suggesting it might have been displaced. However, there was no visible damage to the caps assemblies.
Pressure relief device	The PRD had no visible impact damage.
Manway	The manway cover was closed with 1 of the 6 bolts bent.
Stub sills and couplers	The A end stub sill was bent to the right and its coupler was impact damaged (missing knuckle and broken yoke). The B end stub sill was twisted to the left and broken. The knuckle was missing.

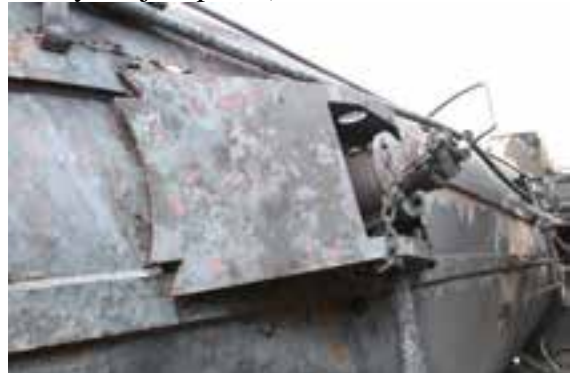
(e) Manway and top fittings (RSI-AAR Safety Project photo)

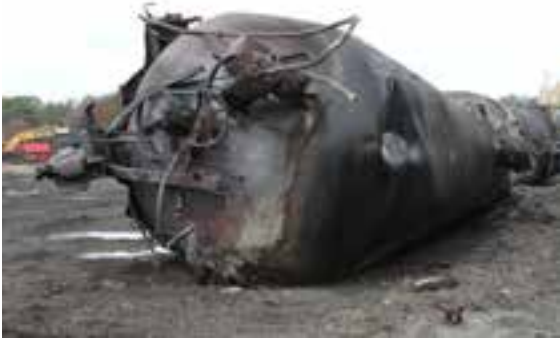
Bottom outlet valve	There was an impact mark on the A end portion of the fabricated skid. The BOV adaptor had sheared off at the flange, exposing a closed BOV ball. The handle assembly was missing and the securement mechanism was impact damaged.
Top fittings	The housing assembly had no impact damage. The fittings inside were not visible for inspection.
Pressure relief device	The PRD inside the housing was not visible for inspection.
Manway	The manway cover was closed with 1 of the 6 bolts broken.
Stub sills and couplers	The A end stub sill was broken and twisted upwards, nearly touching the head. The knuckle was missing. The B end stub sill was bent to the right. The coupler was impact damaged and a piece of knuckle was missing.

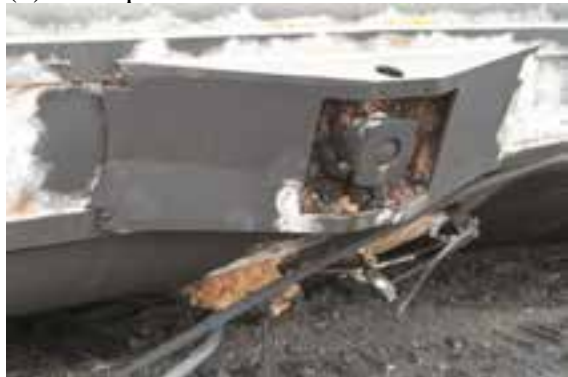
(e) Manway and top fittings

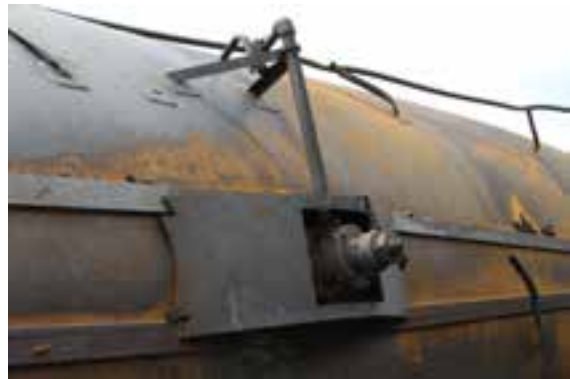
(e) Top fittings and manway

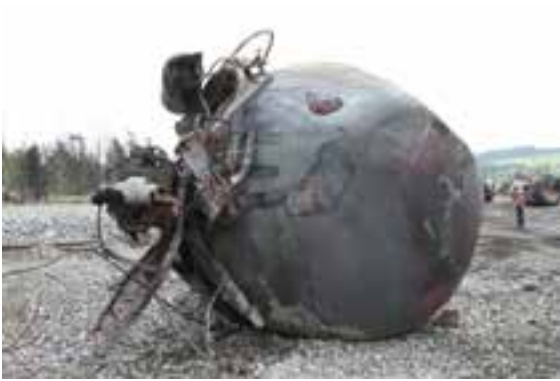
Top fittings	The housing had separated at the flange. All of the fittings inside were impact damaged or sheared off. The area around the damaged fittings was partially covered with product residue.
Pressure relief device	The top portion of the PRD was sheared off.
Manway	The manway cover was closed with 1 of the 6 bolts broken.
Stub sills and couplers	The A end stub sill was broken and bent to the right. Its knuckle was missing. The B end stub sill had no visible damage but its knuckle was impact damaged.

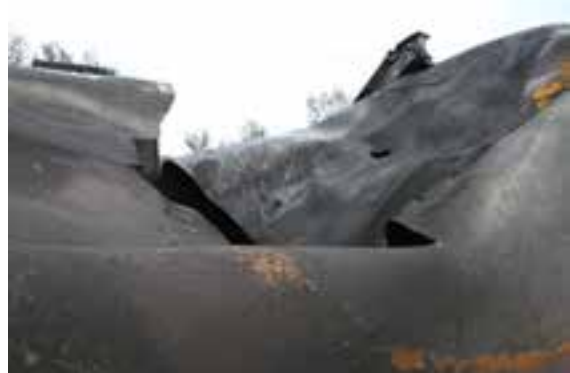
(d) Shell puncture and rupture

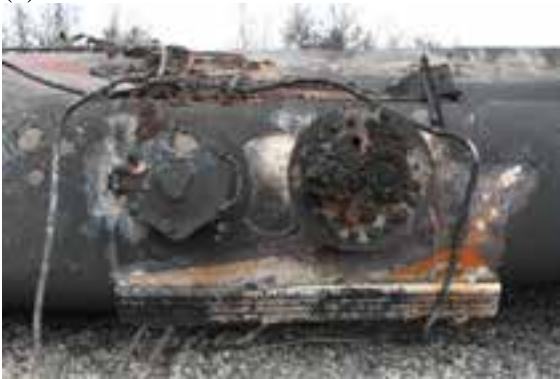
(e) Manway and top fittings

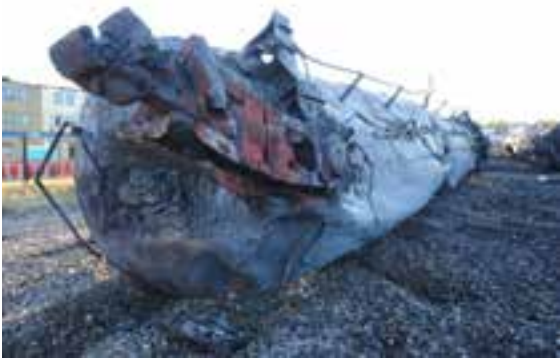
Top fittings	The housing was impact damaged and broken. The 3-inch valve was sheared off and the 2-inch valve was impact damaged.
Pressure relief device	The PRD was deformed due to impact damage. It was also fire-damaged.
Manway	The manway cover was closed. The cover and bolts were extensively fire-damaged.
Stub sills and couplers	The A end stub sill was bent to the left. The B end stub sill was bent to the right and its knuckle was missing. The BL bolster had separated and was missing.

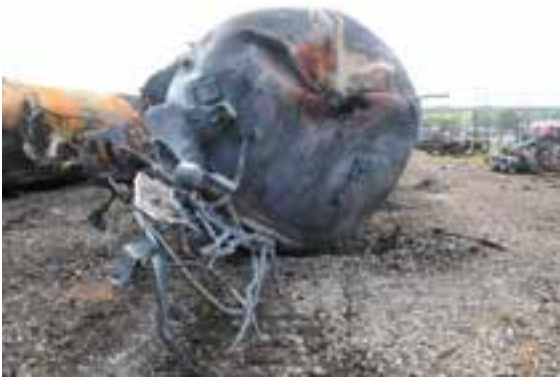
Bottom outlet valve	The fabricated skid was impact damaged on its right side. The BOV adaptor had sheared off at the flange, exposing a partially open BOV ball (opened approximately 1/16 to 1/8 inch). The handle assembly and securement mechanism were missing.
Top fittings	The housing cover was deformed and askew. The wall of the assembly was deformed due to impact damage on the right side. The fittings inside were not visible for inspection.
Pressure relief device	The PRD was inside the housing and not visible for inspection.
Manway	The manway cover was closed with no visible impact damage.
Stub sills and couplers	The A end stub sill was broken and bent upwards and to the right. The BR bolster and right side of the B end stub sill were impact damaged. The coupler was missing.

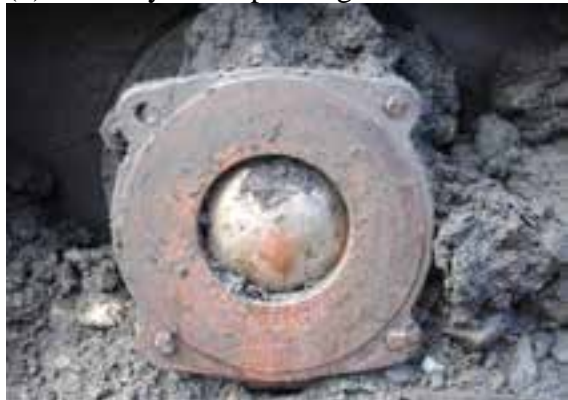
(f) Close-up showing partially open BOV ball

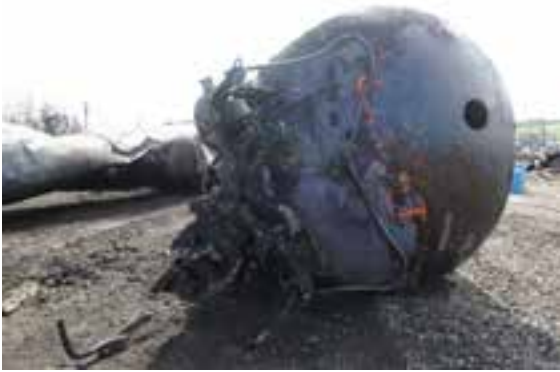
Top fittings	The housing cover was closed but extensively fire-damaged. The portion adjacent to the locking mechanism and the locking pin were burned away. The fittings inside were not visible for inspection.
Pressure relief device	The PRD was inside the housing and not visible for inspection.
Manway	The manway cover was closed. The cover and bolts were extensively fire-damaged.
Stub sills and couplers	The A end stub sill and coupler were impact damaged. The bottom shelf was broken. The B end stub sill was bent downwards and twisted to the right. The knuckle was missing and the bottom shelf was broken.

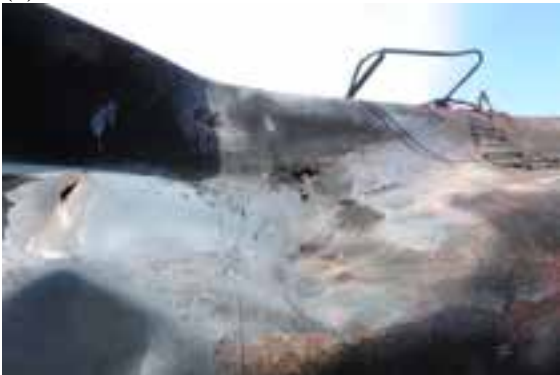
(e) Close up of shell puncture and burn-through

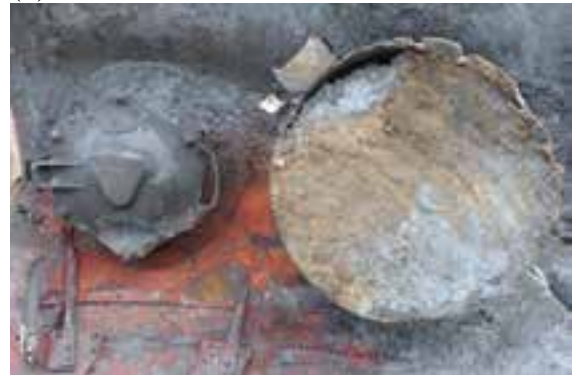
(f) Manway and top fittings

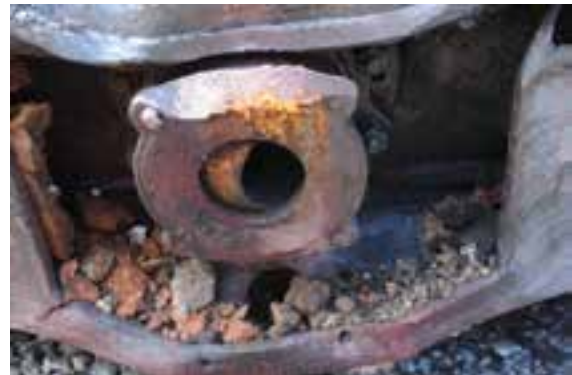
(h) Close-up showing partially open BOV ball

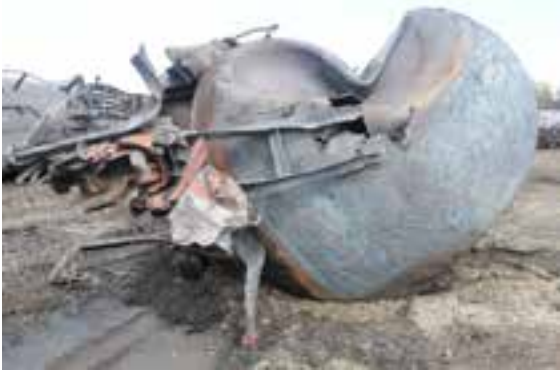
Bottom outlet valve	This car did not have a skid; impact protection was provided by the BOV saddle which exhibited small impact marks around its periphery. The base, handle and cap assembly had sheared off at the saddle as designed, exposing a closed plug.
Top fittings	The housing cover had separated at the hinge and was missing. The liquid valve bolts were broken and the valve was pulled out several inches.
Pressure relief device	Both PRDs were impact damaged and dented and exhibited extensive fire damage.
Manway	The manway cover was in the closed position but 3 of the 8 bolts had sheared off and 1 bolt was bent. There was a visible gap between the manway nozzle and cover.
Stub sills and couplers	The A end stub sill was broken and bent up and to the right. The B end stub sill was broken and the knuckle was missing.

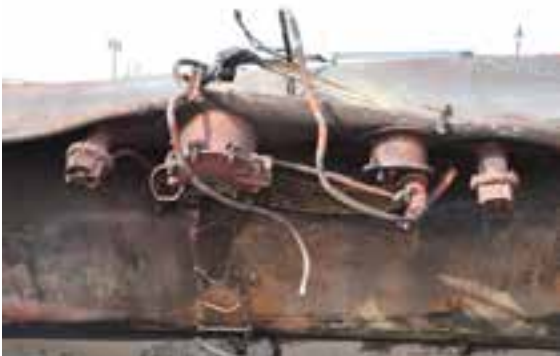
(g) Manway and top fittings (RSI-AAR Safety Project photo)

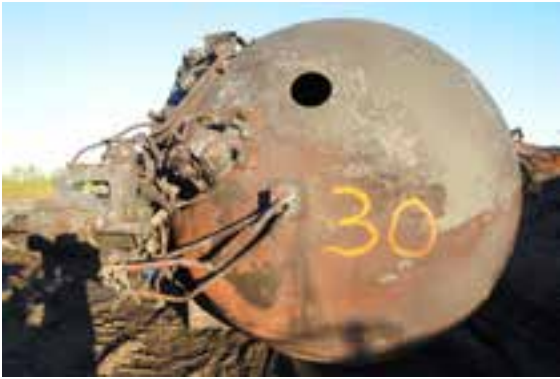
Bottom outlet valve	The fabricated skid and BOV assembly had no significant impact damage. The handle was in the closed position and secured. However, the handle extension and the support brackets were deformed due to impact damage. Product residue was observed on the BOV assembly.
Top fittings	The housing cover had separated at the hinge and was missing. The fittings were sheared off. The area surrounding the top fittings was extensively oxidized with a red discoloration.
Pressure relief device	The top portion of the PRD was sheared off and the PRD was filled with product residue.
Manway	The manway cover was in the closed position but 2 of the 6 bolts had released.
Stub sills and couplers	The A end stub sill was slightly bent to the right and the knuckle was missing. The B end stub sill had no significant impact damage.

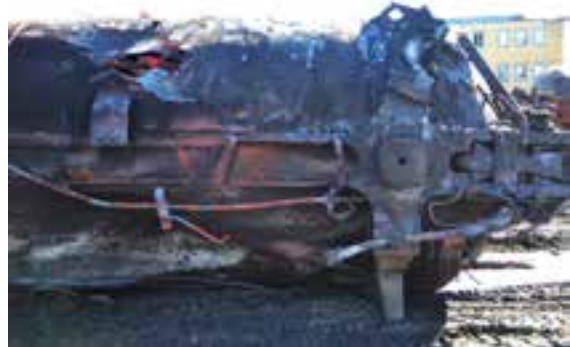
(d) Burn-through in shell (RSI-AAR Safety Project photo)

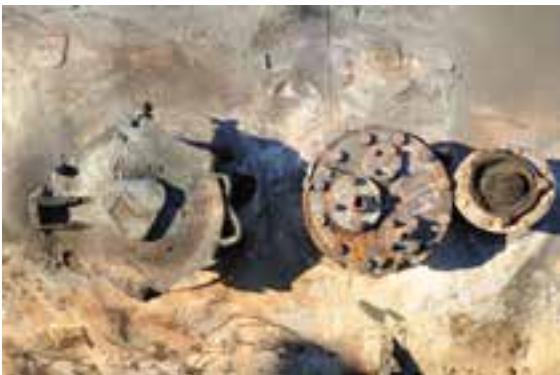
(g) Manway, top fittings and PRD

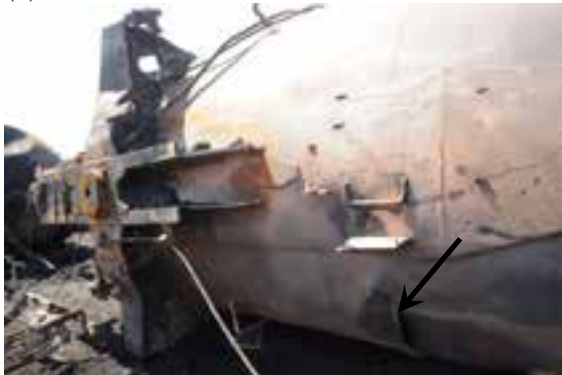
(e) Rupture in shell (arrow)

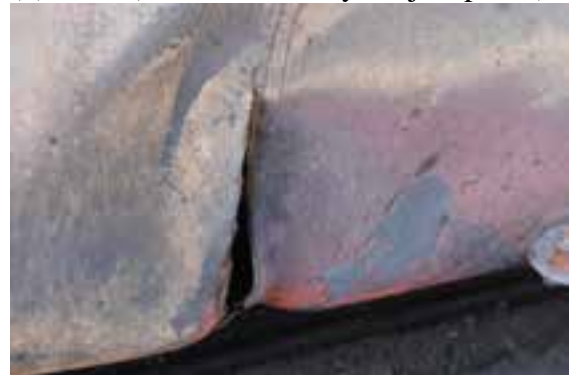
(f) Close-up of rupture arrowed in (e)

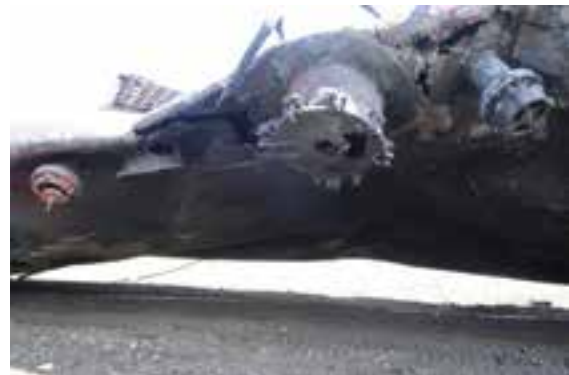
(h) Top fittings, manway and PRDs

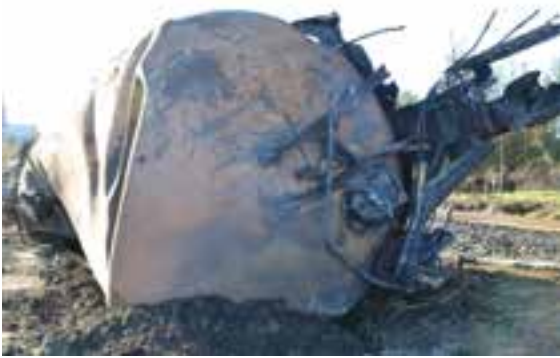
(a) B end head (RSI-AAR Safety Project photo)

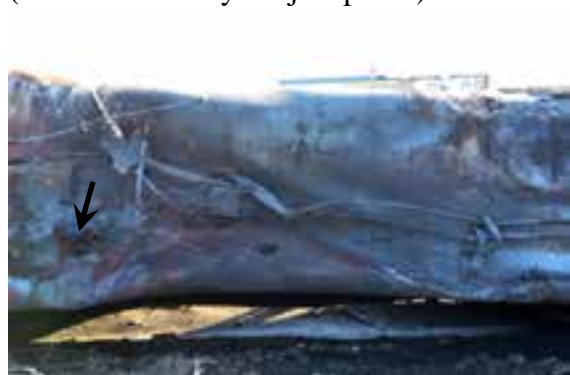
(f) Burn-throughs and puncture (arrow) on shell (RSI-AAR Safety Project photo)

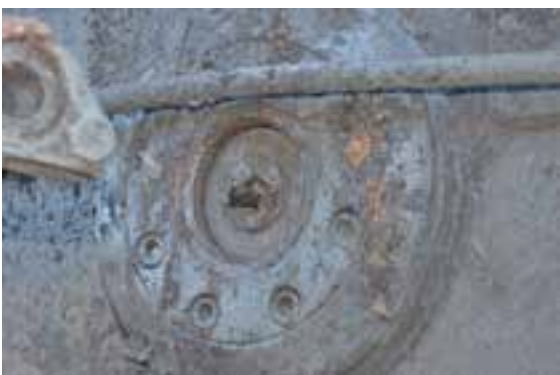
(g) BOV (RSI-AAR Safety Project photo)

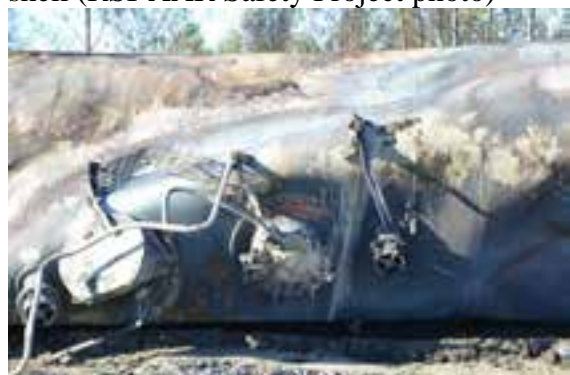
(h) Top fittings, manway and PRDs (RSI-AAR Safety Project photo)

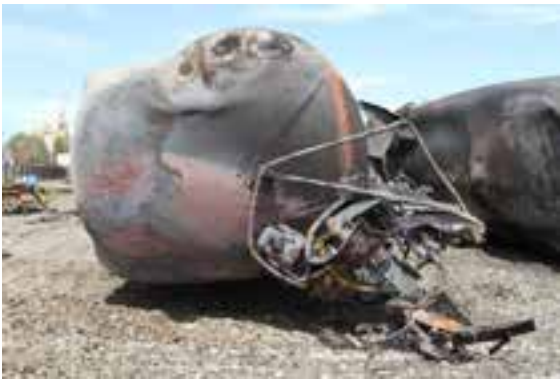
Heads	The A end head had a deep dent in the bottom-right quadrant and a shallower dent on the bottom-left. The top-right edge of the B end head was severely crushed and contained a large rectangular impact mark.
Bottom outlet valve	The cast skid was impact damaged on its right side. The BOV adaptor had sheared off at the flange, exposing a closed BOV ball. The handle was in the closed position. The securement mechanism was impact damaged.
Top fittings	The housing was missing and the top fittings were sheared off.
Pressure relief device	The PRD was extensively fire damaged.
Manway	The manway cover was closed. All of the bolts were damaged and/or covered with debris.
Stub sills and couplers	Both stub sills were broken with the remaining portion bent upwards. Both couplers were missing.

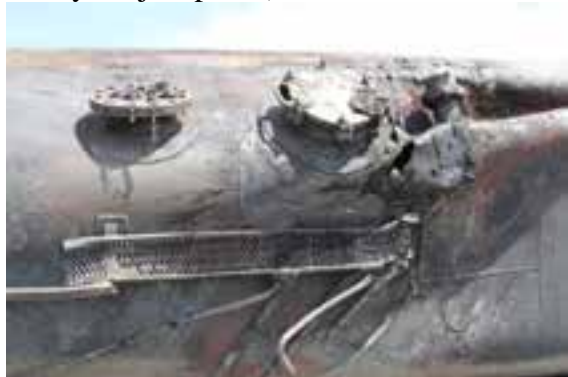
(f) Top fittings, manway and PRD

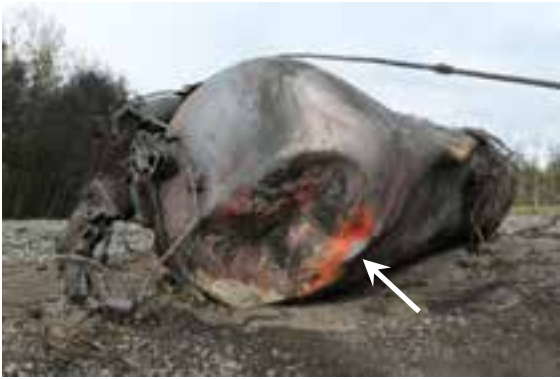
Bottom outlet valve	The fabricated skid was impact damaged on both sides. The BOV assembly was intact but the handle extension and securement mechanism were missing.
Top fittings	The housing was missing and the 2 valves were impact damaged (one was bent and the other sheared off).
Pressure relief device	The PRD had minor impact damage to one bolt on the top portion.
Manway	The manway cover was closed with 2 of the 6 bolts broken.
Stub sills and couplers	Both stub sills were impact damaged and twisted to the right. The B end coupler was still connected to the separated B end coupler from car CTCX 735537 (consist 40). The A end coupler was missing.

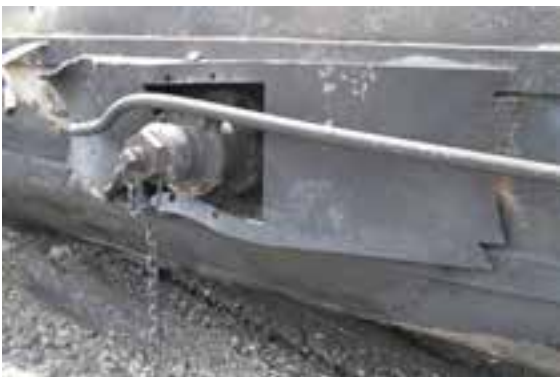
(f) Manway, top fittings and PRD

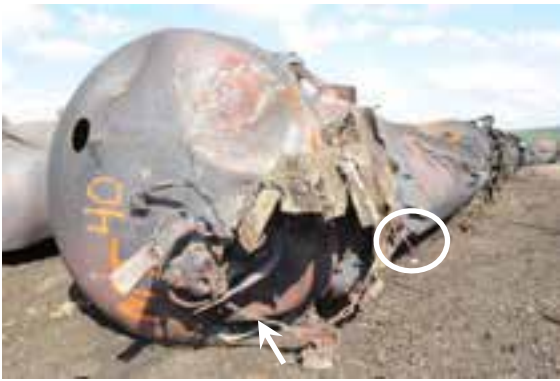
Top fittings	The housing was open and deformed. In-situ photos show that it was open and had some damage when the car came to rest. It was further deformed during staging. There was no visible impact damage to the top fittings.
Pressure relief device	The PRD had no visible impact damage.
Manway	The manway cover was closed with no impact damage.
Stub sills and couplers	The A end stub sill was impact damaged and the separated A end coupler from car WFIX 130616 was still attached to its coupler. The B end stub sill was broken and bent to the left. Its coupler was missing.

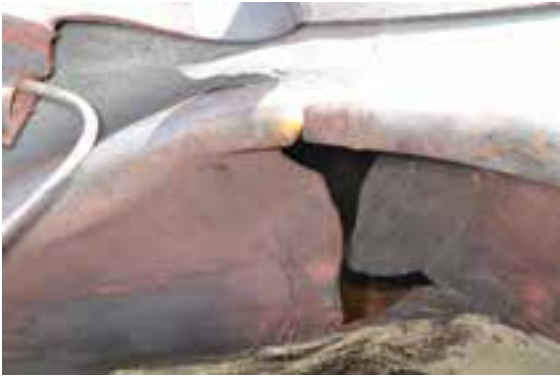
(c) Close-up showing a rupture in the area circled on (a) (RSI-AAR Safety Project photo)

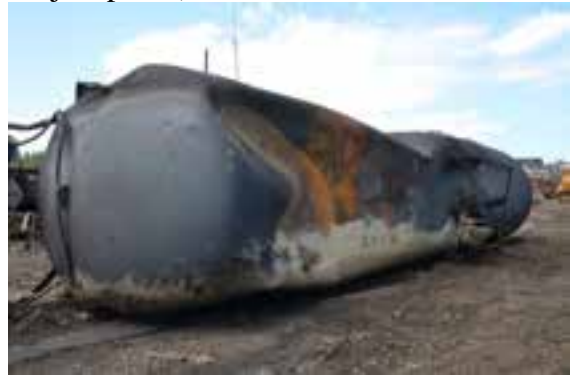
(d) A end (RSI-AAR Safety Project photo)

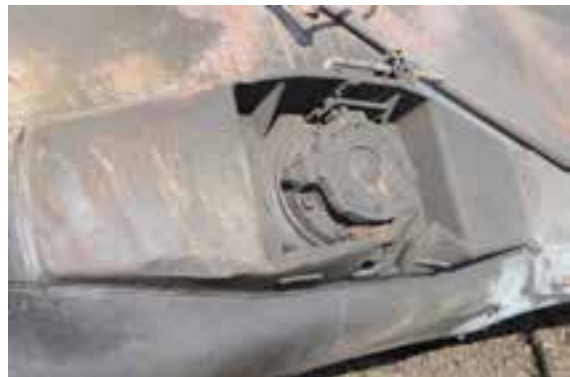
(e) Top fittings, manway and PRD

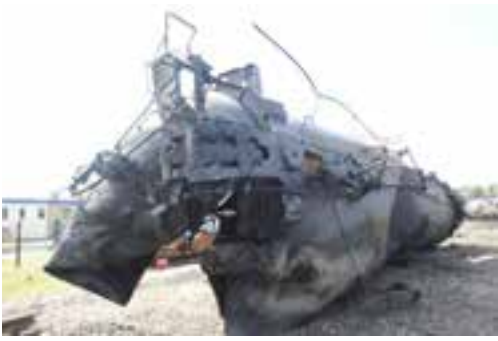
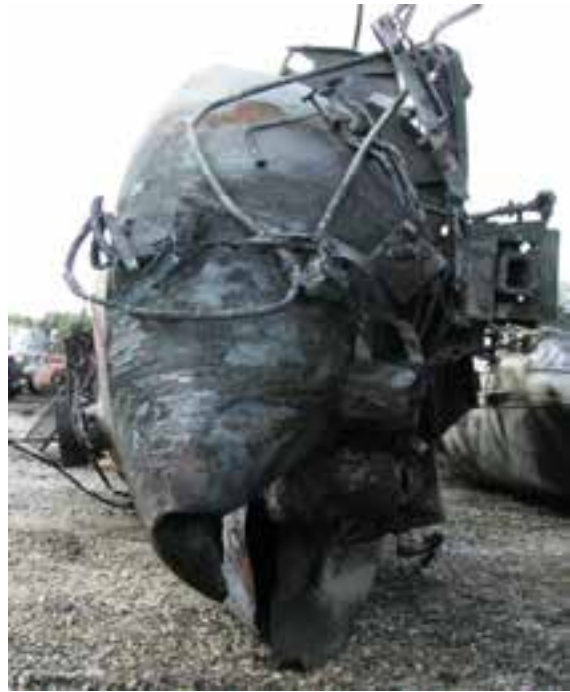
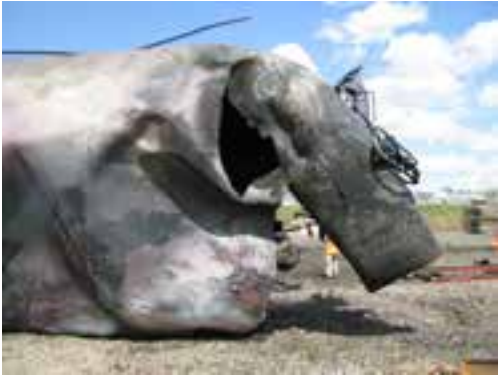
(a) B end head viewed from different orientations

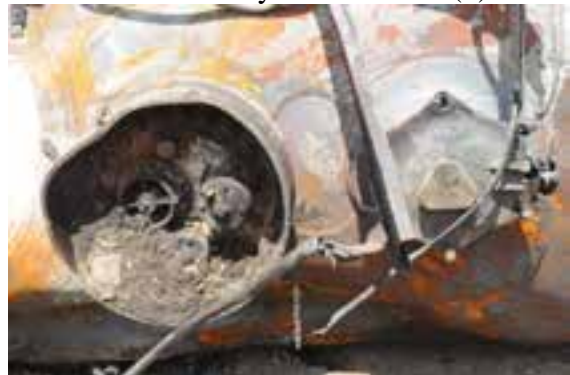
(f) Top fittings and manway

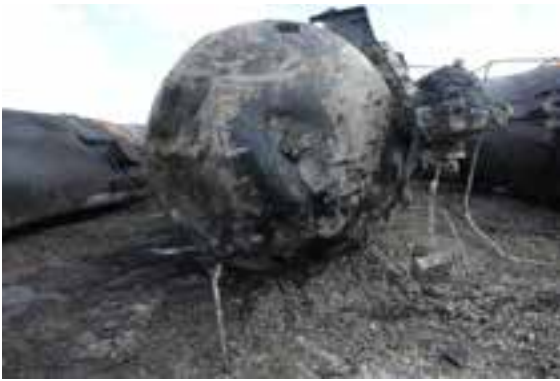
Top fittings	The housing assembly was extensively impact damaged – the cover and wall were deformed and the wall was partially separated from the nozzle. Some of the fittings were hidden from view – the others had no visible damage.
Pressure relief device	The PRD inside the housing was not visible for inspection.
Manway	The manway cover was closed when the car came to rest. It was opened during recovery operations. One manway cover bolt was missing and 1 bolt was bent.
Stub sills and couplers	The A end stub sill was broken, bent to the left and its coupler knuckle was missing. This stub sill had separated at the fillet weld between the front sill pad and the head. This crack had propagated to the body bolster pad fillet weld and into the head-to-shell weld. The B end stub sill was partially obscured by dirt. The portions visible were unremarkable.

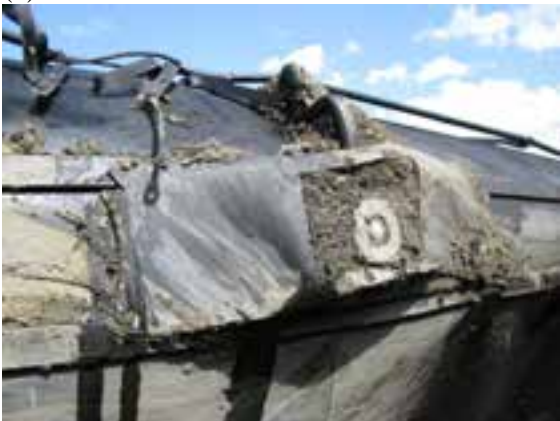
(f) Top fittings and manway

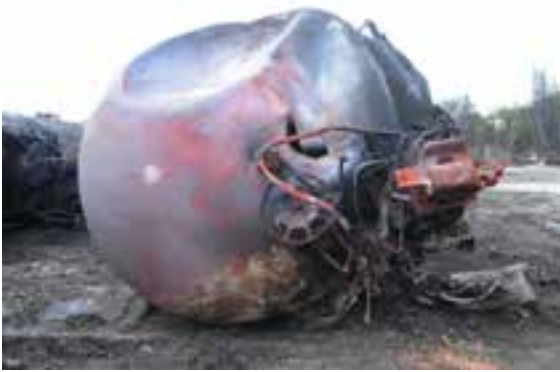
Top fittings	The housing cover was slightly askew but still secured. The fittings inside were not visible for inspection.
Pressure relief device	The PRD inside the housing was not visible for inspection.
Manway	The manway cover was closed with no visible impact damage.
Stub sills and couplers	The A end stub sill was partially obscured by dirt. The portions visible were unremarkable. The B end stub sill was broken and bent to the right.

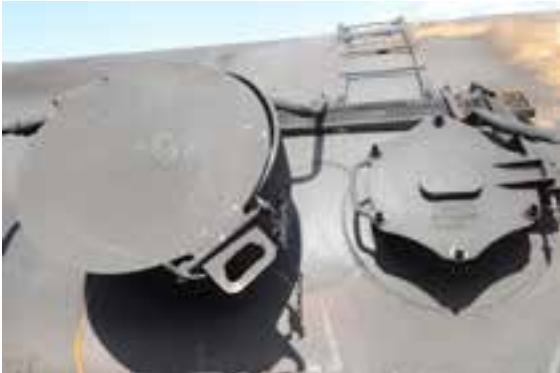
(g) Top fittings and manway

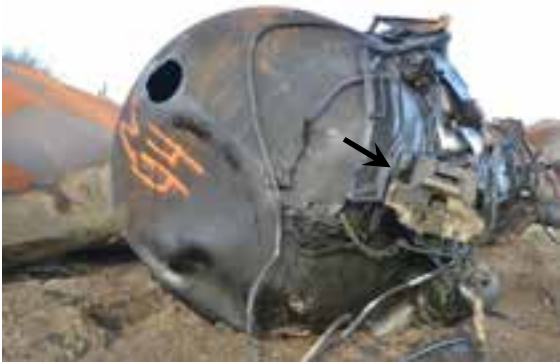
(a) B end head (RSI-AAR Safety Project photo)

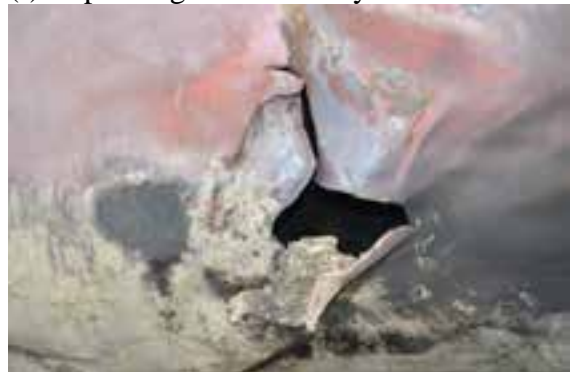
(h) Close-up of puncture in shell (RSI-AAR Safety Project photo)

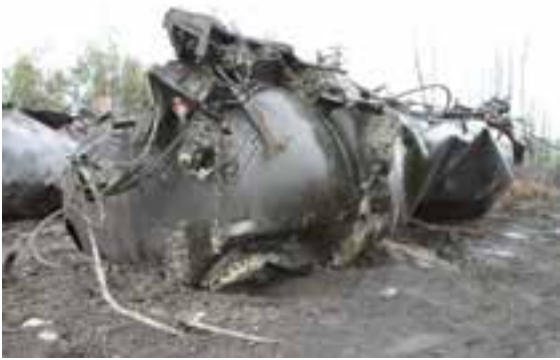
Top fittings	The housing assembly and its cover were present but only partially visible due to the orientation of the car after it was staged. The fittings inside were not visible for inspection.
Pressure relief device	The PRD inside the housing was not visible for inspection.
Manway	The manway was not visible for inspection due to the orientation of the car after it was staged.
Stub sills and couplers	The A end stub sill front sill pad had separated from the head at the fillet weld. The crack extended back to the body bolster pad weld. The B end stub sill was broken and its coupler was missing.

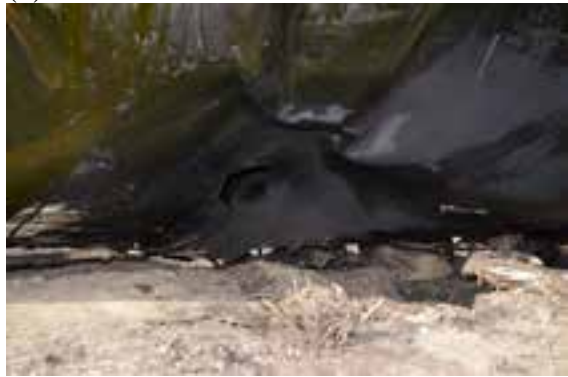
(f) Puncture in top of shell, manway and top fittings (RSI-AAR Safety Project photo)

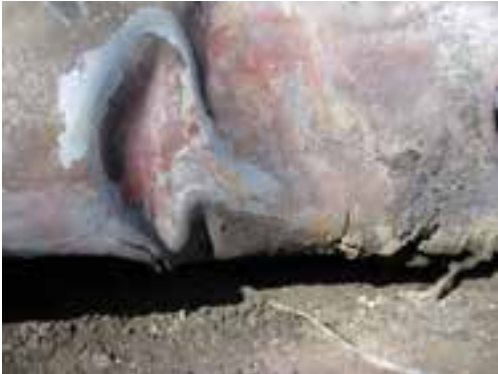
(c) Shell damage in the area indicated by the arrow on (b)

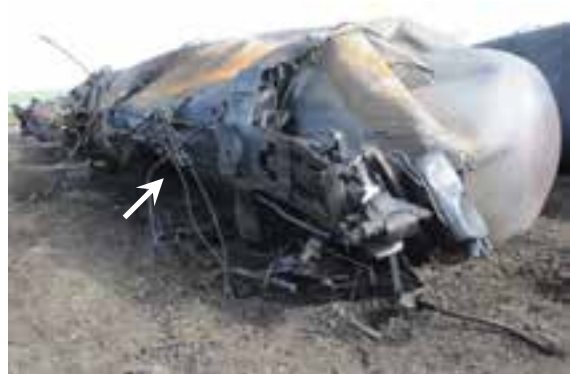
(d) Bottom of the shell viewed from the B end

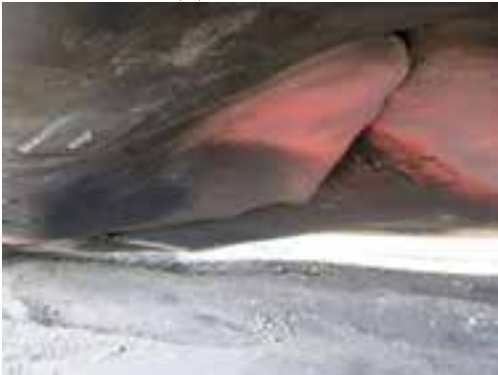
(e) Shell rupture in the area indicated by the arrow on (d)

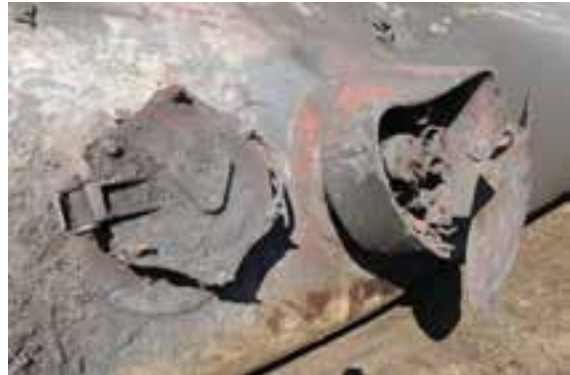
(f) Manway and top fittings

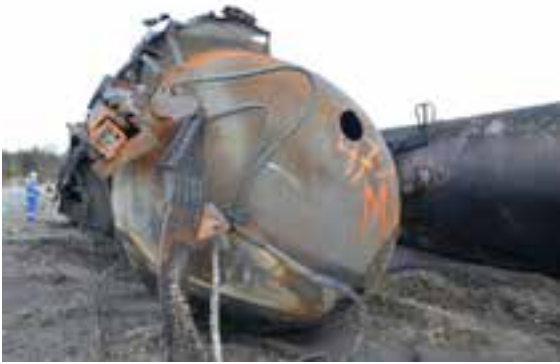
(a) A end head (RSI-AAR Safety Project photo)

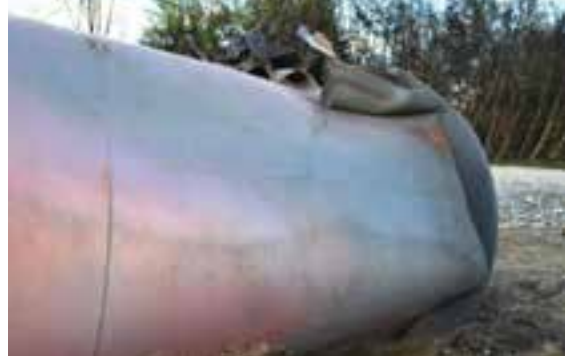
(f) Rupture at B end head-to-shell joint (RSI-AAR Safety Project photo)

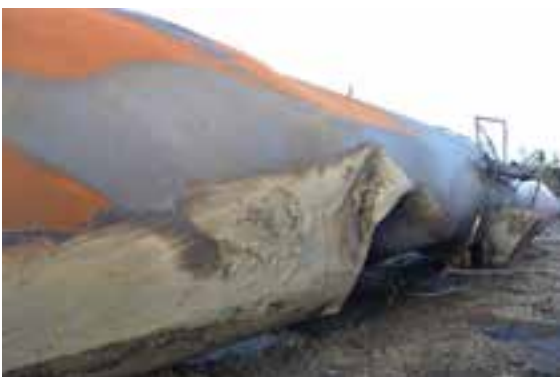
(g) Top fittings (RSI-AAR Safety Project photo)

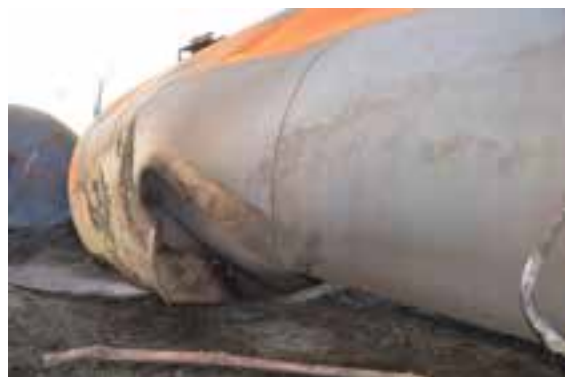
(h) Shell (RSI-AAR Safety Project photo)

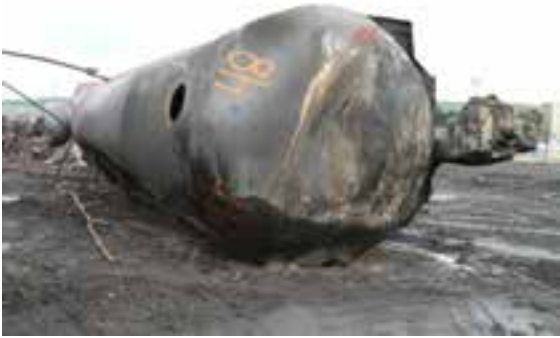
Bottom outlet valve	The fabricated skid and BOV assembly were unremarkable. The handle extension was separated from the BOV inside the skid. The handled extension and securement mechanism were extensively deformed due to impact damage.
Top fittings	The housing cover was slightly deformed and askew but still secured. The top fittings inside were not visible for inspection.
Pressure relief device	The PRD inside the housing was not visible for inspection.
Manway	The manway cover was closed with 2 of the 6 bolts broken above the nut and 1 bolt bent and knocked out of its lug.
Stub sills and couplers	The A end stub sill was bent to the left. The coupler was partially obscured by dirt - the knuckle was missing. The B end stub sill was broken and had separated at the head brace to front sill pad fillet weld, exposing the draft gear inboard lugs. The coupler was missing.

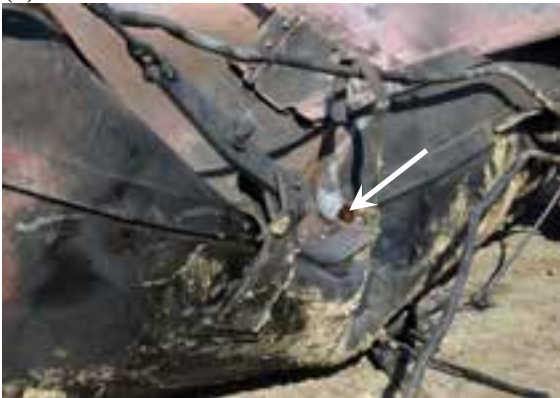
(e) Close-up showing small rupture (arrow) in the area circled on (c) (RSI-AAR Safety Project photo)

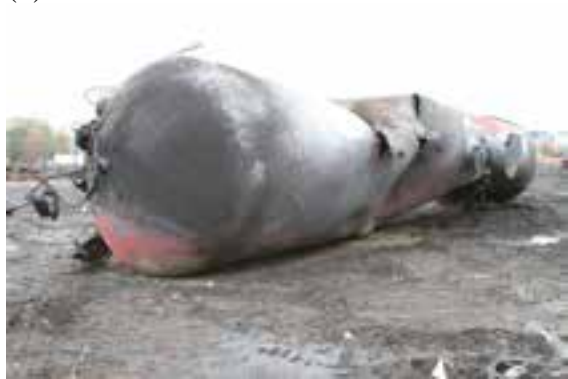
(f) Shell viewed from the B end

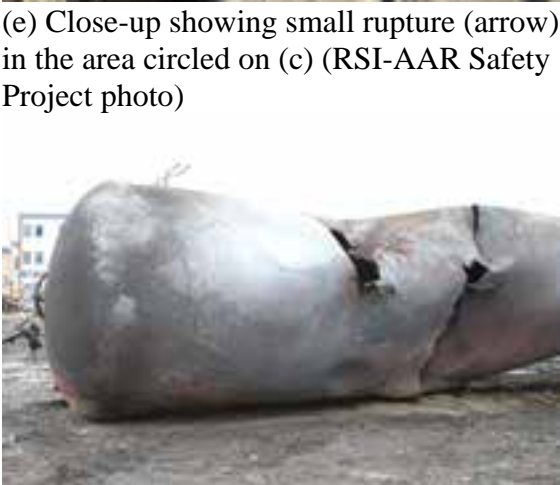
(g) Large ruptures in the shell

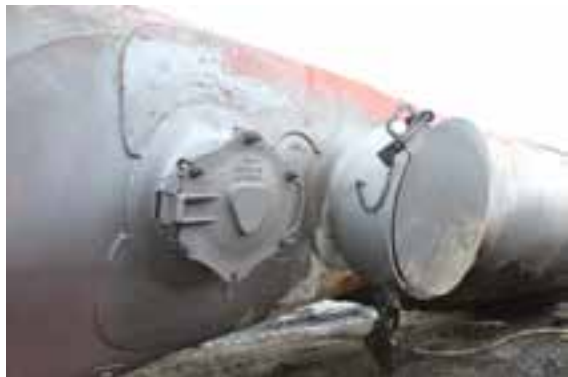
(h) Manway and top fittings

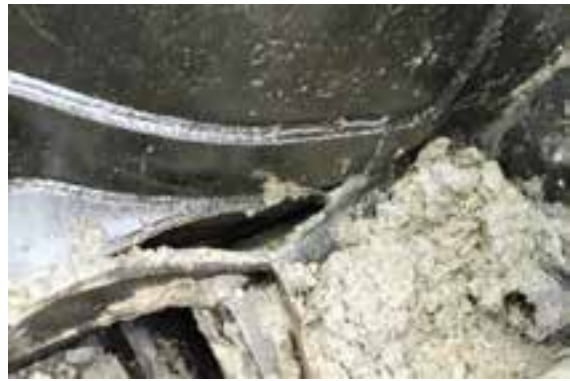
(b) Close-up showing failed B end stub sill welds

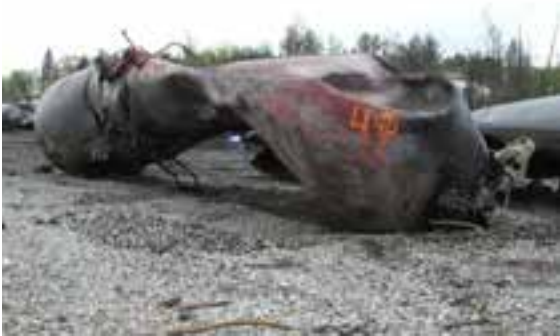
(c) Shell viewed from the B end

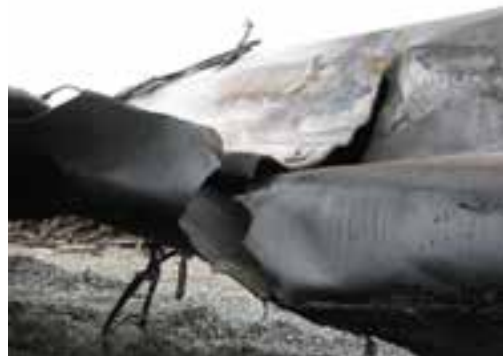
(h) Rupture in shell between BOV and B end

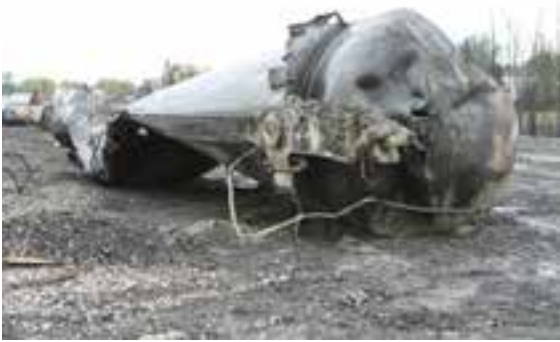
(a) A end head and bottom of shell

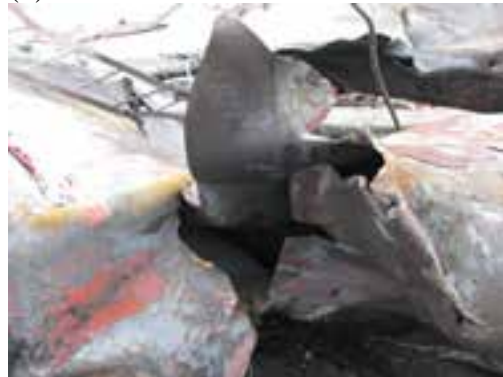
(f) Shell rupture adjacent to manway

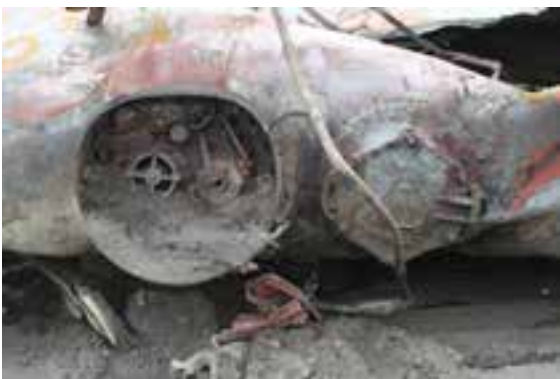
(g) Top fittings and manway

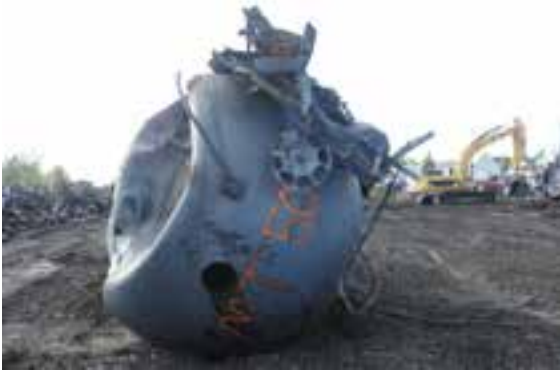
Top fittings	The housing was impact damaged and askew. It was only partially visible due to the position of the car after staging. The fittings inside were not visible for inspection.
Pressure relief device	The PRD was only partially visible due to the position of the car after staging. No impact damage was observed.
Manway	The manway was only partially visible due to the position of the car after staging. It was closed with a gap between the cover and nozzle. Three bolts were visible: 1 was broken and another was released.
Stub sills and couplers	The A end stub sill was bent and partially broken behind the striker plate. The coupler was missing. The B end stub sill was bent to the right and broken. Its coupler was broken.

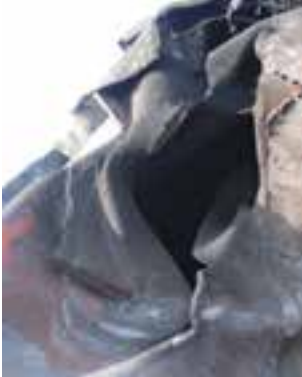
(c) Close-up showing rupture at shell-to-head weld at B end

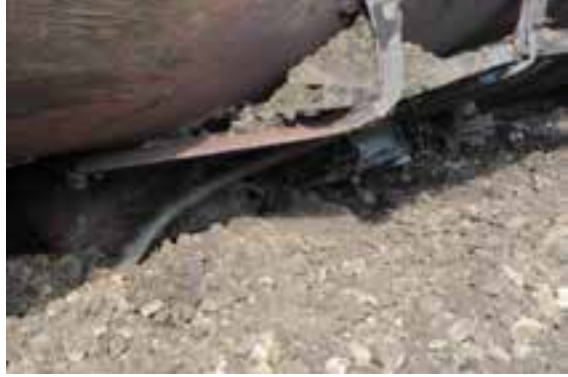
(d) Top fittings, manway and PRD

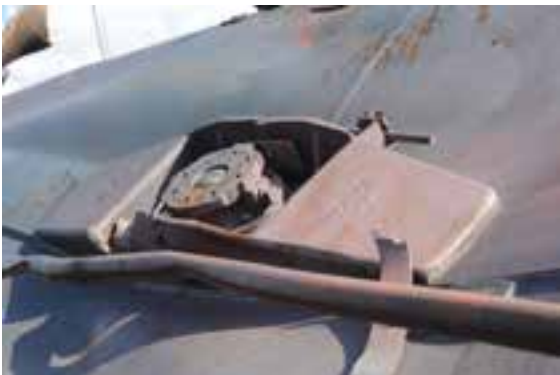
(f) Shell viewed from the A end

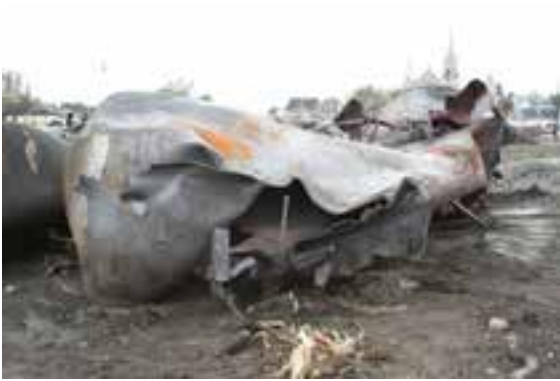
Pressure relief device	The top portion of the PRD was sheared off.
Manway	The manway cover is closed with 3 of the 6 bolts released, 1 bolt was broken above the nut.
Stub sills and couplers	The A end stub sill was impact damaged and slightly bent downward. The coupler was broken. The B end stub sill was broken apart. The front sill pad had separated from the tank at the fillet weld. The BR body bolster had partially separated from its pad and the pad had also partially separated from the tank at the fillet weld. The coupler was missing.

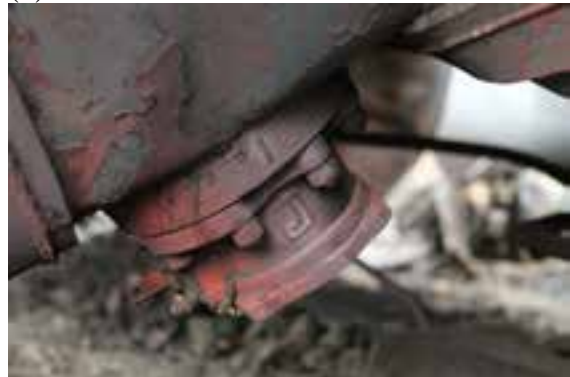
(e) Top fittings and manway

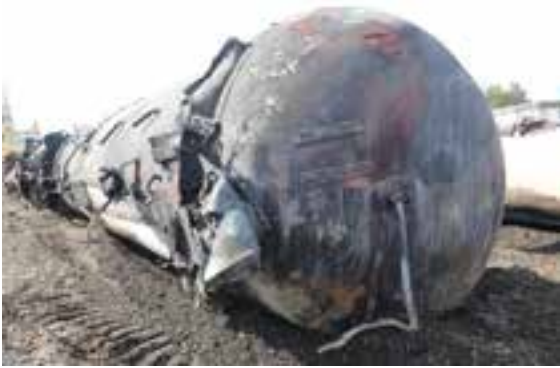
Pressure relief device	The PRD inside the housing was not visible for inspection.
Manway	The manway cover is closed with no visible impact damage.
Stub sills and couplers	The A end stub sill was broken and bent to the right. The B end stub sill was broken and bent downward. Both couplers were missing.

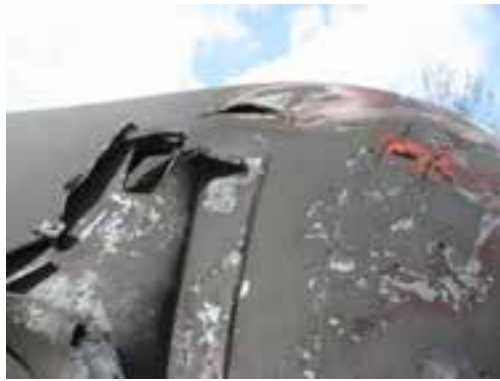
(b) Close-up showing small ruptures at B end

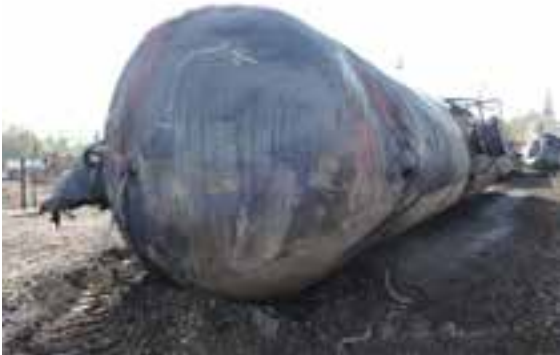
(c) Shell viewed from the B end

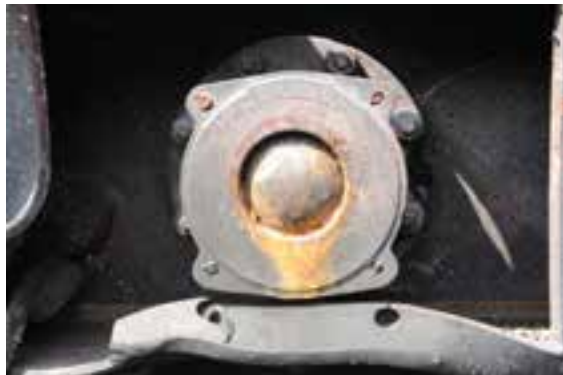
(h) Close-up showing closed BOV ball

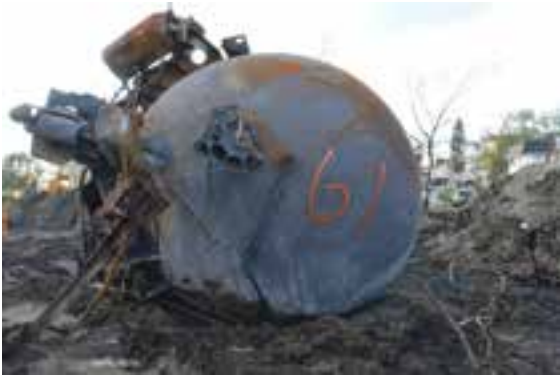
(a) B end head (RSI-AAR Safety Project photo)

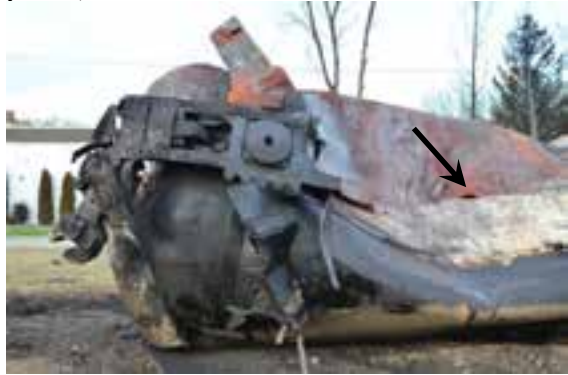
(d) Close-up showing small rupture in the shell bottom (arrow) (RSI-AAR Safety Project photo)
