OPERATIONAL SERVICES BRANCH
ENGINEERING LABORATORY REPORT

LP149/2013

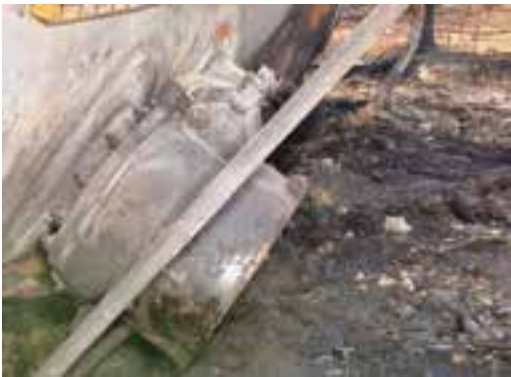
(e) Top fittings (RSI-AAR Safety Project photo)

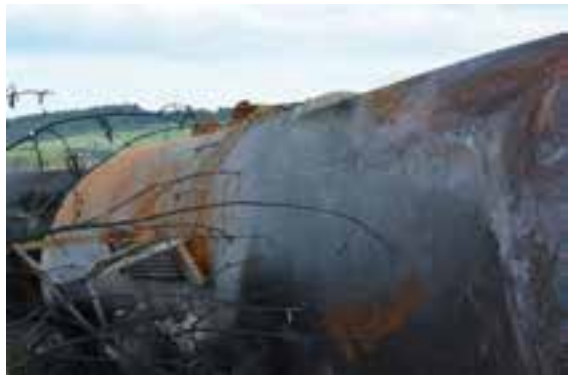
(h) Shell (RSI-AAR Safety Project photo)

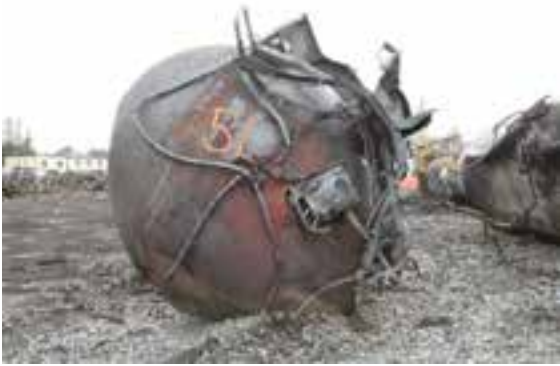
Bottom outlet valve	The cast skid was broken at the side pointing towards the B end. The crack extended to the skid-to-shell weld and into the rupture in the shell. The BOV adaptor had sheared off at the flange, exposing a closed and oxidized BOV ball. The handle was closed and secured.
Top fittings	The housing was missing and the top fittings were sheared off.
Pressure relief device	The PRD nozzle was sheared off at the reinforcement pad.
Manway	The manway cover was closed with all 6 bolts damaged or released.
Stub sills and couplers	The A end stub sill had minor impact damage. The B end stub sill was broken and distorted to the right. The coupler was missing.

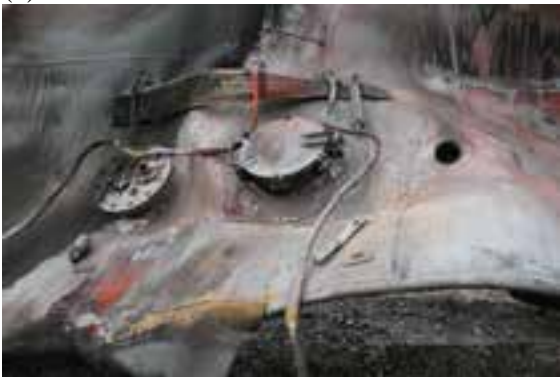
(e) Top fittings, manway and PRD

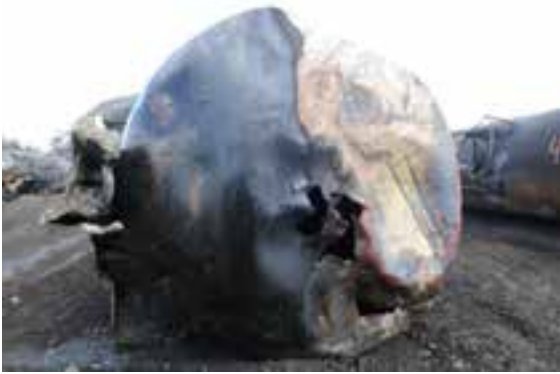
Top fittings	The housing was closed, slight askew and not secured. The top fittings inside had no visible impact damage.
Pressure relief device	The top of the B end PRD was dented. The A end PRD had no visible impact damage.
Manway	The manway cover was closed with 4 of the 8 bolts broken or loose.
Stub sills and couplers	Both stub sills were bent to the left and broken, exposing the draft gear inboard lugs. Both couplers were missing.

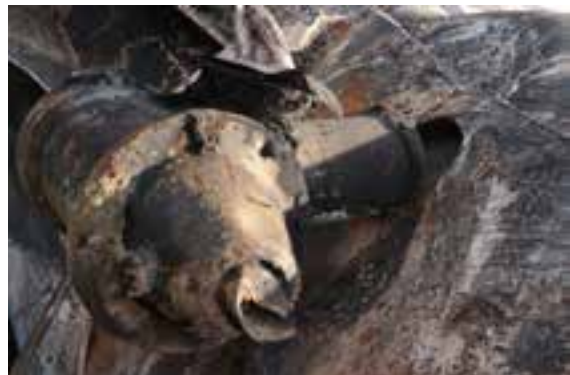
(h) Body-mounted brake cylinder separated from tank

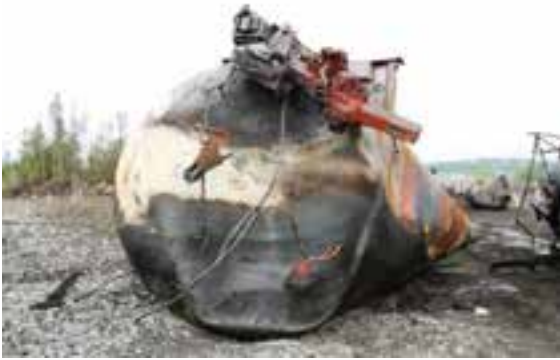
Pressure relief device	The PRD was not visible for inspection.
Manway	The manway was not visible for inspection.
Stub sills and couplers	The A end stub sill was broken and the coupler was missing. The B end stub sill was bent to the left and partially separated at the draft gear. The coupler was still connected to the separated A end coupler from car ACFX 79383 (consist 58).

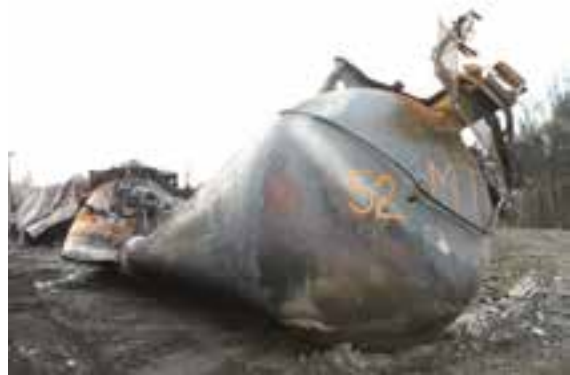
(d) A end head and shell

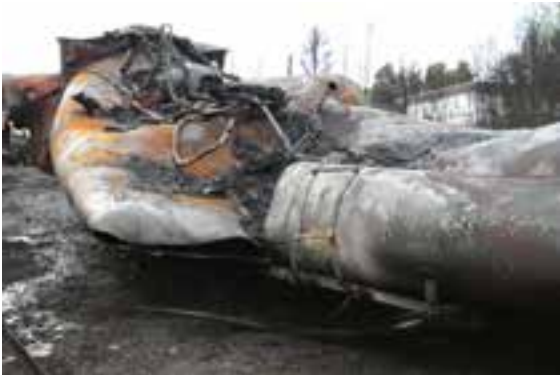
(e) Ruptures in middle of the shell's left side

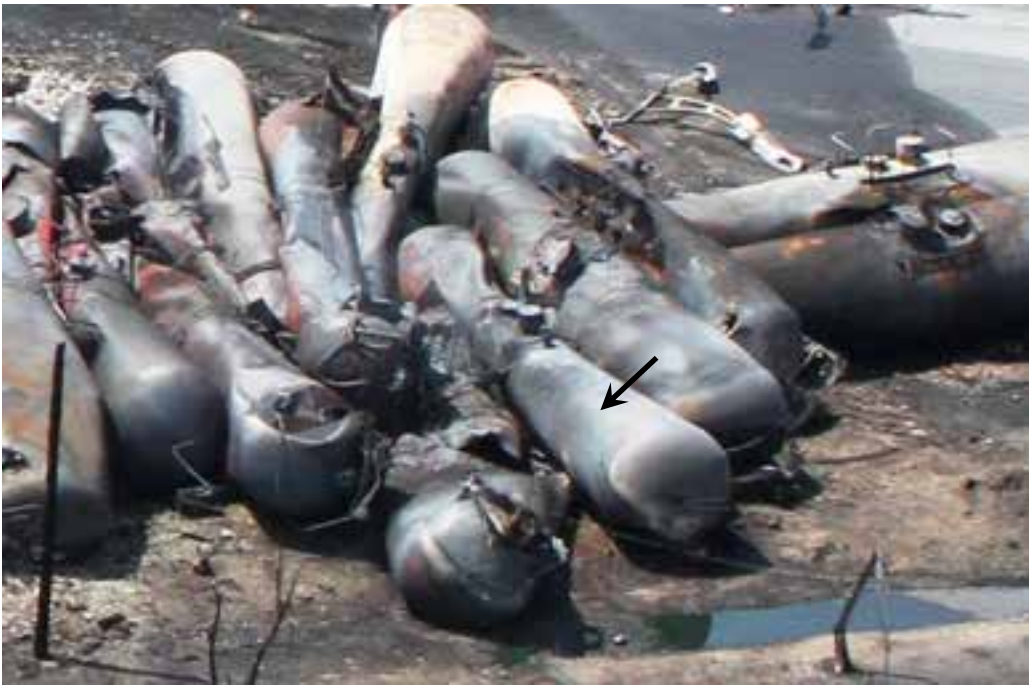
(a) Aerial view showing car PROX 44150 (arrow) in- upright, squeezed between cars PROX 44428 and TILX 316533 (consist no. 59 and 61)

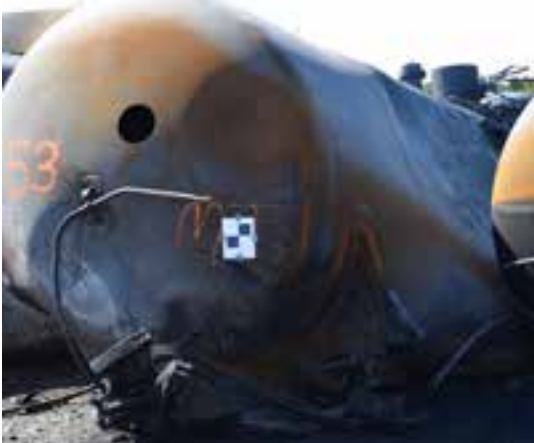
(d) Right side of shell viewed from the B end (RSI-AAR Safety Project photo)

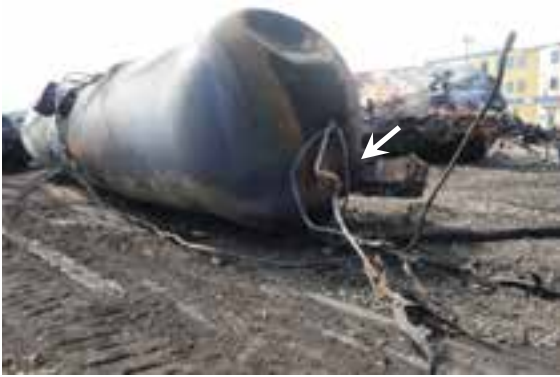
(a) Shell top viewed from the B end

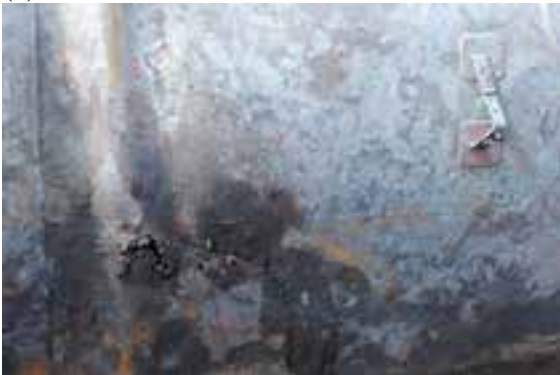
(e) Burn-through on left side of shell – see arrow in (d)

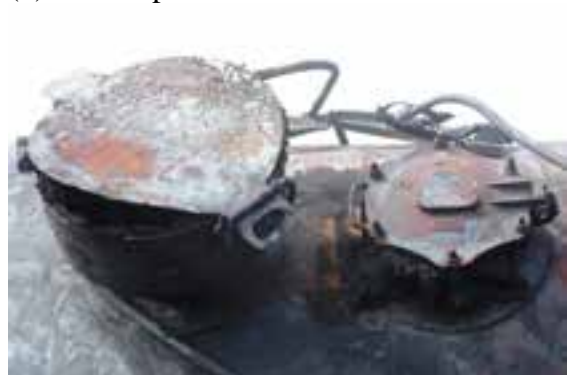
(f) Top fittings and manway

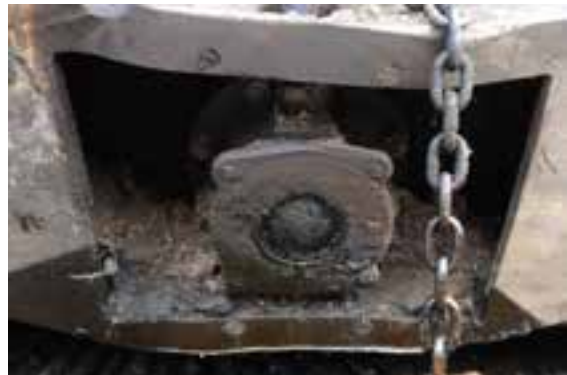
(h) Close up showing product leaking from BOV

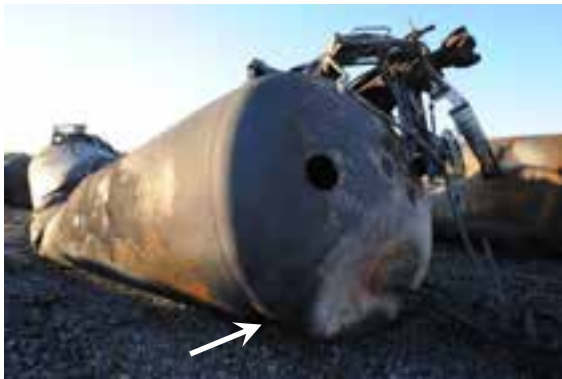
(a) Shell viewed from the B end

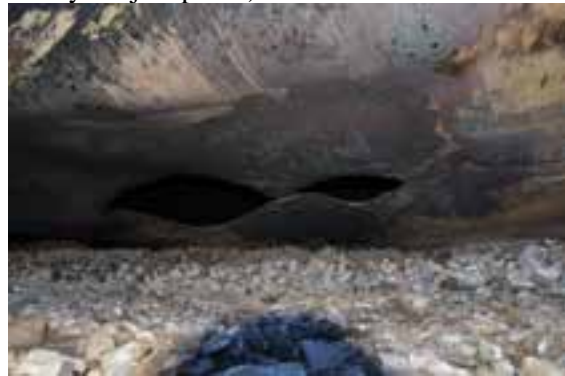
(d) Close-up showing rupture in shell top – see arrow on (c) (RSI-AAR Safety Project photo)

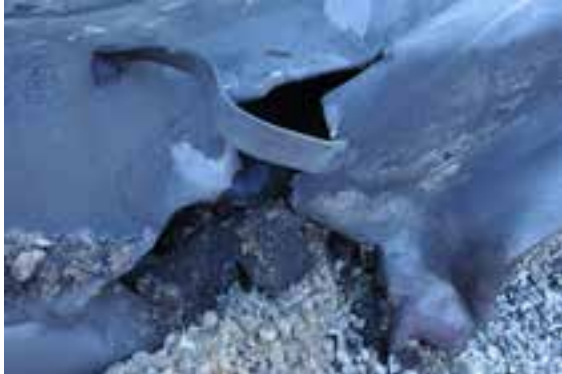
(e) Rupture in middle of right side – see area circled in (c)

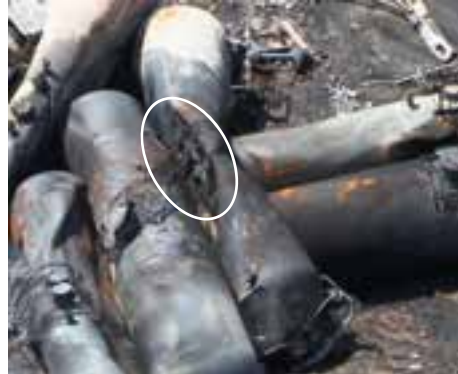
(f) PRDs, top fittings and manway (circled)

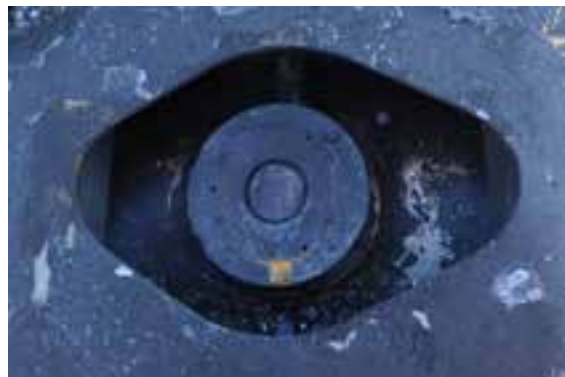
(h) Close up showing BOV ball

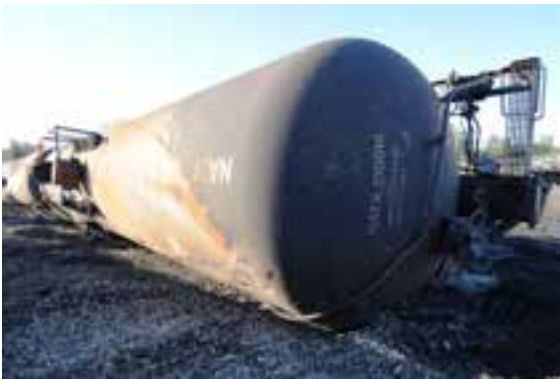
(a) Shell viewed from B end

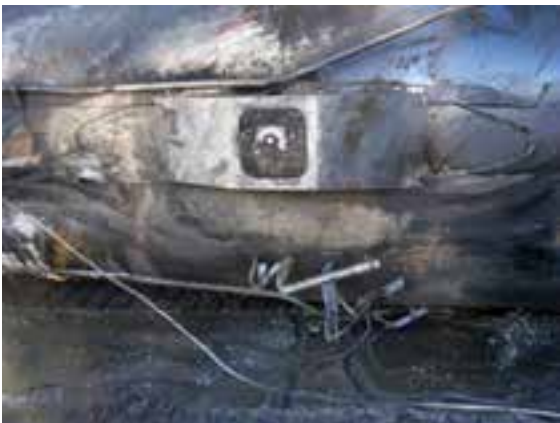
(f) PRD, manway and top fittings

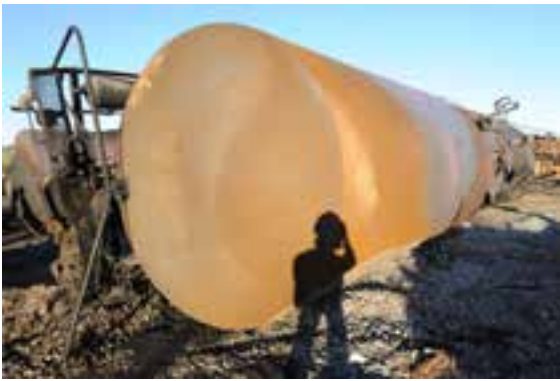
(a) Shell top viewed from the B end

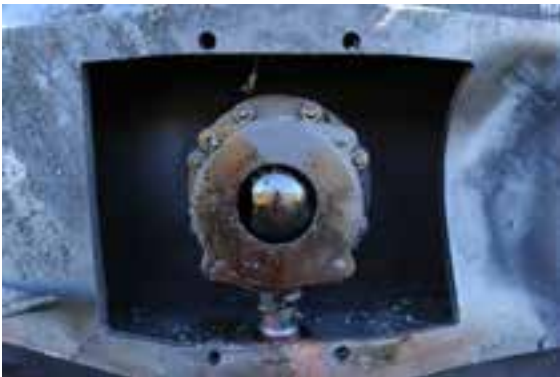
(g) Close-up showing partially open BOV ball

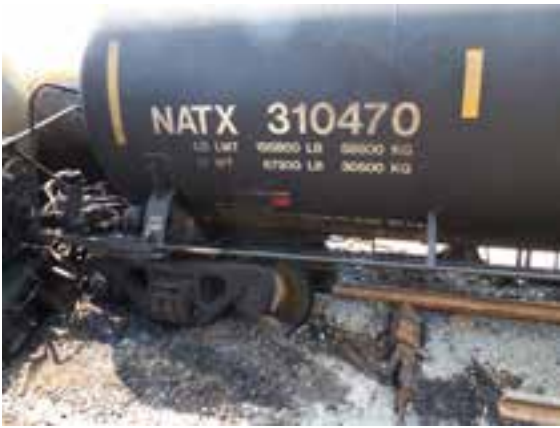
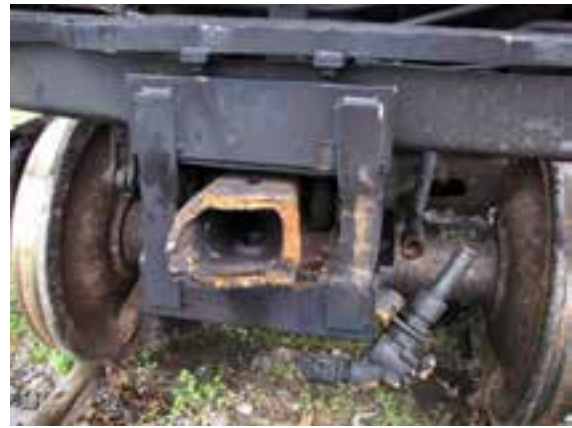
(a) In-situ photo showing the B end viewed from the right side (b) B end stub sill

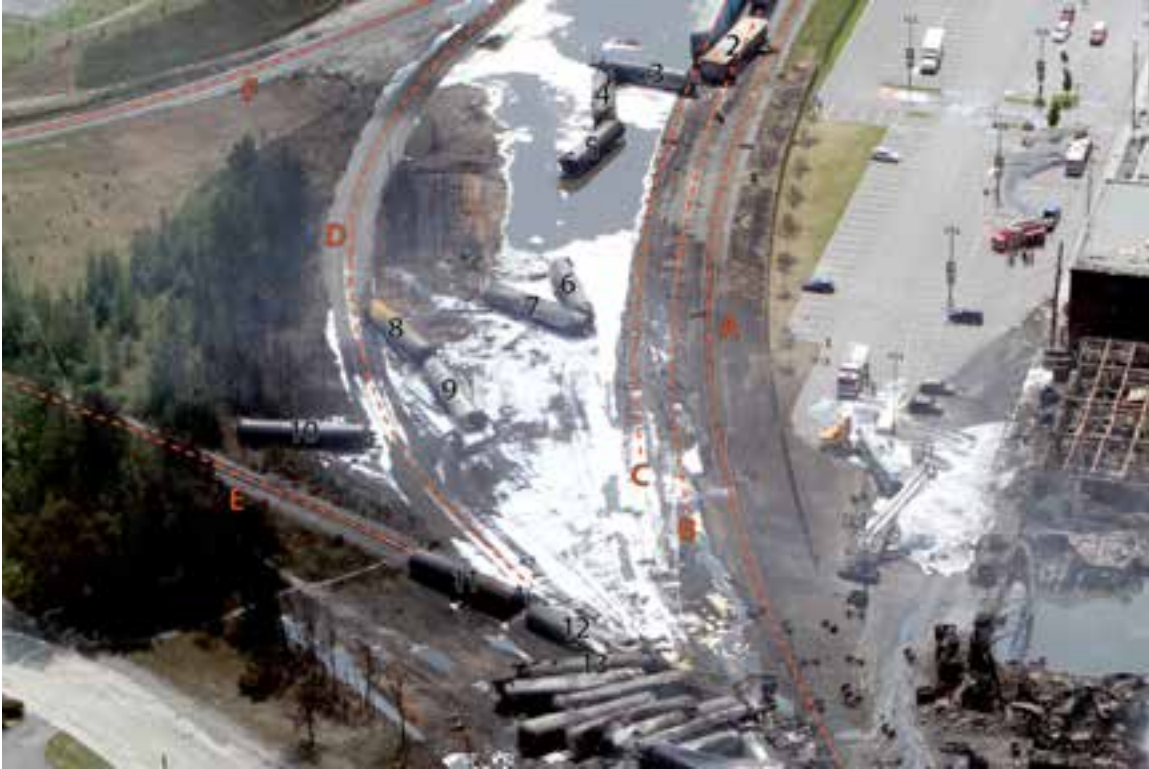
Figure B-1: Aerial view of derailment zone showing the position of derailed cars from consist no.2 (box car) through consist no.13 (tank car NATX 310457)

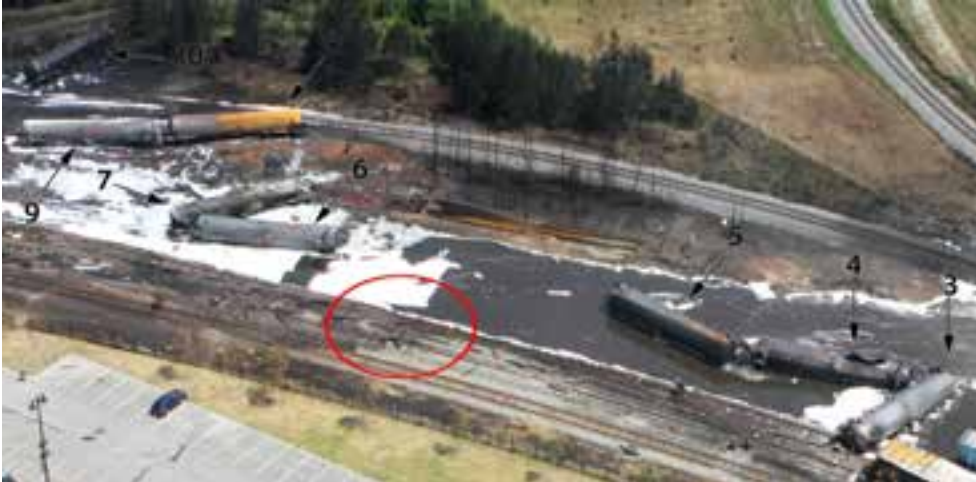
(a) Aerial view looking north showing consist no.3 through 10. The broken portions of yard tracks 1 and 2 are circled.

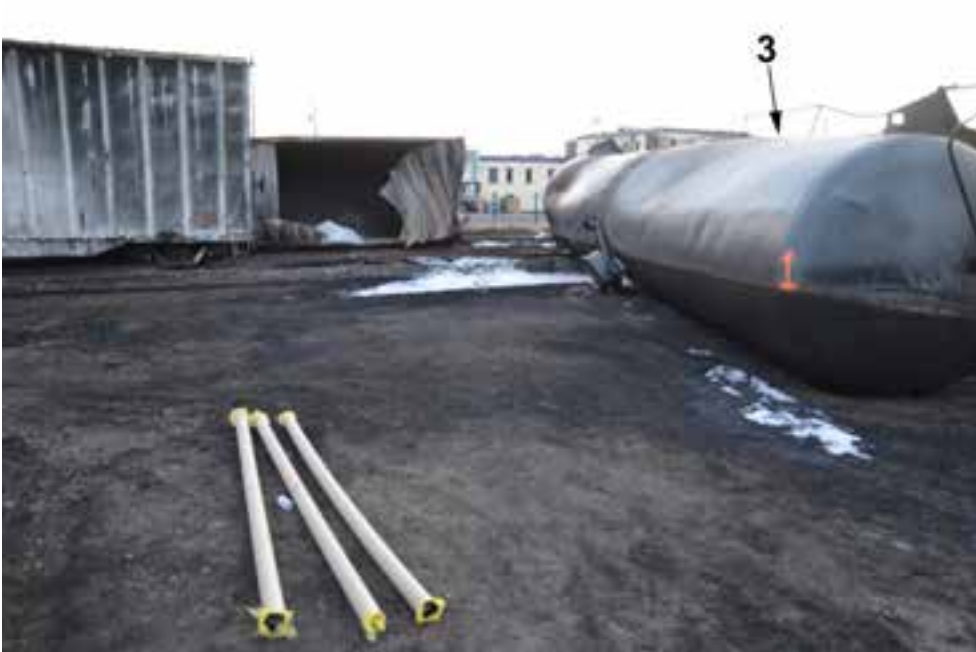
(b) In-situ photo showing location of consist no.3 near a box car parked on yard track 2 (RSI-AAR Safety Project photo)

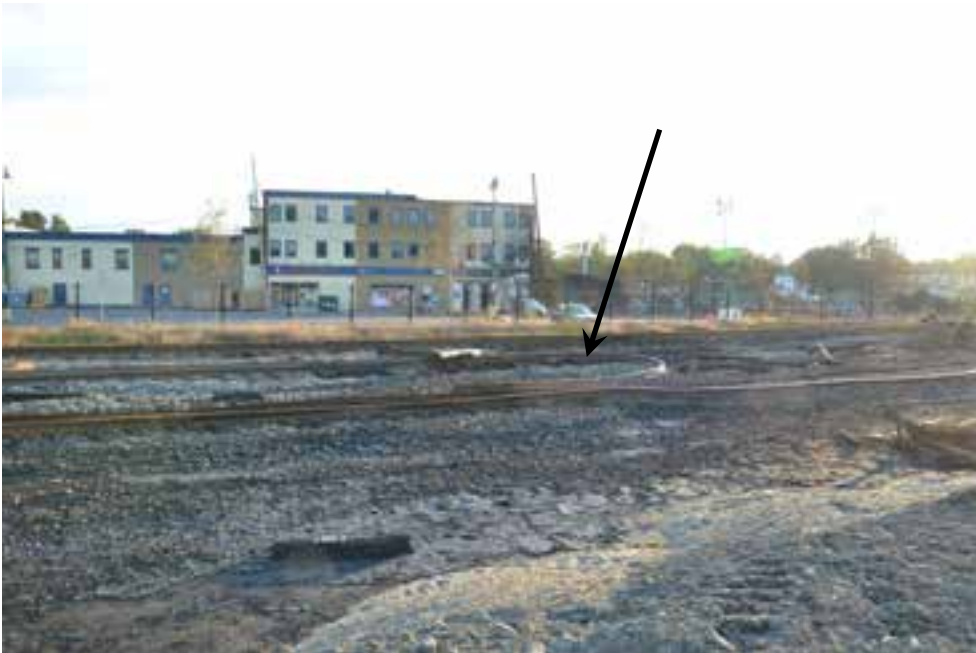
(d) In-situ photo showing a close-up of the area circled in Figure B-3a. The arrow points to a broken rail bent back 180 degrees (RSI-AAR Safety Project photo).

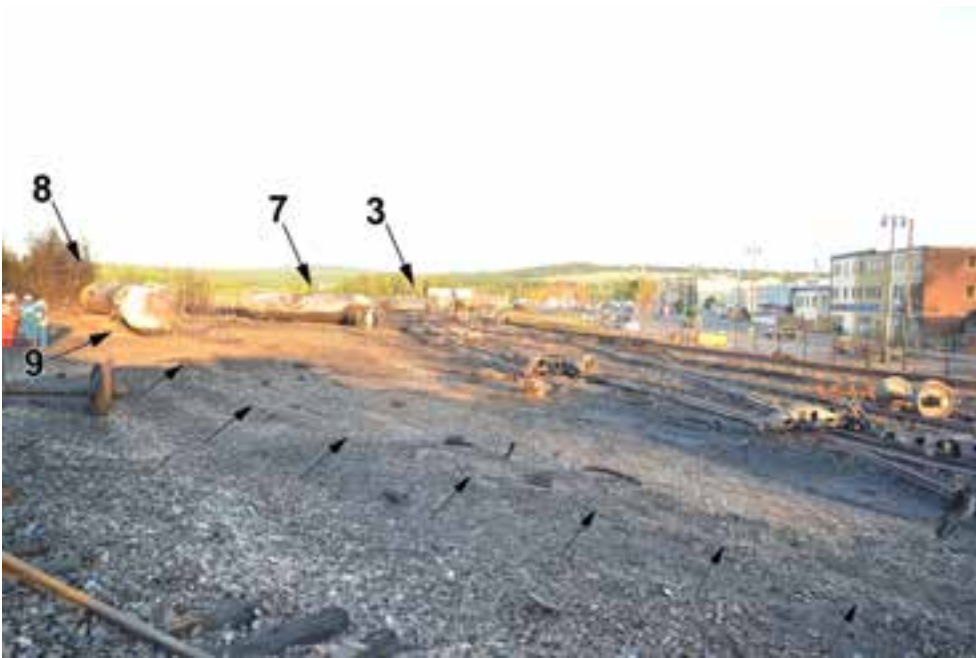
(e) In-situ photo showing a ground mark and debris originating from consist no.8 and 9 (RSI-AAR Safety Project photo)
