OPERATIONAL SERVICES BRANCH ENGINEERING LABORATORY PROJECT SUMMARY	Occurrence Number R13D0054	Occurrence Classification 2	Date of Occurrence 06-Jul-2013
	Project Title: Tear Down of Hand Brakes		
Project Number: LP007/2014	Vehicle Type: Montreal, Maine & Atlantic Railway, Train MMA-002		
Prepared By: M.S. Wallis, P.Eng. (Senior Engineering Specialist – Mechanical)			
Approved By: S. Dionne, Ph.D. (Manager, Material Analysis and Structures)		Released On: 27 MAR 2014	
Released By: L. Donati, Ph.D. (Director of Operational Services)		Revision:

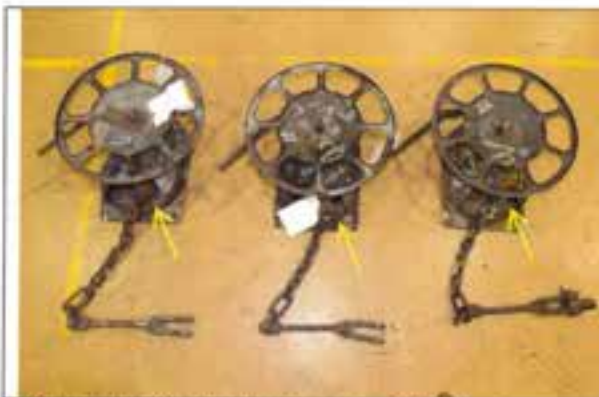
following the occurrence. The three handbrakes were in the released position with the upper chain attachment point clearly visible. White paint residue was visible at the upper chain attachment point on all the handbrakes although mostly removed due to fire damage on number one (Figure 2). The back plate of handbrake number 1 showed deformation (Figure 3) whereas the other two did not. The handwheel and release handle were removed from each handbrake. The nut used to secure the release handle had been welded to its shaft in each case and had to be cut before removal. The heads of the solid rivets used to join the front housing to the back plate were cut using an abrasive disc and the housing was lifted off (Figure 4).

Fig 1. Three handbrakes as received, front view
Note position of upper chain attachment point
(arrows)

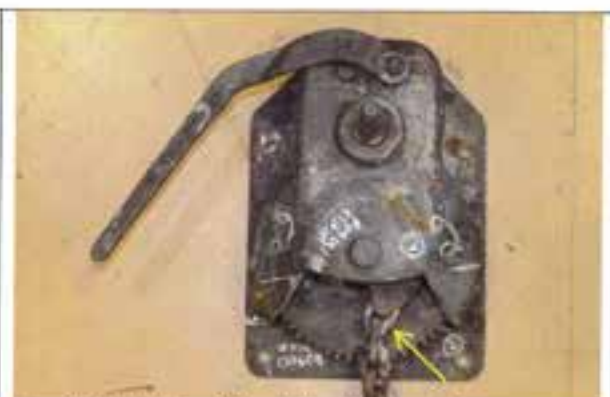
Fig. 2. Handbrake 2 handwheel removed
Note white paint residue on chain (arrow)

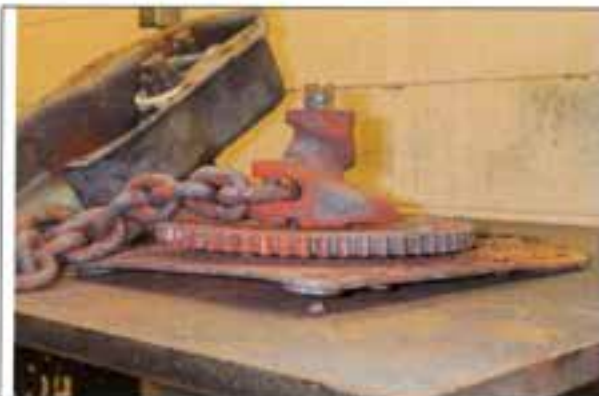
Fig 3. Handbrake 1 showing back plate deformation

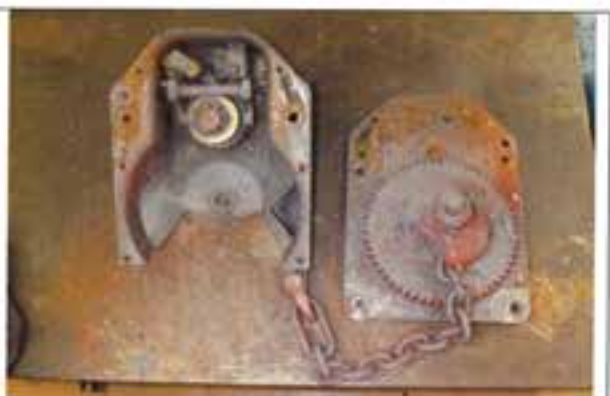
Fig 4. Handbrake 1 showing housing removed

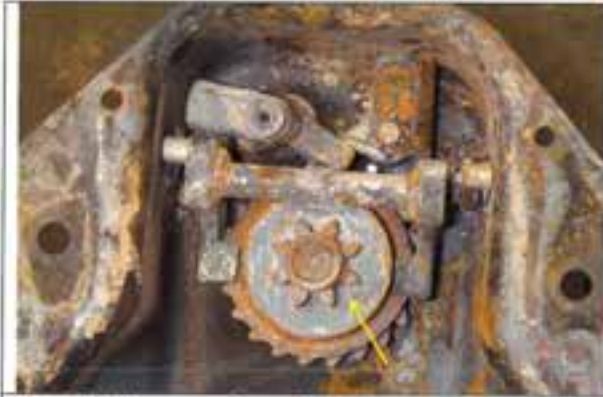
The pitch of the smaller (pinion) gear and the larger (ring) gear of each handbrake was visually examined. There was no sign of gear damage on any of the handbrakes that would indicate that they had been in the applied position at the time of the occurrence (Figures 5 and 6).

Fig 5. Pinion gear of handbrake 3
Note uniform gear tooth pitch (arrow)

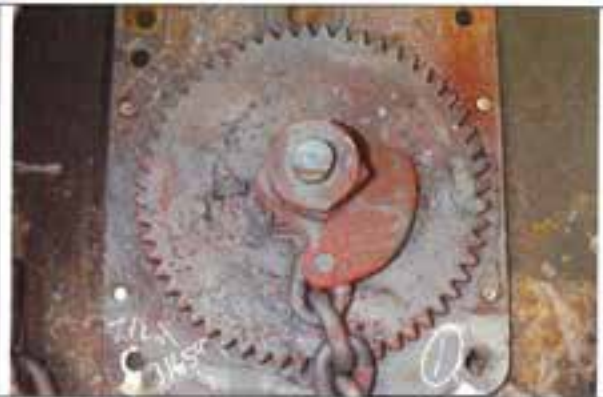
Fig 6. Ring gear of handbrake 1
Note uniform gear tooth pitch
