AVIATION INVESTIGATION REPORT

A00C0060

LOSS OF CONTROL – COLLISION WITH TERRAIN

CESSNA 180J C-GRPR

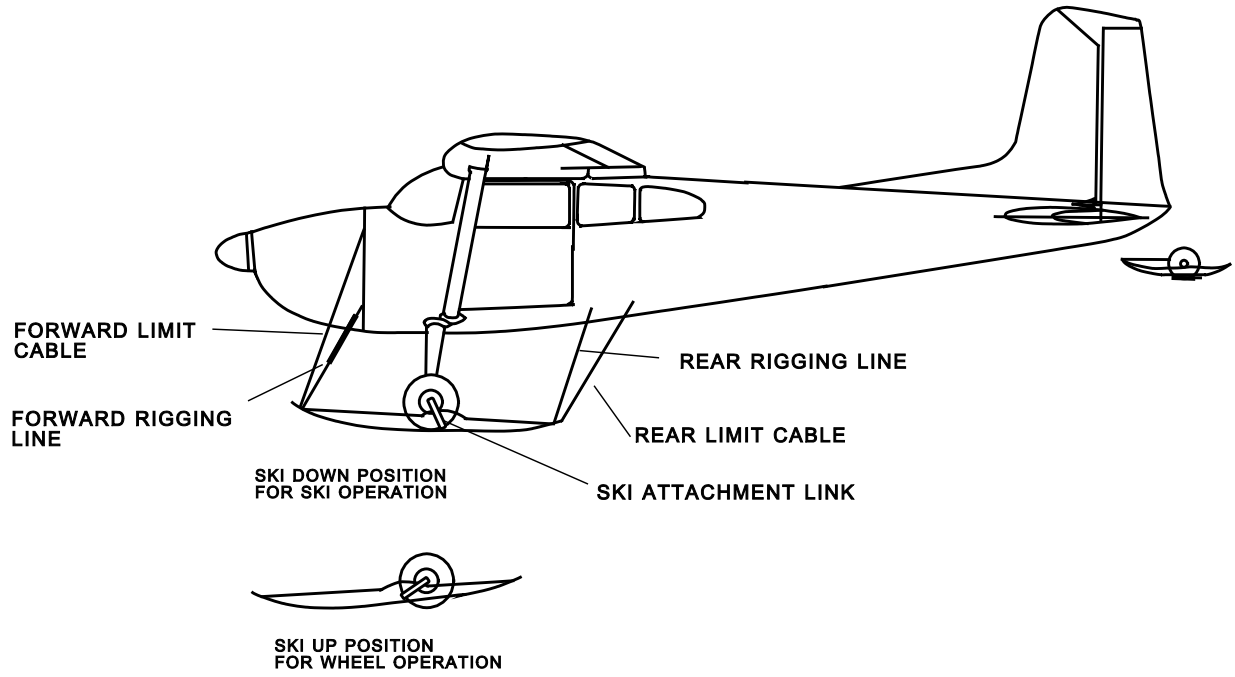
Appendix A - Aircraft Diagram

The aircraft's landing gear configuration was converted from floats to skis on 01 December 1999, and the aircraft had operated for 67 hours since that time (see Appendix A). The Federal Fluidyne C3200 wheel-skis
