AVIATION INVESTIGATION REPORT

A00H0005

RUNWAY EXCURSION

BOEING 727-200 C-GXFA

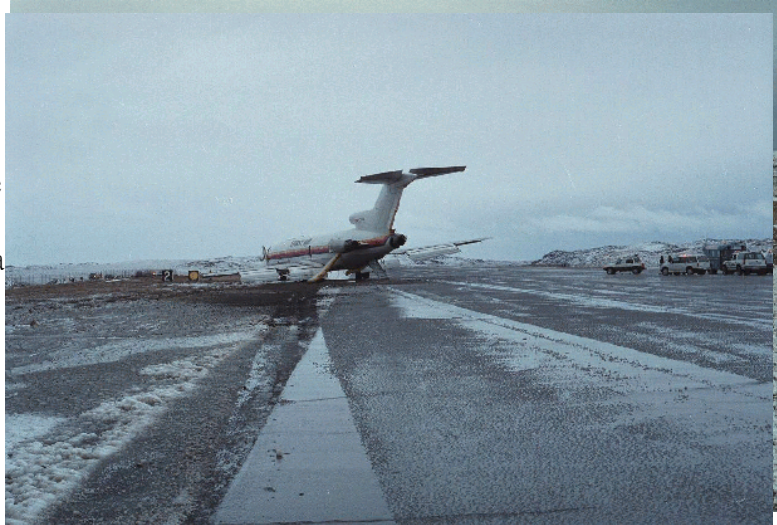
Shortly after touching down near the centreline of the runway, the aircraft began to drift to the left. Both main landing gears slid completely off the runway. The nose wheel to the right of the main gear remained on the runway. Because of the drift angle, the cockpit area was over the runway surface, and the cockpit crew were not aware that the aircraft had left the runway surface. The aircraft returned completely to the runway surface but then began to drift left again as reverse thrust was applied. At this point, the crew had concerns that limited

runway remained, and the decision was made to use the thrust reversers even though it was known that the aircraft could drift to the left again. The left wheel exited the runway, but the right main gear and the nose gear remained on the runway until just before the aircraft slowed to a stop. At the last moment, with the left main gear in the unprepared area to the left of the runway, the aircraft pivoted nose-left and came to rest 7000 feet from the threshold of Runway 35. At 1200, the captain called for the emergency evacuation drill. The first officer made the evacuation announcement, but, because of the manner in which he set up the passenger address (PA) system, the announcement was not heard in the cabin. Subsequently, all passengers and crew evacuated the aircraft without injury.

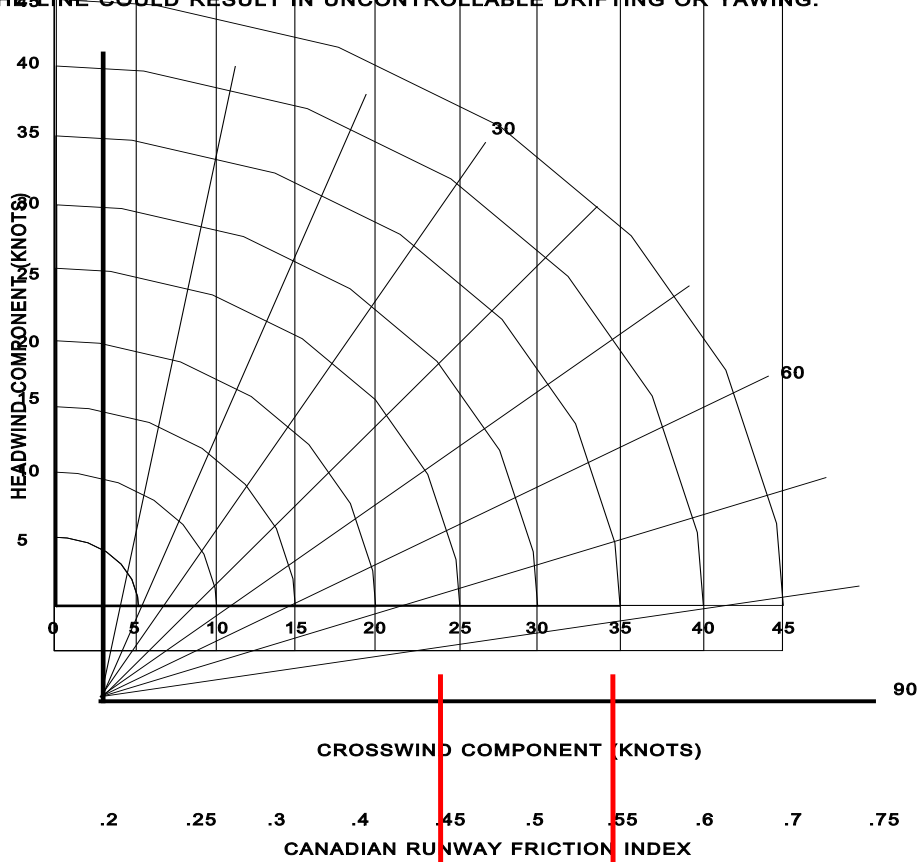
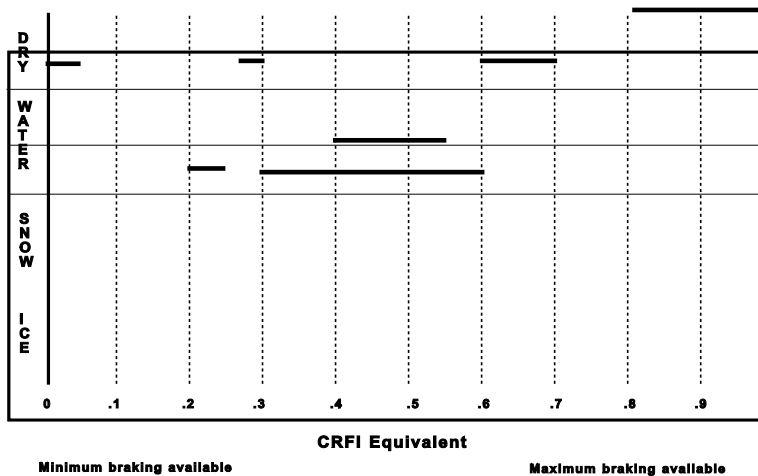
Appendix A—Canadian Runway Friction Index (CRFI)

THIS CHART PROVIDES INFORMATION FOR CALCULATING HEADWIND AND CROSSWIND COMPONENTS. THE VERTICAL LINES OF THE CROSSWIND COMPONENT ALSO INDICATE THE MINIMUM RECOMMENDED CRFI FOR THE REPORTED CROSSWIND COMPONENT. A REPORTED CRFI TO THE LEFT OF THIS LINE COULD RESULT IN UNCONTROLLABLE DRIFTING OR YAWING.

HEADING FOR RUNWAY 35 IS 316 DEGREES TRUE
 ACTUAL WIND 050 AT 20 KNOTS GUSTING TO 31 KNOTS
