AVIATION INVESTIGATION REPORT

DIFFICULTY TO CONTROL

ONTARIO FUN FLYERS INC.

CESSNA 150G C-FVDR

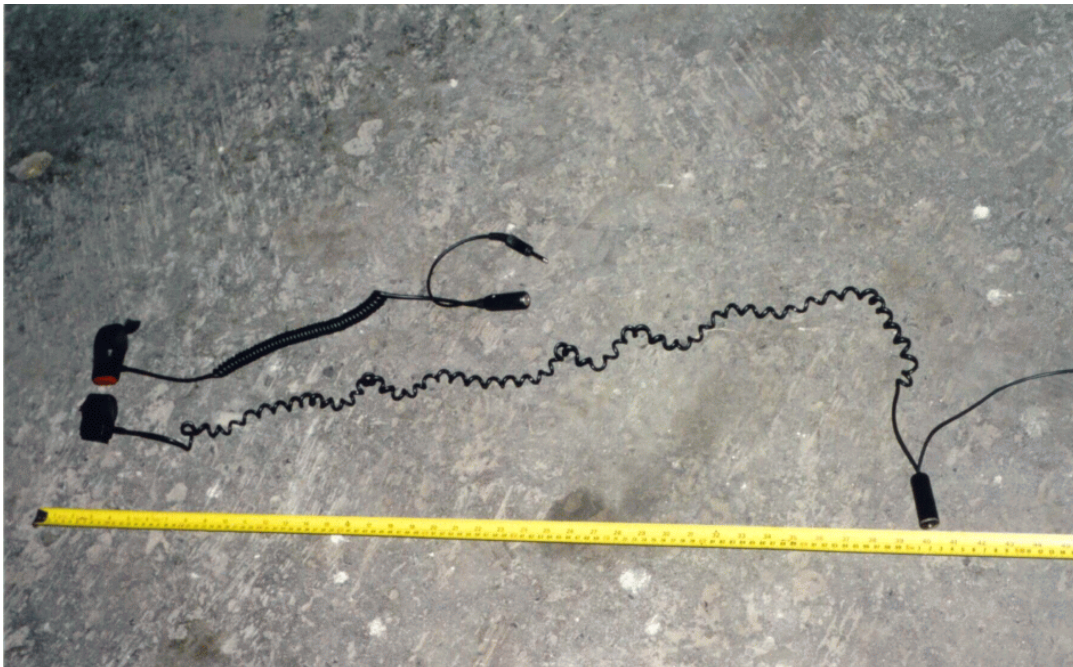
An examination of the flight control system did not reveal any anomalies that could have restricted or jammed the elevator controls. During the examination of the aircraft, it was noted that the cabin air control knob

(ancillary control), which is located on the right side of the instrument panel, was pulled fully out. The aircraft had been modified to facilitate the use of headsets and boom microphones. This included the installation of a radio panel in the centre of the dash, with receptacles for the push-to-talk connections. A push-to-talk button was attached to each control column by a velcro strap. A spring-coiled electrical cord led from the push-to-talk button to the receptacle on the radio panel. The spring-coiled cord on the left side was new and approximately two feet long when contracted. The cord on the right side, which was old and had lost most of its recoil, was approximately four feet long when relaxed. It was common practice for the instructor in the right seat to take up the slack in the electrical cord by wrapping it around the right control column eight or ten times.

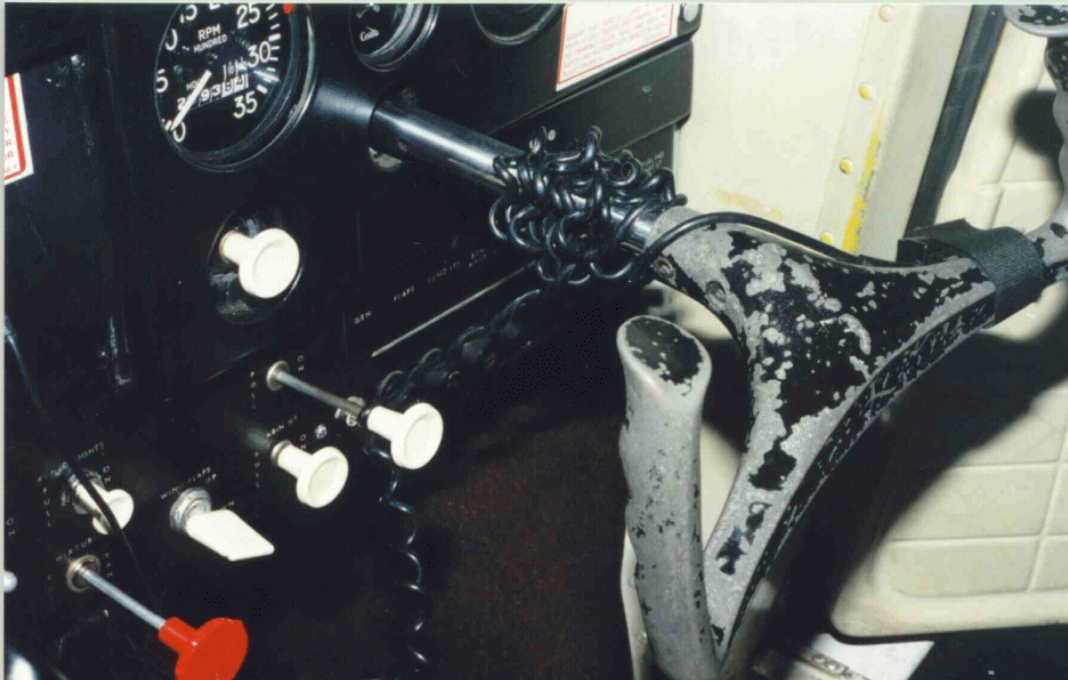
When the aircraft landed, the elevator control system was functioning normally. There was no binding or indication of any previous binding in the elevator system, nor was there an indication of any damage to any part of the elevator system. The cause of the restriction in the elevator control system had to be something subtle and transitory. The investigation revealed that if the push-to-talk cord was wrapped loosely around the control column, a single loop could snag on the cabin air control knob, and the electrical cord would then restrict the aft movement of the control column. This likely happened as the student was attempting to recover from the stall. The action of pushing the control column forward likely allowed a loosely wrapped electrical cord hanging from the right control column to swing forward and snag the cabin air control knob. The fact that the aircraft was in a nose-down attitude would also tend to allow the loop to swing forward. When the control column was pulled back, the cord would remain snagged and tighten on the knob. This was most likely the condition the aircraft was in when the instructor took control from the student. During the landing approach, when the control column was moved forward to compensate for the flap selection, the tension on the cord would have relaxed, allowing the cord to swing free of the air control knob, freeing the control column through its full travel.

1. The push-to-talk cord on the right side of the aircraft was stretched to twice its normal length and wrapped loosely around the control column. The cord could therefore become entangled on the aircraft ancillary controls.
2. It is likely that the push-to-talk cord became snagged on the cabin air control knob, restricting the movement of the elevator control.
