AVIATION INVESTIGATION REPORT

A01H0004

LANDED BESIDE RUNWAY

AIR CANADA REGIONAL AIRLINES

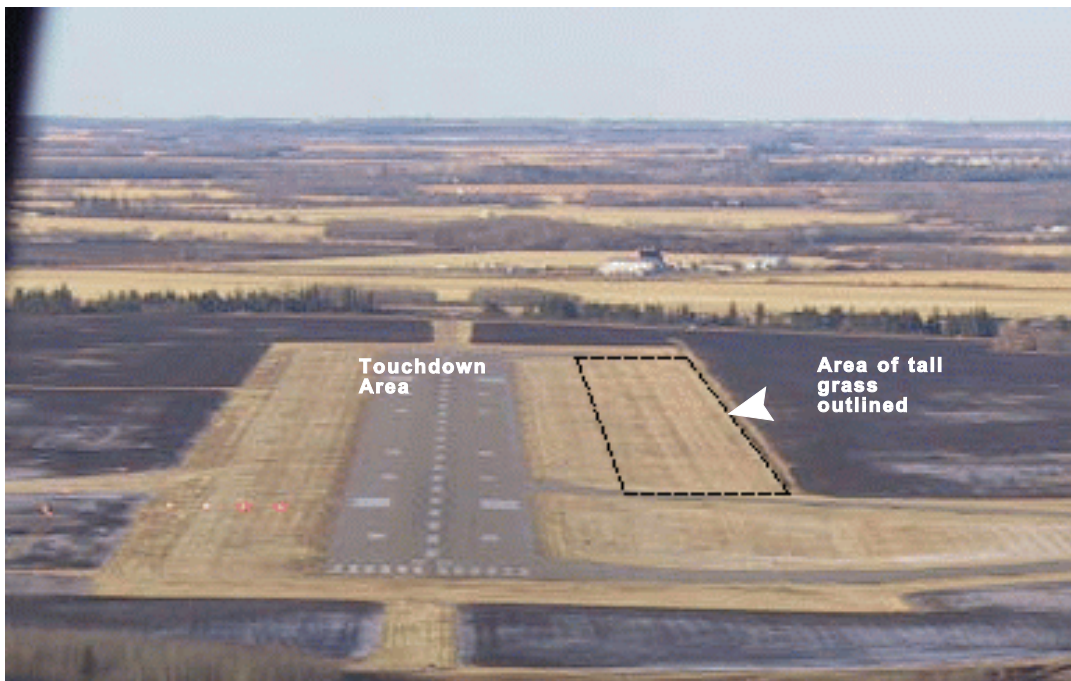
Comments concerning the runway environment were obtained from pilots who had landed on Runway 22 before and after CDR8321. The first officer of a flight that landed at 0747 that morning recalled only that the runway had some snow on it. The first officer of a flight that landed at 1032, after the 20-foot wide swath had been cleared down the centre of the runway, commented that the cleared area made the runway look very obvious, and that without it, it would not be hard to mistake the grass area for the runway.

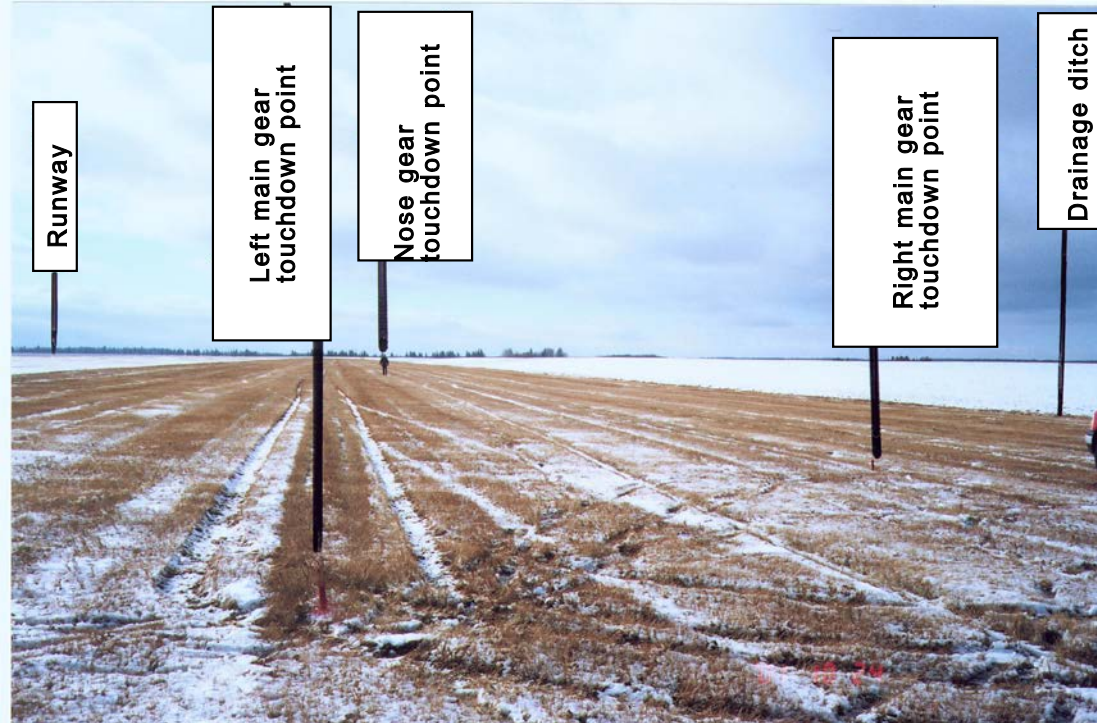
The day before the occurrence, the grass around the perimeter of Runway 04/22 was being cut when it started to snow, and the airport maintenance worker did not finish. The grass around the runway perimeter had been cut except for a strip about 150 feet wide and about 4000 feet long beside and parallel to the runway. Runway 04/22 is asphalt surfaced and is 150 feet wide and 5000 feet long. The grass that had been cut was about five centimetres long and the uncut grass was about 15 centimetres long. At the time of the occurrence, snow had accumulated to a depth of about three centimetres. The short grass was covered with snow but the long grass protruded through the snow. The protruding grass was light brown in colour. The uncut grassy strip contained some tracks from ground vehicles. A wind sock was near the middle of the far end of the grassy strip and the PAPI lights for Runway 04 were just beside the far end.
