AVIATION INVESTIGATION REPORT
A02A0065

SEAT FAILURE AND LOSS OF CONTROL

BLUENOSE SOARING CLUB
SCHEMPP-HIRTH KG CIRRUS (GLIDER) C-GUIL
STANLEY AIRPORT, NOVA SCOTIA
21 MAY 2002

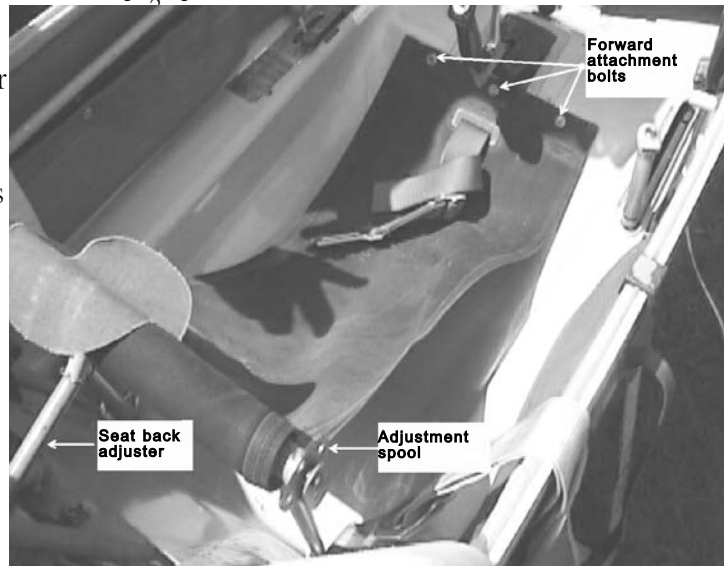
The seat is a slung cloth hammock (See Figure 1 - Seat Assembly). The front attachment, under the pilot's legs, is secured to the floor by three bolts, and is not adjustable. The aft attachment, behind the pilot's shoulders, is a spool attached to a movable seat frame. The spool allows the pilot to vary the number of material wraps, and provides height adjustment. The seat back frame adjusts fore and aft to move the pilot's body fore or aft. Adjustment is accomplished by selecting the appropriate hole in the spring loaded lever and aligning it with a stationary pin attached to the airframe structure. In the most forward position, the pilot is in a semi-reclined seating position; the further rearward the selection, the more reclined the upper torso of the occupant. Examination of the glider seat assembly did not establish the exact position of seat adjustment at impact. After the accident, the right and centre attachment bolts were found to have pulled out of their anchor nuts, the bolts remaining within the seat fabric and aluminum attachment strip. The left bolt was still in its anchor nut, but was only finger tight.

The seat assembly and the airframe anchor nuts were removed and sent to the TSB Engineering Branch for examination to determine the thread condition of the bolts and anchor nuts. There was no indication of excessive wear, deformation, or other damage to the threads of the bolts. The threads on the right and the centre anchor nuts indicated that they had been previously cross-threaded, resulting in significant damage. The first four threads of the right anchor nut had a shinier surface appearance than the remainder of the threads in that anchor nut. It was not possible to quantify the extent to which this thread damage reduced the clamping strength of the anchor nuts. It could not be determined, through engineering analysis of the seat and attachment hardware, whether the bolts pulled out prior to ground impact or as a result of ground impact loads.

During the accident launch, acceleration forces would have effectively pressed the pilot rearward, transferring high load forces to the seat and its attachment hardware. Two of the three forward seat attachment bolts were found detached. The shiny appearance of the threads on the right anchor nut was likely due to the bolt tearing out, which would suggest that the bolt in the right anchor nut was only engaged by a maximum of four threads. Ordinarily, this amount of thread engagement would be sufficient to provide the maximum strength of the bolt and anchor nut assembly. However, in this occurrence, the threads had been previously damaged by cross-threading, and the assembly may not have been able to develop the full clamping force. It could not be determined why the bolts were not completely fastened.

1. The combined effect of the cross-threading damage, the probability that the centre and right bolts were not fully engaged, and the acceleration forces of the launch resulted in the bolts pulling free from the anchor nuts, resulting in seat failure.
2. The pilot lost control of the glider when the seat failed.
