AVIATION INVESTIGATION REPORT
A0200105

LOSS OF CONTROL AND COLLISION WITH TERRAIN

SILVERLINE HELICOPTERS INC.
SCHWEIZER 269C (300C) C-GGUV
SU34 HARE FIELD, ONTARIO
18 APRIL 2002

Report Number A0200105

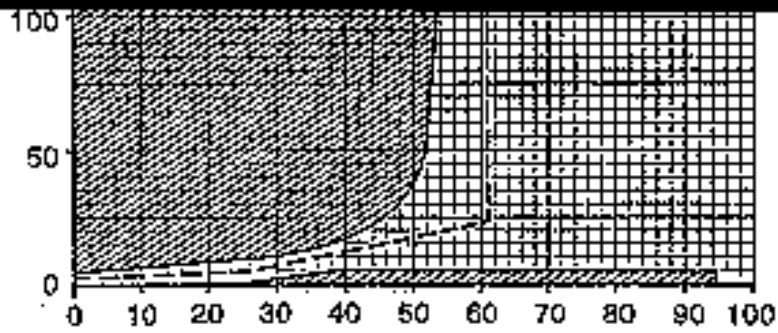
Appendix A – Schweizer 269C Height-Velocity Diagram

The aircraft flight manual⁹ emergency procedures for autorotation call for a glide speed of 52 KIAS until initiating the flare at 50 feet agl. The normal procedures for practice autorotation contain a warning to avoid airspeed and altitude combinations that are inside the height-velocity curve **during power recovery**. The height-velocity chart (Appendix A) states that operation is to be avoided in the shaded area, which is below 55 KIAS at 150 feet agl, and 50 KIAS at 200 feet agl, decreasing linearly to zero airspeed at 450 feet.

4. The instructor allowed the helicopter’s speed and height to reach a state from which, according to the height-velocity chart, a safe autorotative landing was unlikely.
