AVIATION INVESTIGATION REPORT

A02O0406

ROLL OSCILLATIONS ON LANDING

AIRBUS 321-211, C-GJVX AND C-GIUF

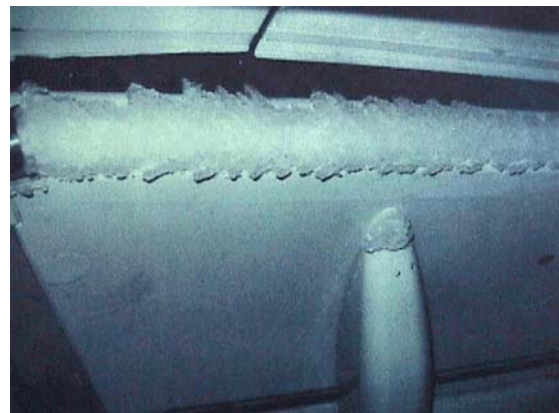
In December 1998, two similar events occurred involving a foreign carrier's A321 aircraft landing in CONFIG FULL in icing conditions. The roll oscillations were attributed to ice accretion, particularly on the flap leading edges, affecting the slot between the main flaps and wing box. Because the main flaps are similar on the A320 and A321, and no events of this nature were ever reported on the A320, the icing conditions were considered to have caused the events and no changes to the

Photo 1. Ice accretion on main flaps leading edges from a December 1998 A321 event
