AVIATION INVESTIGATION REPORT

A02P0179

ENGINE POWER LOSS – COMPONENT FAILURE

EUROCOPTER SA 315B LAMA HELICOPTER C-GGHG

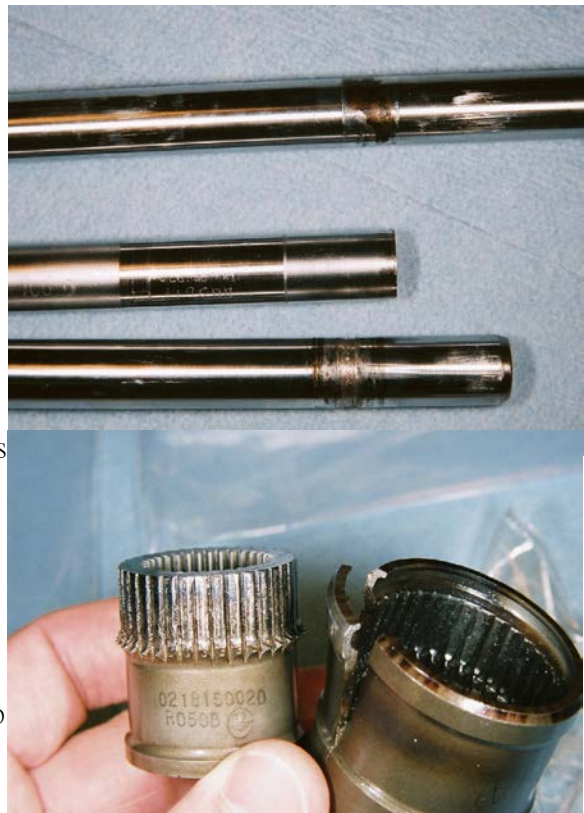
Examination of the engine components revealed that the fuel injection tube had fractured into three sections (see Photo 1). Both fractures occurred at a change in cross-section created by a brazed-on sleeve. Most of the fracture surfaces were obliterated by component rubbing after separation. The fuel tube was scored radially at various points along its length.

The splines on the axial compressor forward coupling sleeve (part number 0218997020) and the stub shaft³ (part number 0218150020) were found stripped and no longer capable of providing drive connection between the axial compressor rotor shaft and the reduction gearbox (see Photo 2).

The splined drive in the forward coupling sleeve of the axial compressor failed progressively because of premature wear. The deterioration of the splined drive caused radial motion to be introduced to these parts, leading to distortion of the fuel injection tube. When the wear became significant enough, the wobble of the shaft was amplified, causing the fast-growing disruption of the fuel tube. The fatigue observed during the metallurgical analysis and the bangs heard by the passengers are indications that the fuel tube broke sometime before the engine flamed out.

The premature wear of the forward coupling sleeve can be attributed to various factors. Because of their symmetrical aspect, the contact marks on the sleeve and the stub shaft can be attributed to inappropriate axial trueness of the assembly, leading to a flexion or wobble during rotation of the shaft (i.e. the shaft was not lined up with the axis of the sleeve), and ultimately to the premature wear of the splines. Because of this improper positioning, the sleeve was undertaking a cyclic relative motion around the shaft, which inflicted some constraints on the washer, and ultimately the washer failed. When the washer failed, it deposited filings in the oil groove; this would have interfered with the lubrication of the splines and contributed to the deterioration and premature wear of the axial compressor forward coupling sleeve assembly. Furthermore, some of its parts then possibly wedged themselves between the splines of the stub shaft and the forward coupling, thus eventually forcing the coupling to split. This splitting was eased by the improper material hardness at manufacture. Moreover, the anti-seize compound contaminant found in the engine was likely applied during overhaul onto the fuel injection tube outer support bushings, to facilitate assembly of the engine. The compound was likely displaced during assembly and was found mixed with metallic residue that filled the sleeve coupling lubrication grooves. This contamination altered the lubrication of the splined drive
