AVIATION INVESTIGATION REPORT

A03A0022

LOSS OF CONTROL AND COLLISION WITH TERRAIN

CESSNA 210N, N104WF

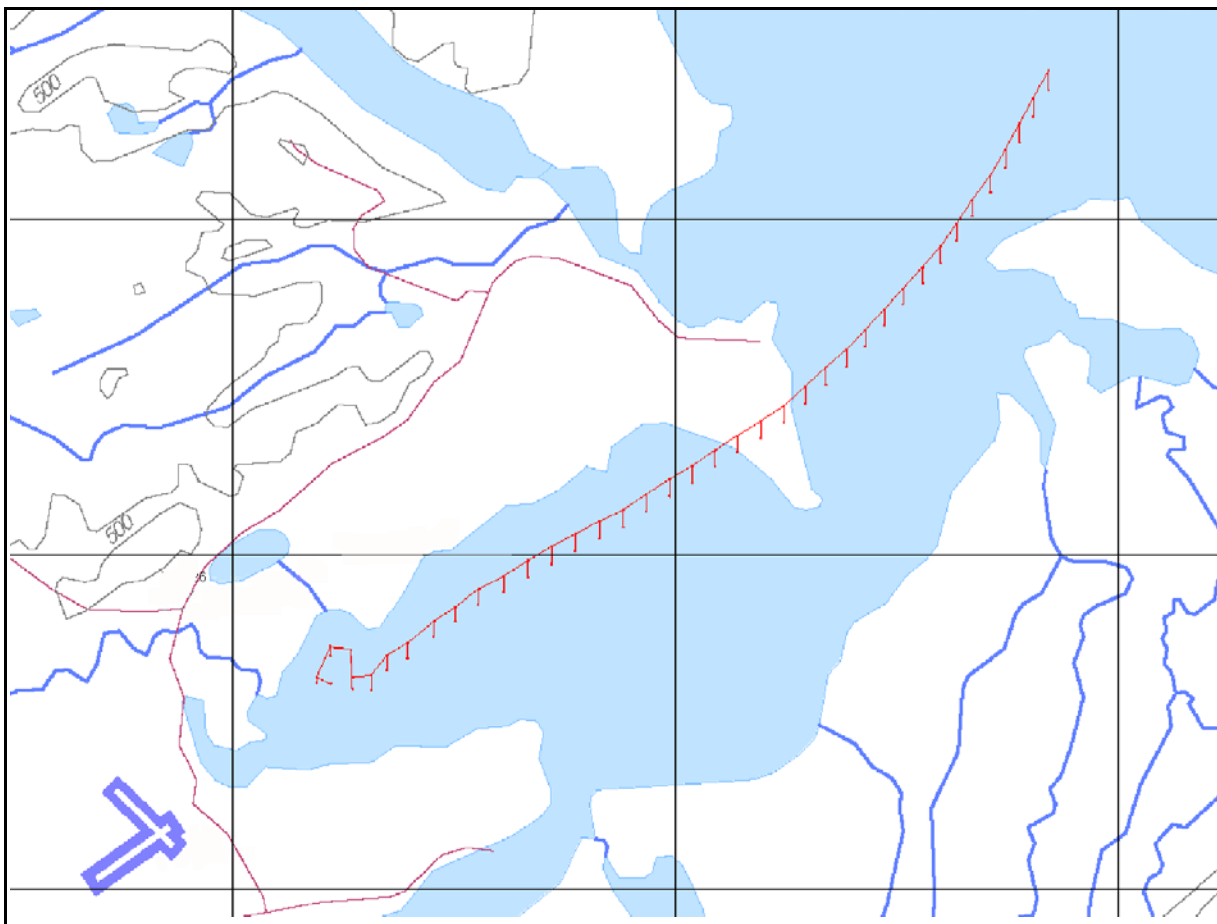
Appendix A - Final Flight Path

At 1800, while 23 nautical miles (nm) from the Goose Bay airport, the aircraft had descended to 2000 feet and was cleared for a straight-in precision approach radar (PAR) to Runway 26. Air traffic control radar data showed that the aircraft proceeded inbound at 2000 to 2100 feet, with occasional small corrections to maintain the on-course track (See Appendix A - Final Flight Path). At 1808, just inside 6 nm from Goose Bay, the pilot radioed that the attitude indicator had failed. The PAR controller immediately reverted to "No Compass" approach procedures, advising the pilot to disregard the compass.

Shortly after the pilot's transmission, the aircraft veered left, descended rapidly to 1400 feet, then levelled on a northerly heading. The PAR controller then discontinued the approach and attempted to aid the pilot by advising of necessary corrections to the flight path. The aircraft stayed on a northerly heading for approximately 20 seconds climbing gradually to 1600 feet; it then entered a spiral dive to the left. The PAR controller initiated a search immediately upon losing radar and radio contact with the aircraft. The aircraft wreckage was found by ground searchers at about 0100 hours on 15 February 2003. The search had been hampered by darkness, reduced visibility in blowing snow, and the lack of an ELT signal. The aircraft struck the ice-covered surface of Hamilton Inlet, 5 nm east of the airport, at 1809 (one hour after local sunset), in a left-wing-down, nose-low
