## AVIATION INVESTIGATION REPORT

A03O0012

### LOSS OF CONTROL – COLLISION WITH TERRAIN

PROVINCE OF ONTARIO,  
MINISTRY OF NATURAL RESOURCES  
EUROCOPTER AS 350 B2 (HELICOPTER) C-GOGN  
MEKATINA, ONTARIO  
21 JANUARY 2003

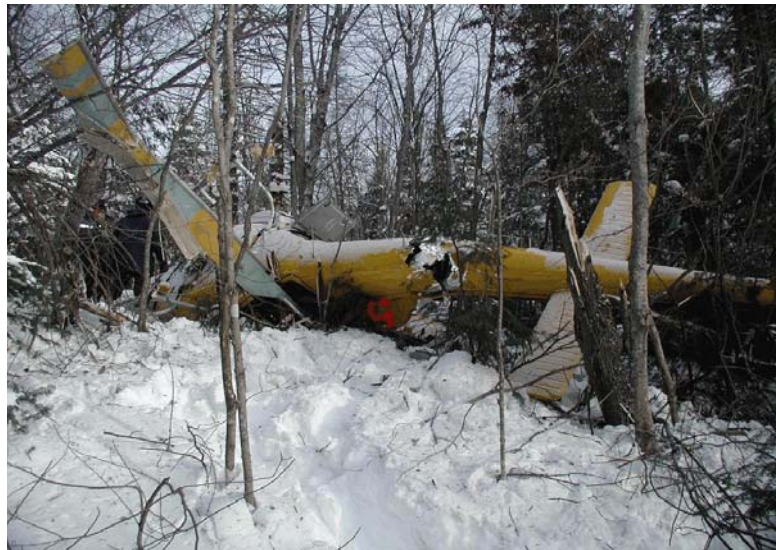
**Photo 1.** C-GOGN wreckage

The helicopter struck and cut tree tops prior to striking the ground in a steep, nose-down, inverted attitude. The nose section, windscreen and overhead roof section were completely destroyed on impact. All three main-rotor blades were extensively damaged at the time of impact, but remained attached to the rotor head. The engine (Turbomeca Arriel 1D1, serial No. 9359) was attached to the helicopter; however, the mounts were damaged. Damage to the engine was unremarkable and consisted mainly of distortion of the intake and exhaust. The fuel tank, located in a compartment behind the rear seats and under the upper deck, was completely shattered.

The snow and ground under the helicopter were saturated in jet fuel, hydraulic fluid and engine oil. The tail section of the helicopter was fractured approximately five feet aft of the attachment to the fuselage, but remained attached. The tail-rotor drive shafts were damaged. The aircraft wreckage was recovered and transported to Sault Ste. Marie Airport for further examination.

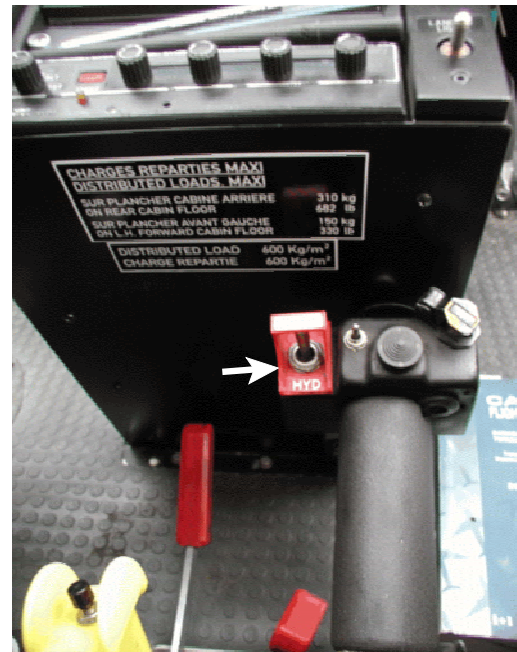
The hydraulic CUTOFF switch (Photo 2) on the collective was found in the forward or normal position. The switch guard was broken by impact forces and the switch housing was bent rearward. Because of the extent of the damage to the switch, the switch position prior to impact could not be determined, nor could the switch be tested for electrical continuity. The switch was disassembled and no discrepancies were noted that would indicate a pre-existing condition that may have prevented normal operation. This switch is powered through the hydraulic circuit breaker (CB).

Photo 2. Hydraulic CUTOFF switch and guard

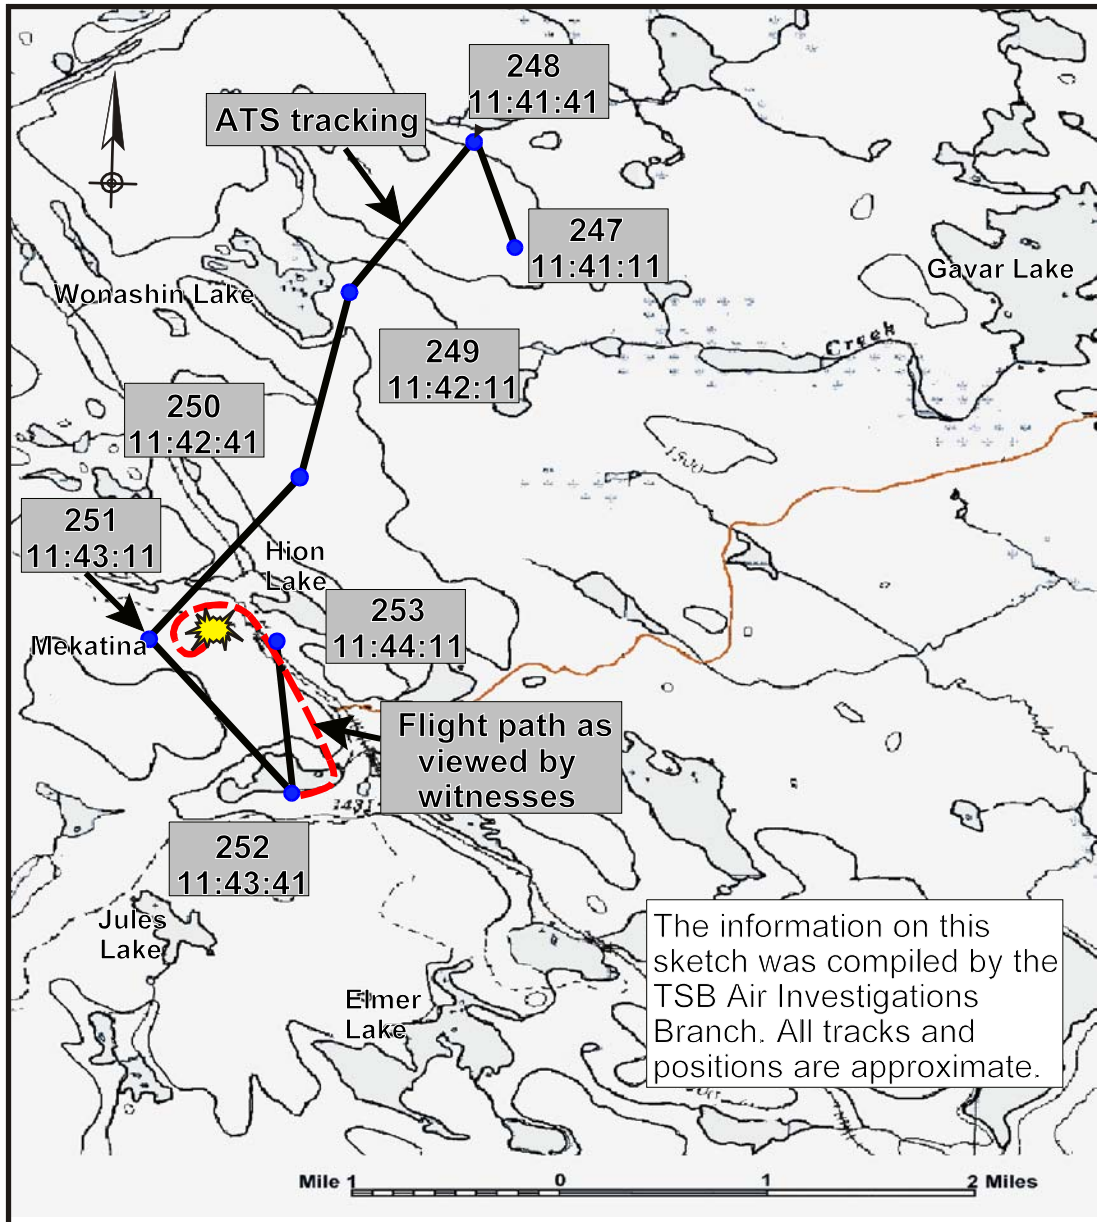
# Appendix A – C-GOGN ATS Tracking

- No. 247 11:41:11 It is likely that the hydraulic failure occurred after the helicopter passed No. 247 and before reaching No. 248. The pilot reported the hydraulic failure approximately two minutes later, at 11:43.

- No. 252 11:43:41 The helicopter was at this approximate position when the pilot reported the hydraulic failure and described the logging site in Mekatina, where he was planning to land.
