AVIATION INVESTIGATION REPORT

A03P0259

NAVIGATIONAL ERROR – PREMATURE DESCENT

AIRBUS 319-114 C-FYKW

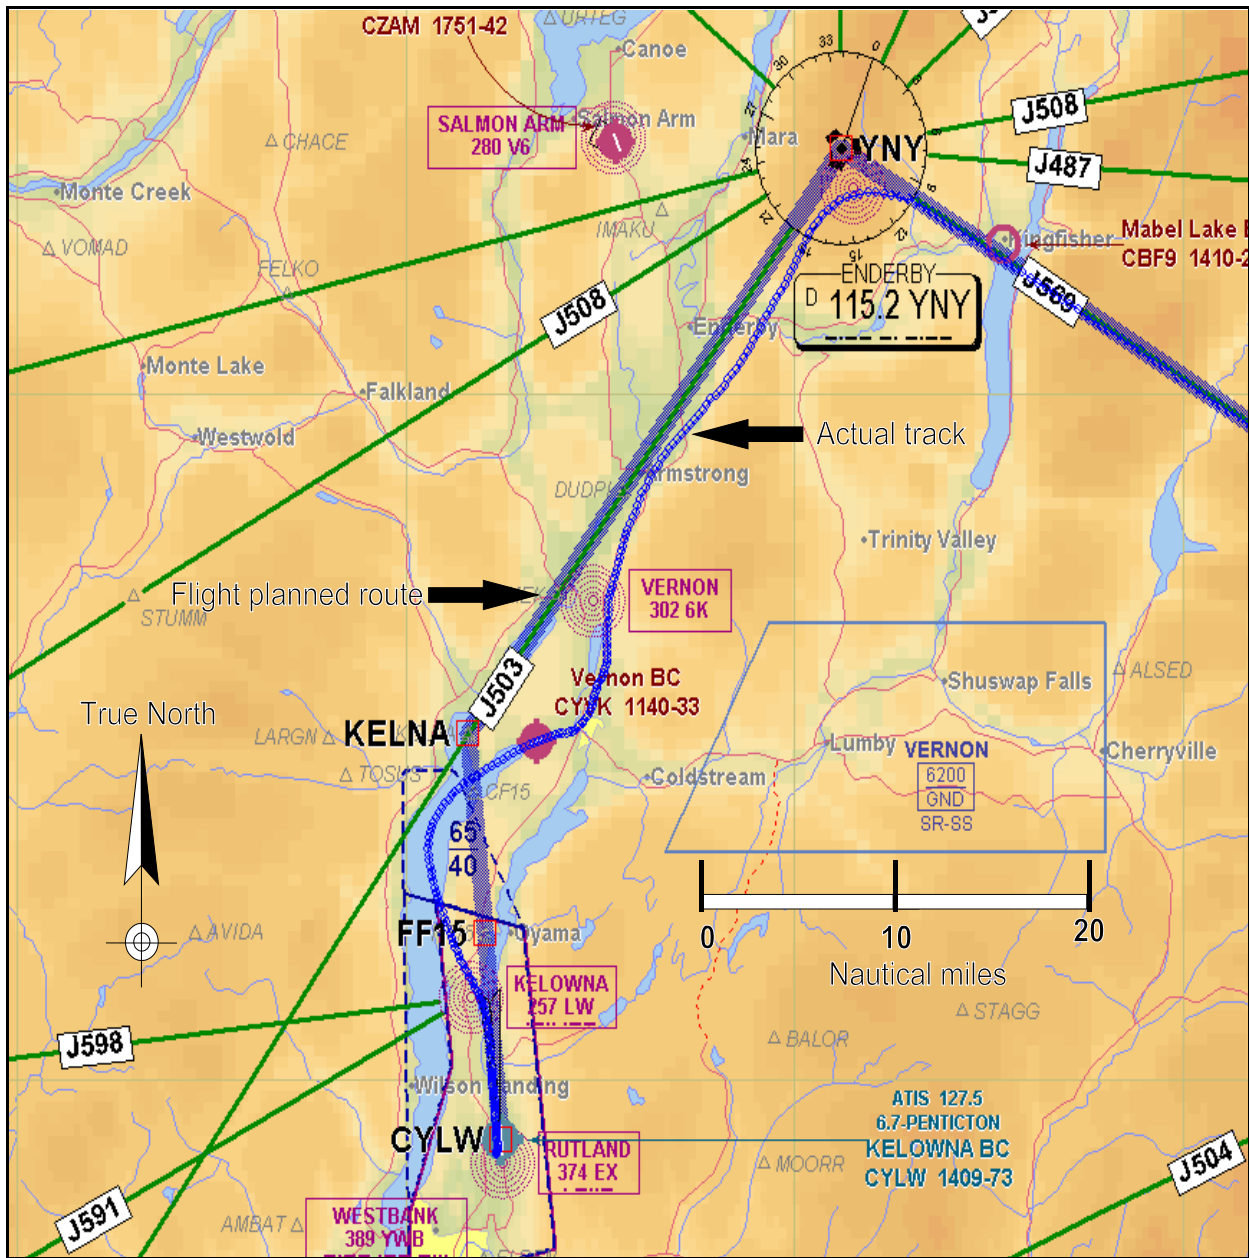
Appendix A – Track of Air Canada 186

It was concluded from information gathered from the FDR data and some flight simulations that when the Vernon airport came into view, the captain misidentified it as the Kelowna Airport and turned the aircraft to the right to line up with the centreline of Runway 23 at Vernon. Neither crew member noted that the aircraft heading and the runway heading were 80 degrees off the intended landing runway, Runway 15, nor did they make effective use of the aircraft's navigation system during the approach. The first officer, although unfamiliar with the area, was aware from his cockpit displays that considerable distance remained to the Kelowna Airport. He was, however, initially distracted by radio calls with company personnel and was slow to intervene in the approach to the Vernon Airport.

1. While executing a visual approach to the Kelowna Airport, the captain misidentified the Vernon Airport as the Kelowna Airport and executed a visual approach to the Vernon Airport, descending to 730 feet agl before executing a go-around.
2. The first officer was aware from his cockpit displays that considerable distance remained to the Kelowna Airport. He was, however, initially distracted by radio calls and was slow to intervene in the approach to the Vernon Airport.
