AVIATION INVESTIGATION REPORT
A03P0268

COLLISION WITH DOCK

WEST COAST AIRLINES LTD.
DE HAVILAND DHC-6 100 (TWIN OTTER) C-FGQH
VANCOUVER HARBOUR, BRITISH COLUMBIA
03 SEPTEMBER 2003

Report Number A03P0268

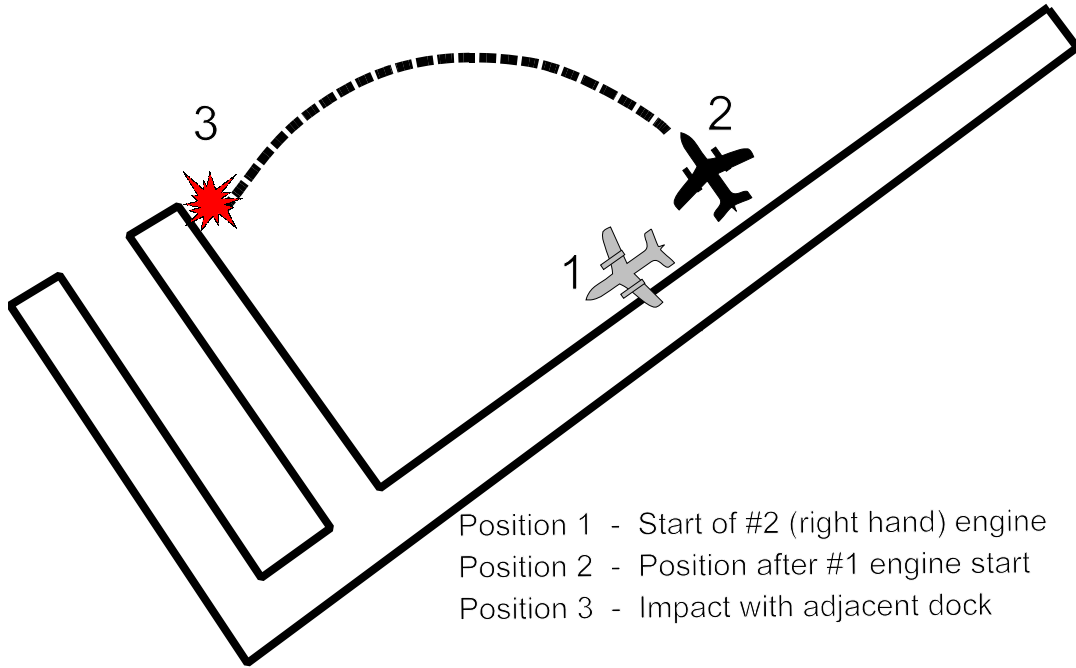
Appendix A - Dock Layout

As the PIC started to rotate the nose of the aircraft away from the dock, he realized that all the lines had been released, and that the aircraft was adrift. He responded by attempting to hold the aircraft's floats against the dock by using slight reverse on the right-hand engine, while carrying out the start of the left engine. During the left engine start, the aircraft pivoted clockwise to a position about perpendicular with the departure dock (See Appendix A). This rotation was caused by the movement of the left propeller from FEATHER to its operating range.
