AVIATION INVESTIGATION REPORT

A03W0202

CONTROLLED FLIGHT INTO TERRAIN

CESSNA 414A C-GVZE

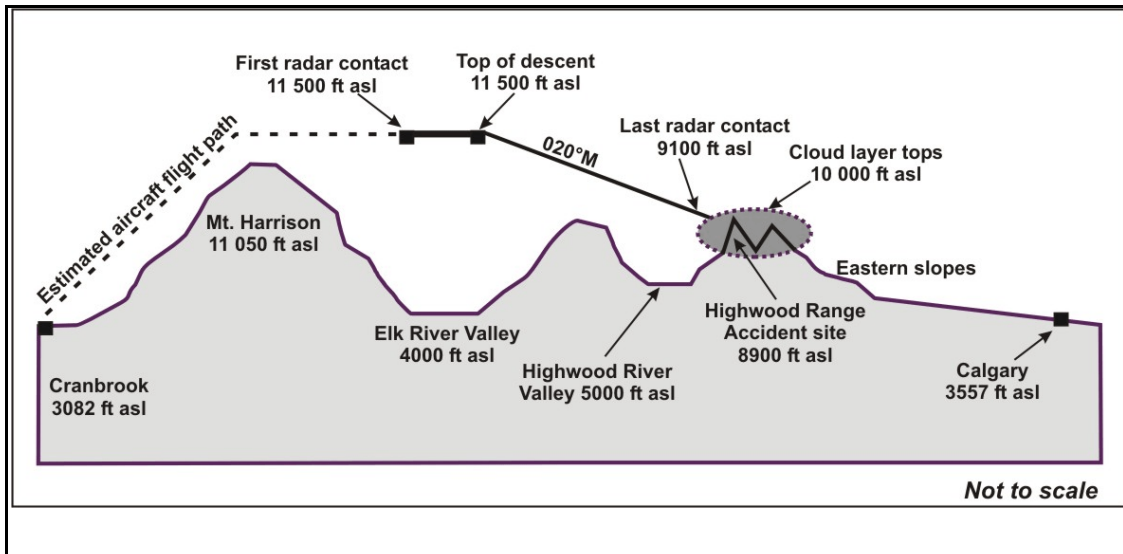
Air traffic control (ATC) radar began recording C-GVZE at 1931, when the aircraft was about 65 nautical miles (nm) from Calgary, west of the Continental Divide. The initial recorded altitude was 11 500 feet asl, and at 1933, a descent was begun out of 11 400 feet, which continued at a relatively stable rate of 828 feet per minute for the remainder of the flight. The descent started over the Continental Divide; it continued over the high mountain ranges east of the Divide and into the Highwood Range, east of the Highwood Valley.

The target disappeared from radar at 1936; the last recorded information showed the aircraft at 9000 feet asl and 240 knots ground speed. From initial radar contact until the beginning of the descent, the ground speed remained constant at about 195 knots in cruise and accelerated to an average of 225 knots during the descent (see Figure 1).

The Highwood River Valley is a large, wide valley that lies on the west side of the Highwood Range, where the impact occurred. Beyond the Highwood Range, on the flight path toward Calgary, the terrain drops off into the eastern slopes of the foothills (see Figure 1).
